# SERVICE No. 573 BULLETIN

February 8, 1978

Subject: Wing Fuel Tank Cap Modification

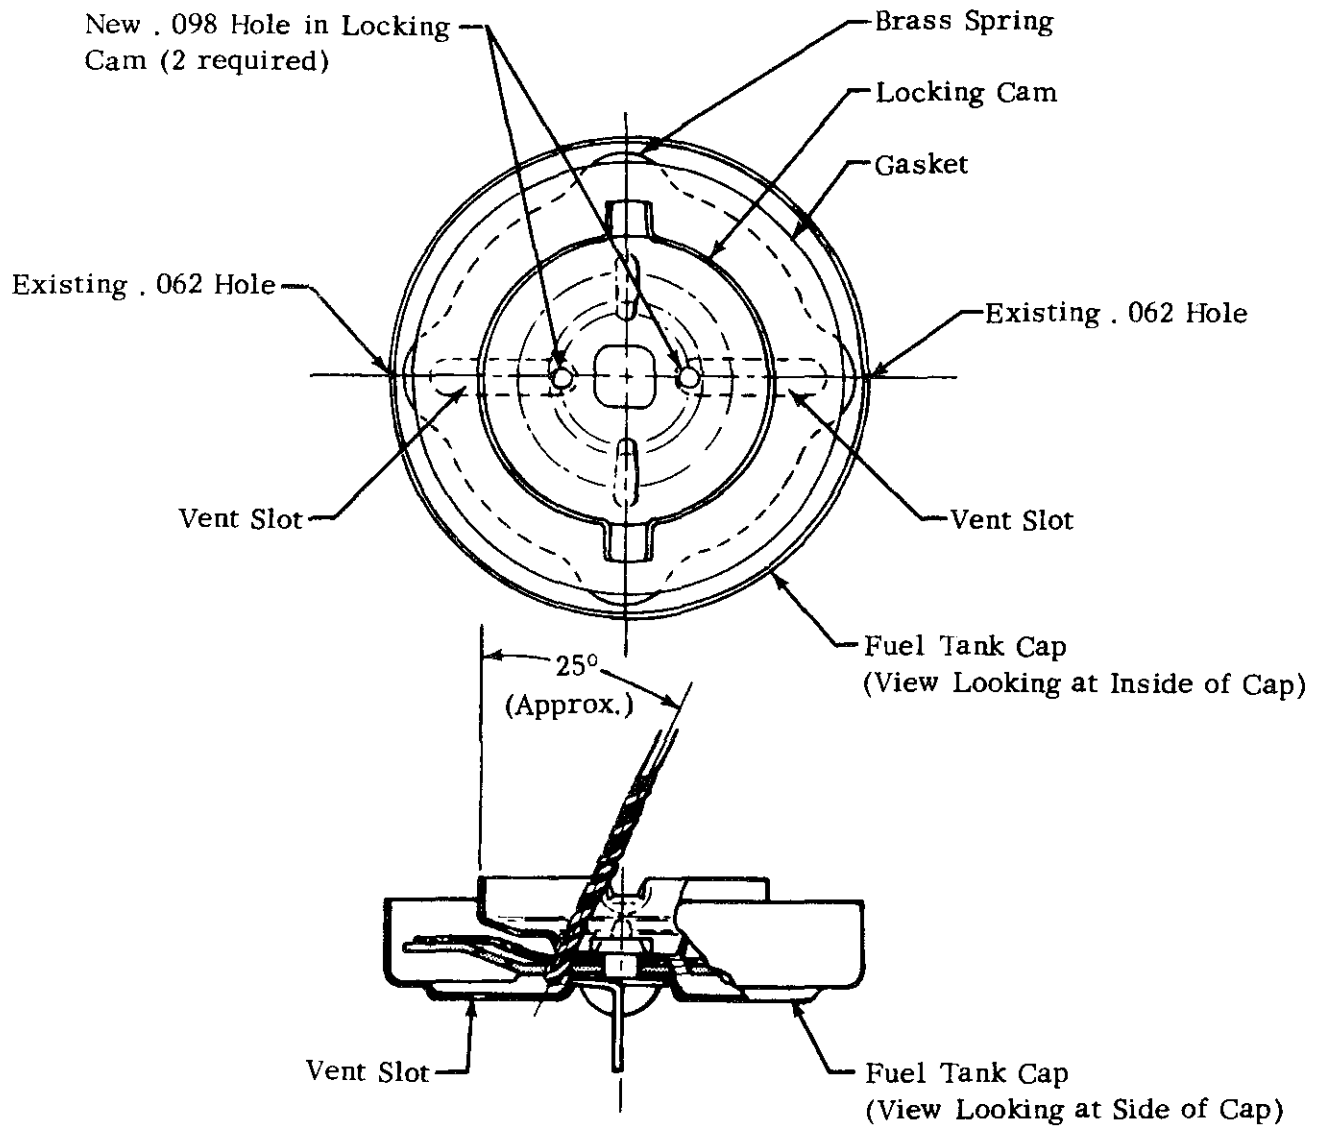
A recent fuel tank collapse was attributed to inadequate venting, caused by obstruction of the cap vent holes (installed per above referenced Service Bulletin). Accumulation of foreign material (corrosion, dirt, ice, etc.) inside the cap "sealed off" the cap internal vent slots.

This service release provides instructions to drill two additional vent holes in the cap assembly to insure adequate venting -- in the event that the present vent slots (located in the cap locking cam plate) are obstructed and recommends cleaning and inspecting present vent slots.

1. Remove fuel tank caps from wings and rework caps as follows:
  - a. Locate and mark center of two .098 holes on locking cam of cap as shown. Use existing .062 vent holes to index location of new .098 holes.
  - b. Drill two .098 holes ( $\pm 40$  drill) through locking cam. Angle drill to intersect end of vent slots as shown. **CAUTION: Do not allow drill to go through top cover of cap.**
  - c. Insert .032 wire in existing .062 holes. End of wire will be seen in new .098 holes if holes were correctly drilled.
  - d. With .032 wire in .062 holes, slide wire back and forth to loosen any corrosion or dirt that may be in the vent slots. Clean cap thoroughly with compressed air.
2. Reinstall reworked fuel tank caps and make proper Logbook entry of Service Bulletin 573 compliance.
