Rib Repair Diagram

PIPER AIRCRAFT CORP.
 LOCK HAVEN, PENNA.
 SERVICE DEPARTMENT

S. M. No. 10

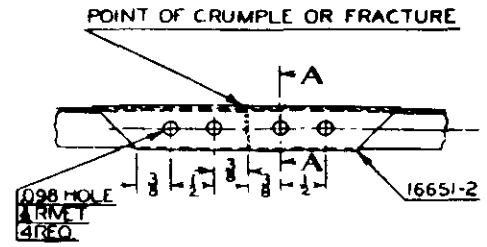
NOTE: FORM REINFORCEMENT OVER CAPSTRIP AND RIVET TO WEB OF CAPSTRIP AS SHOWN

NOTE: THIS REPAIR MAY BE USED AT ANY POINT ON CAPSTRIP EXCEPT AT CLUSTERS OR FORWARD OF FRONT SPAR.
