# SERVICE BULLETIN

No. 174B

Piper Aircraft Corporation

**SUBJECT:** Inspection and Maintenance of Fuselage Fabric in Area of Windshield Top Attachment Channel

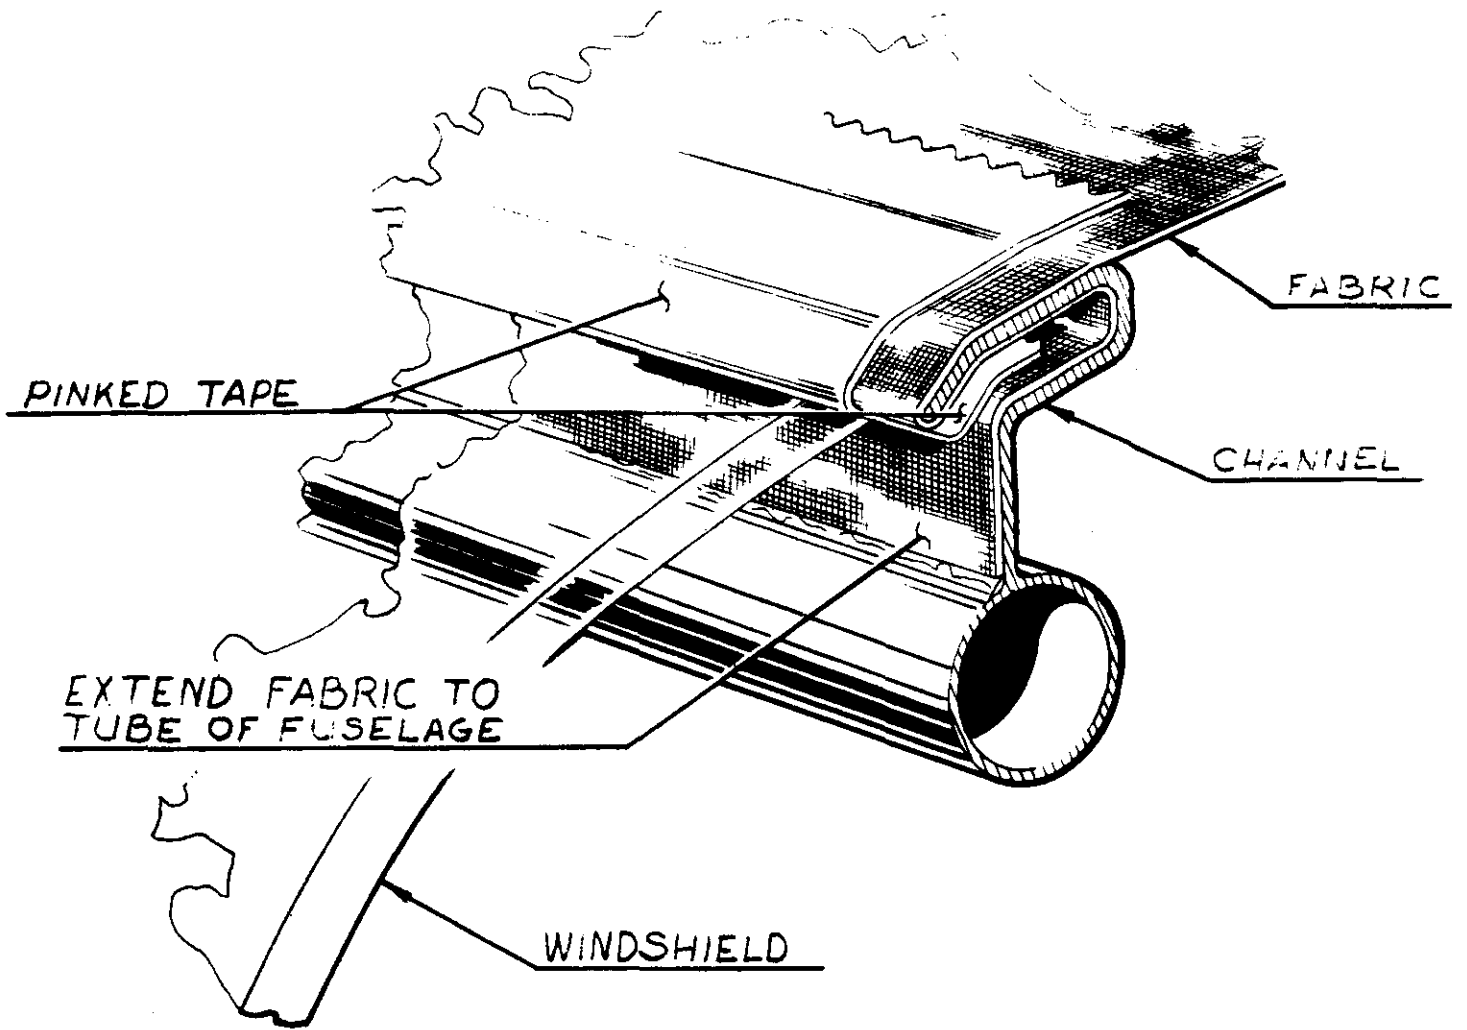
Service experience indicates that, in a few cases, the above mentioned airplanes have had difficulties with the fabric where it attaches to the fuselage under the windshield top and/or directly over the rear edge of the windshield top attachment channel.

During the service life of these airplanes it has been brought to our attention that, during the recovering operation, the fabric at the windshield channel was attached in a very careless manner, resulting in an unsafe condition.

All the above mentioned airplanes shall be carefully inspected at this point and any sign of deterioration of the fabric shall require that a strip of 2-1/2 inch pinked reinforcement tape be added per sketch shown on the reverse side of this bulletin.
