VENDOR SERVICE PUBLICATION

SUBJECT: Oil Pump Impeller and Drive Replacement; AVCO Lycoming Service Bulletin No. 385C dated October 3, 1975 (attached).

Service Bulletin No. 385C
(Supersedes Service Bulletin No. 385B)
Engineering Aspects are
FAA (DEER) Approved

SUBJECT: Oil Pump Impeller and Drive Replacement

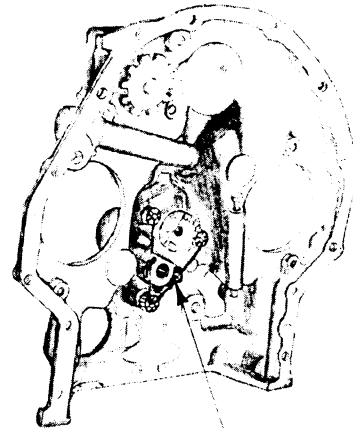
Figure 1. Interior View of Accessory Housing Showing Location of Cotter Pin in Oil Pump Idler Shaft

INSPECTION: Applicable remanufactured engines shipped after December 21, 1972 should be inspected to determine if this modification is required: first of all, if the engine log book indicates the engine has not been modified in accordance with Service Instruction No. 1230 or No. 1272, proceed to remove the accessory drive cover from the mounting pad at the lower right side of the accessory housing to obtain access to the area between the crankcase and the accessory housing. On some engines this accessory drive pad is not machined, in this event it will be necessary to remove either the left magneto or the *fuel pump to obtain access to the area between the crankcase and the accessory housing. Regardless of which accessory pad is used, determine if the oil pump idler gear is secured with a cotter pin at the location shown in figure 1. This can be accomplished using an inspection mirror, preferably an illuminated one. If the cotter pin is visible, it is unnecessary to perform the modification required by this bulletin.

IF IDLER SHAFT IS SECURED WITH A COTTER PIN AT THIS LOCATION MODIFICATION IS NOT REQUIRED

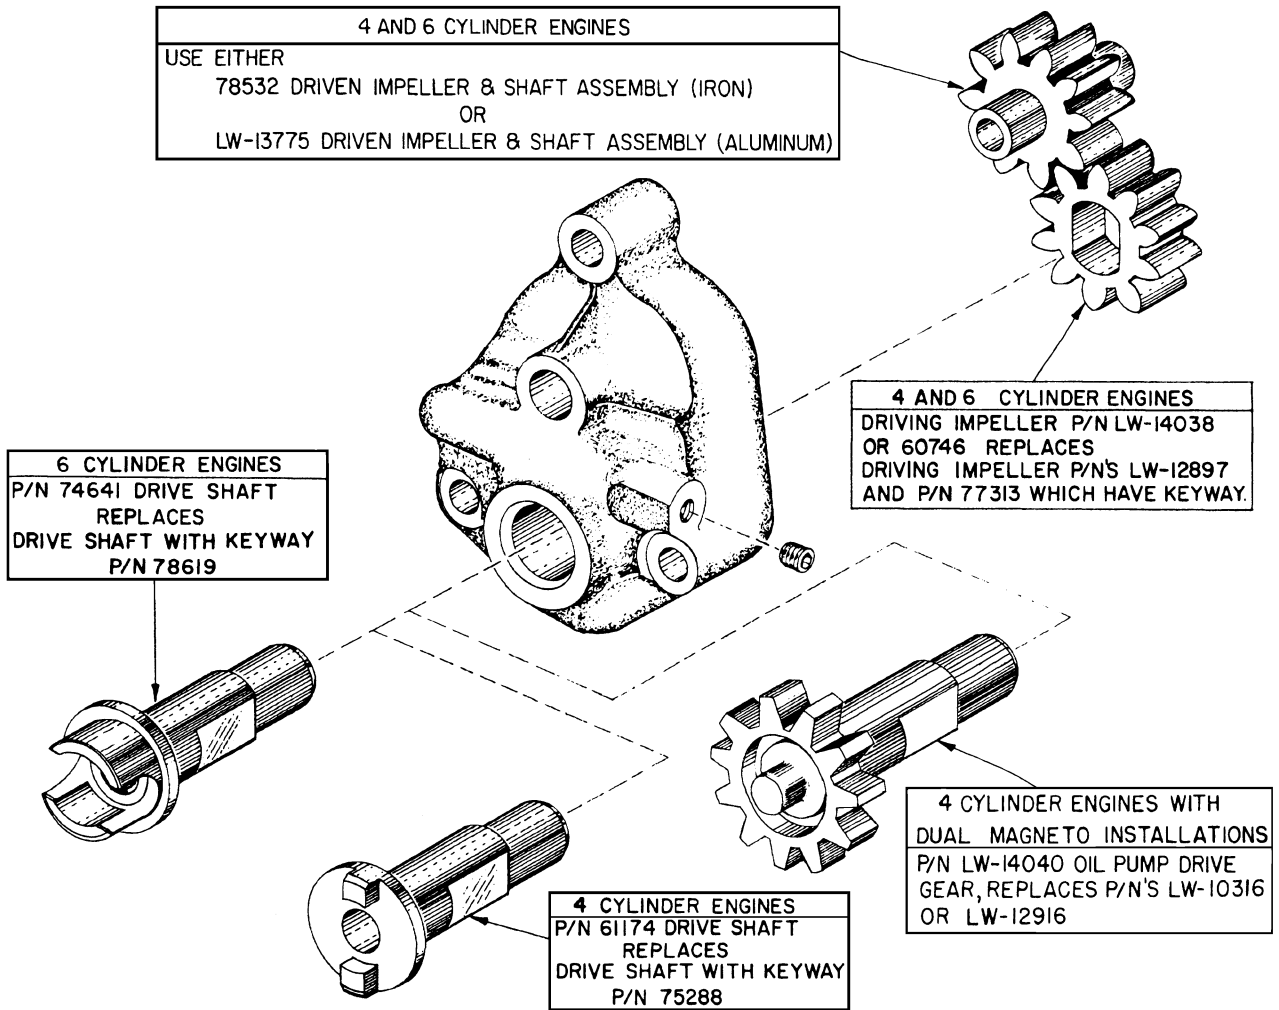
Figure 2. Oil Pump Drive Assembly

This modification consists of replacing the oil pump drive shaft and drive impeller to eliminate the Woodruff key drive which has proven to be the cause of excessive wear in the keyway of the hardened drive impeller. Therefore, it is recommended that all of the applicable engines listed in the chart, as well as any others that may have been modified in accordance with Service Instruction No. 1272, use the following procedure for parts replacement.

3. Reassemble the oil pump using the new drive shaft and drive impeller supplied with the kits shown in the following "Parts Data" section. See figure 2. Be sure all of the parts are lubricated thoroughly during assembly.

After assembly turn the drive shaft several revolutions to determine if it moves freely; if not, open the pump and correct the cause before the unit is reassembled on the engine.
