VENDOR SERVICE PUBLICATION

SUBJECT: AVCO Lycoming Service Bulletin No. 464A

Service Bulletin No. 464A
(Supersedes Service Bulletin No. 464)
Engineering Aspects are
FAA Approved

SUBJECT: Inspection of impulse coupling cam assemblies.

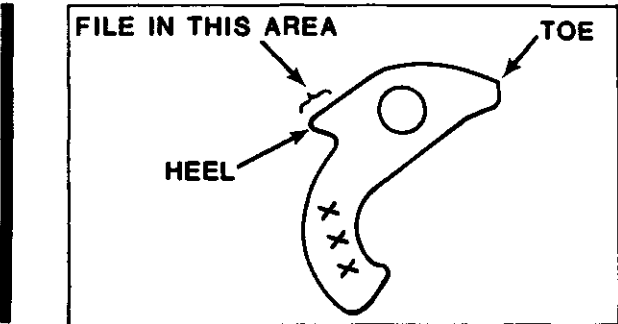
Figure 1.

Some improperly heat treated (soft) flyweights have been reported on impulse couplings currently in service. If this condition exists and is not detected, impulse coupling failure could occur. The flyweights must be inspected in accordance with the instructions in this Service Bulletin and if defective (soft) the impulse coupling or cam assembly must be replaced immediately.

3. Use finger pressure to push inward on the toe (see figure 1) of each flyweight so that the flyweight heel protrudes outward.
4. Using a fine #1, double cut, 1/2 inch wide file, at least 3/32 inch thick, pass the file across the heel of the flyweight attempting to remove material. (See figure 1.) If the flyweight has been properly heat treated the file will "glide" smoothly over the heel of the flyweight, removing no material. If the flyweight is not properly heat treated (soft), the file will not "glide" easily across the surface of the flyweight heel, and material will be removed.

XXX indicates heat treated flyweight by lot number

5. If an improperly heat treated (soft) flyweight is found, immediately remove and replace the cam assembly and/or the impulse coupling assembly following procedures in the magneto overhaul instructions, and paying strict attention to notes and cautions.

11. Any cam assembly with an improperly heat treated (soft) flyweight should be returned to the manufacturer through a currently Authorized Bendix Engine Products Division Distributor.
12. A new method of marking is being implemented to permanently identify heat treated cam assembly flyweights. See figure "1" for location. Pending consumption of current inventory, there will be a mixture of assemblies identified by the following methods.
 1. Original method ---- Yellow paint (Dykem or Lacquer) on the heel of each flyweight.
 2. New method ---- Stamped numbers as indicated in figure "1" on each flyweight.
