BULLETIN

Bulletin No. 96

Subject: Voltage Regulator Relocation Model PA-12
Serial 12-1 to Serial 12-823 Incl.

To: Owners of Piper PA-12 Airplanes

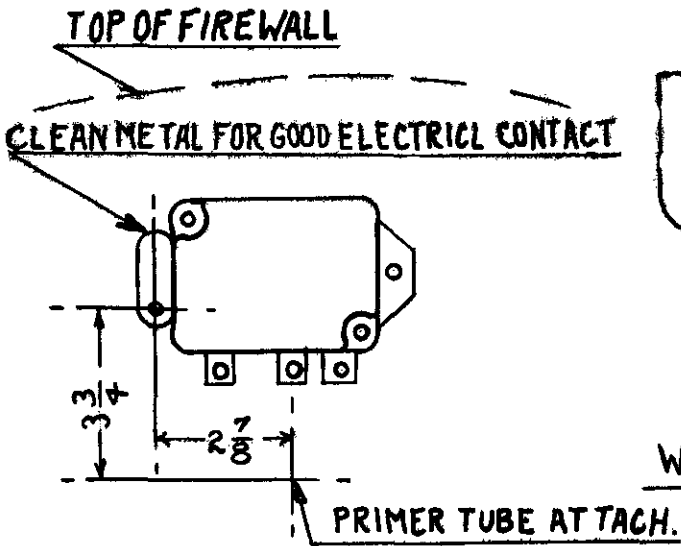
SKETCH 1

It has been found necessary to relocate the voltage regulator due to the excessive heat at the lower right side of the firewall. The new location is in the center of the firewall above the top motor mount attachment points. See Sketch 1 for locating details. A wire harness assembly, part number 10919, is to be used to complete the installation. A Kit to make the complete installation will be available at no charge. All owners of airplanes with serial numbers noted above are requested to contact their local distributor or dealer to secure the kits. The Kit will include:

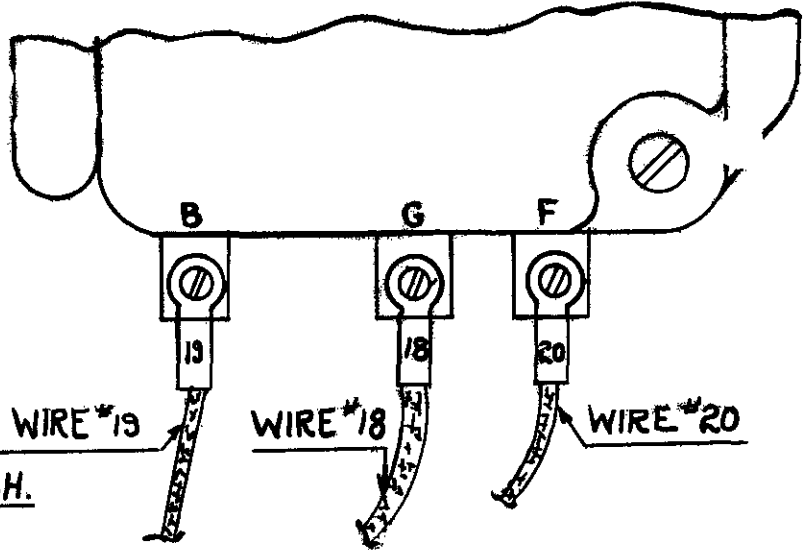
SKETCH 2

Sketch 2 shows the attachment of the wires at the voltage regulator.

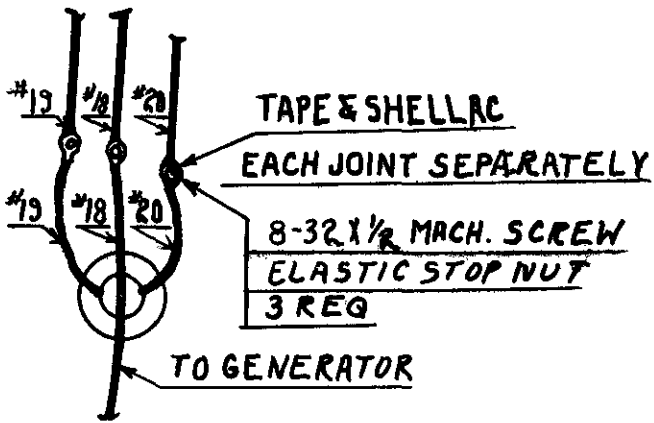
SKETCH 3

Sketch 3 shows the attachment of the wires at the lower right of the firewall.

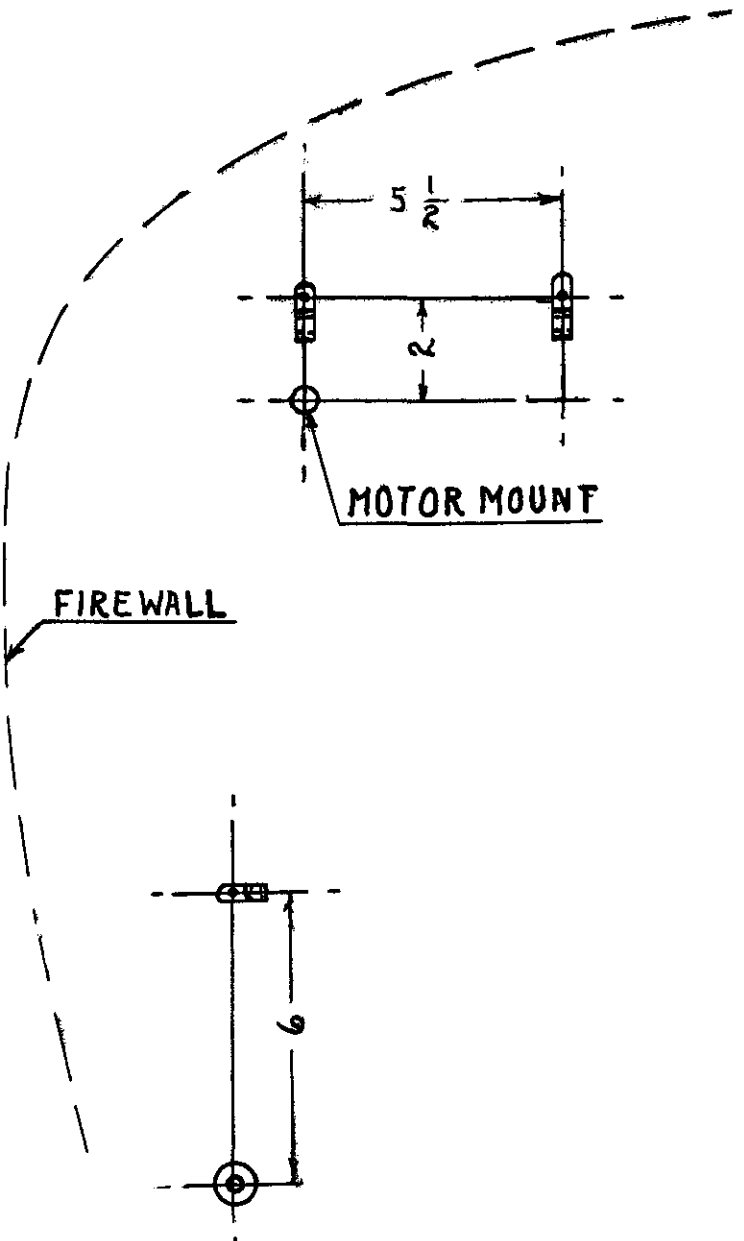
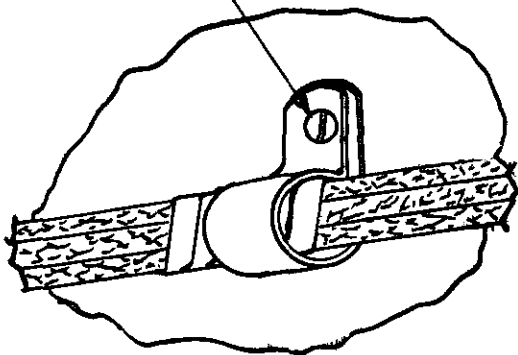
SKETCH 4

Sketch 4 shows a typical clamp installation and also the location of the clamps.
