# SERVICE

# BULLETIN

Bulletin No. 100

**SUBJECT:** PA-12 Cowling Interference

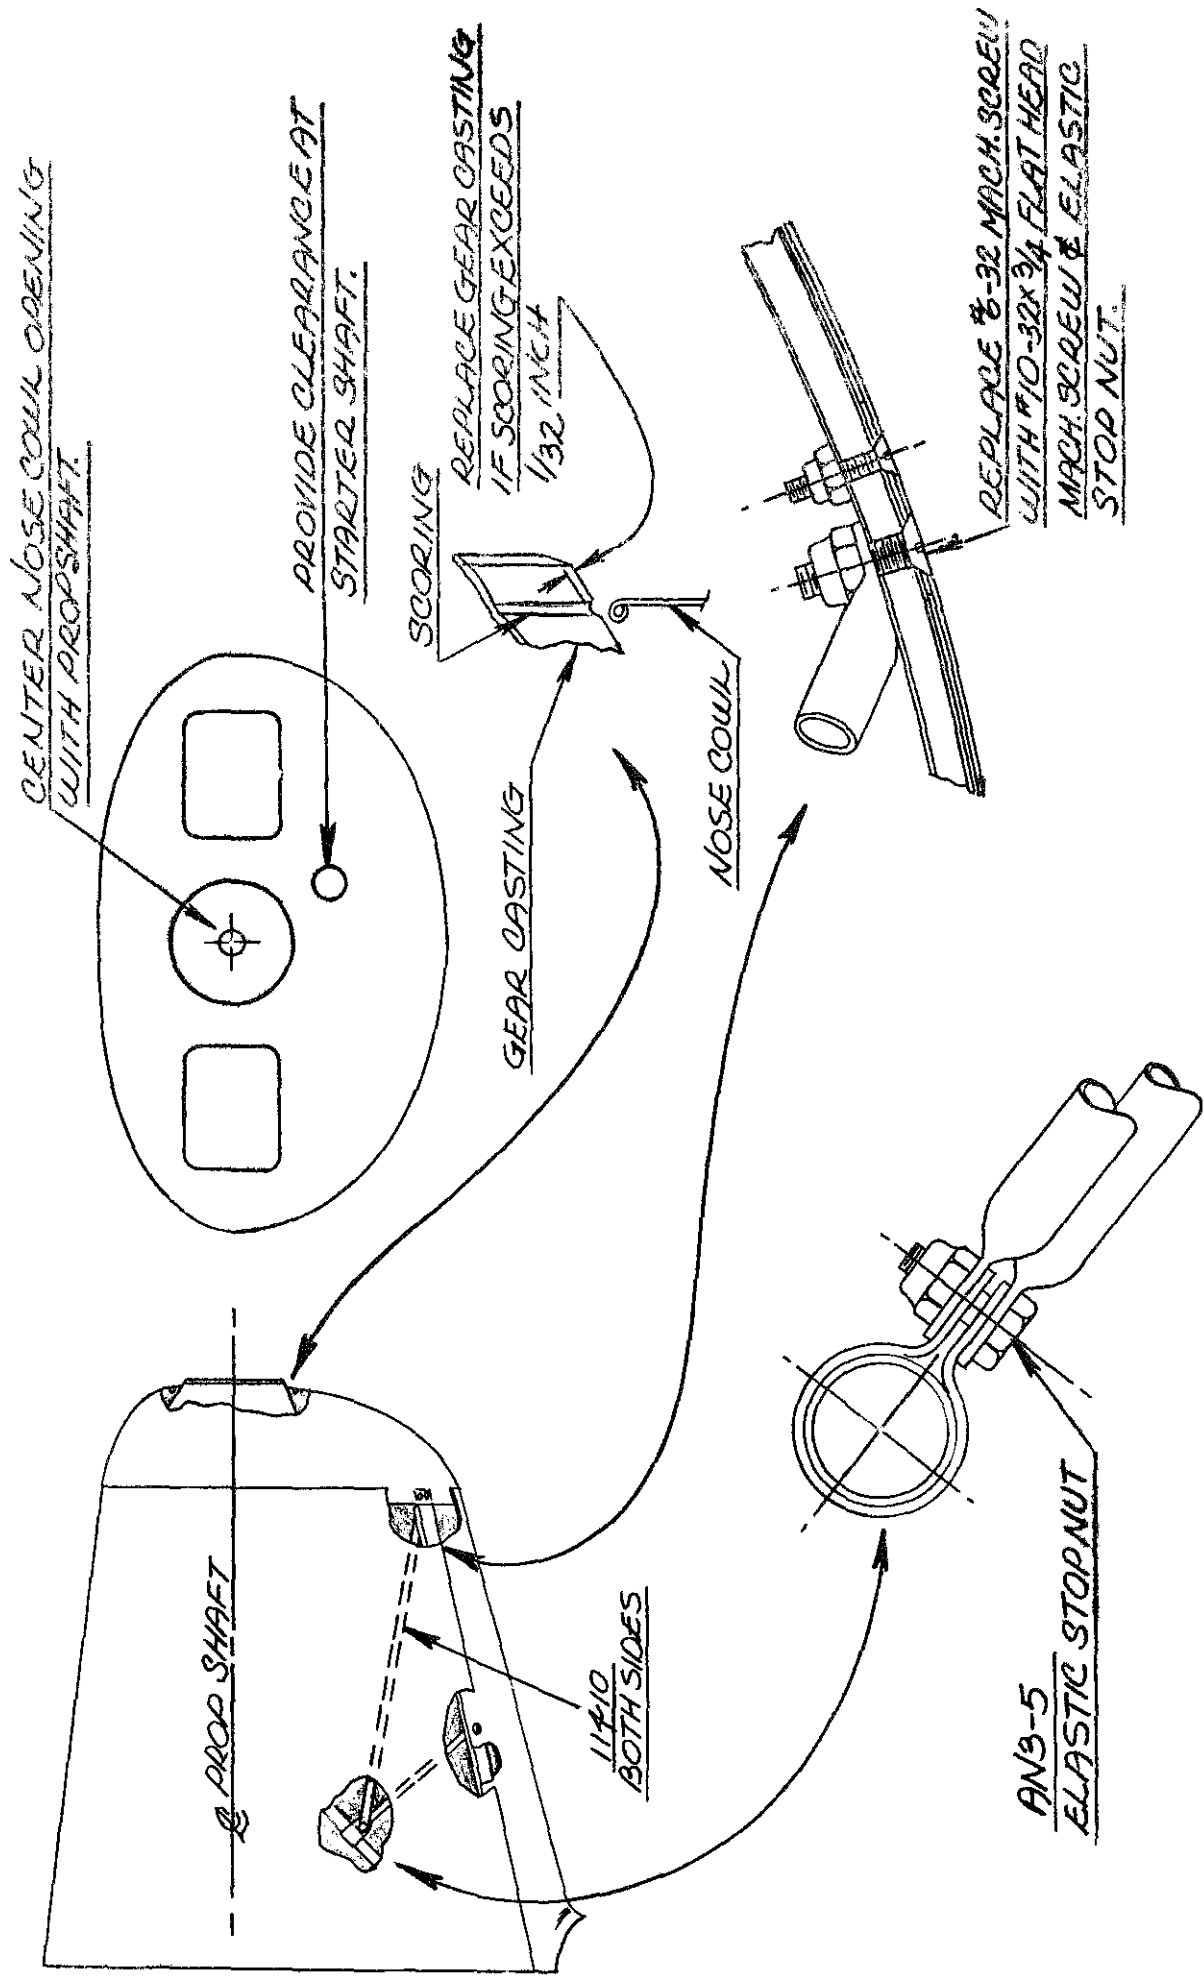
FIGURE 1  
COUIL BRACE INSTALLATION

Some difficulty has been experienced with the PA-12 Cowl attachments loosening and allowing the nose cowl to bear against the starter ring-gear casting near the propeller hub; in some cases, actually severing the casting.

To prevent the occurrence of this difficulty, we recommend that additional braces Part No. 11410 be installed according to the sketch shown on opposite side of this bulletin. These parts are available through your local Piper dealer or distributor.

A general tightening of all cowl attachments is also advised, and particular care should be exercised to "center" the cowl opening with the propeller shaft. Clearance at the starter shaft also should be assured.
