SERVICE

BULLETIN

Number 101

SUBJECT: Ignition Wire Shielding

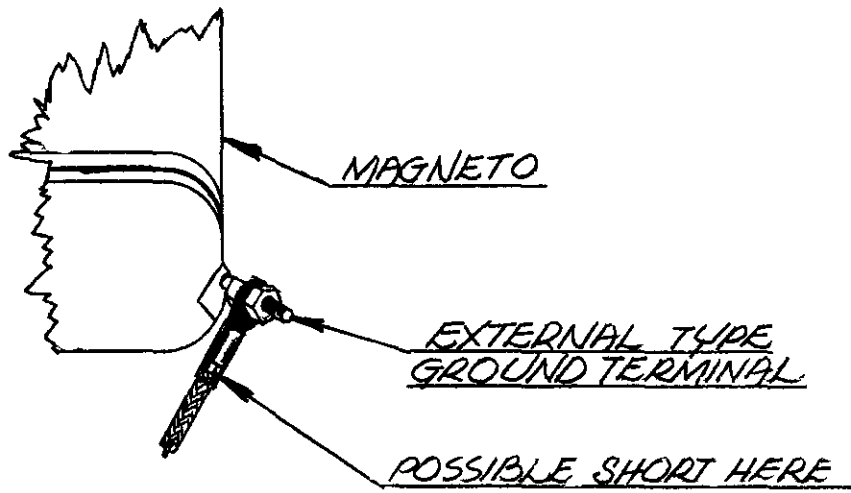
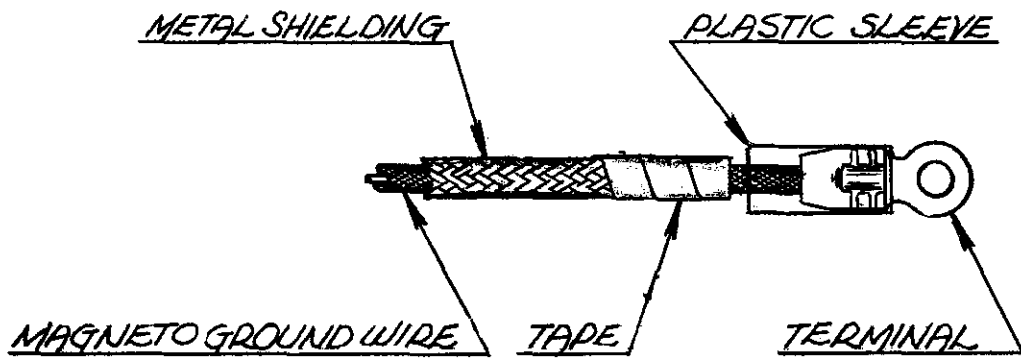
A majority of the above serial number airplanes have the external type attachment for the ground wire on the magneto. (See Sketch on opposite side.)

There is a possibility that the shielding on the magneto ground wire on these airplanes may come in contact with the terminal at the magneto attachment. This will cause grounding of the magneto and result in engine failure.

To prevent the occurrence of this difficulty, it is recommended that the shielding be withdrawn from the plastic sleeve, and securely taped to the wire as shown on the sketch.
