# SERVICE

# BULLETIN

Bulletin No. 102

Subject: Electrical System - Model PA-12

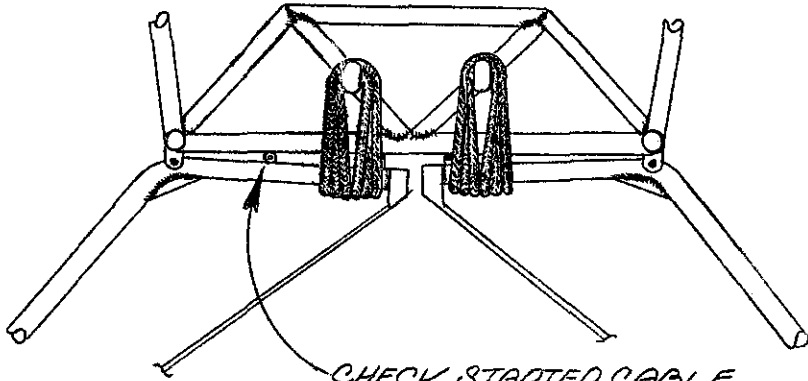
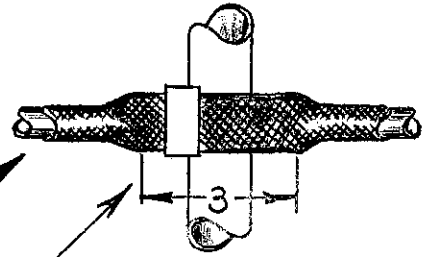
FIGURE 1a

- a. With the compression of the rubber stop blocks in the landing gear, there is a possibility that the starter cable insulation may be damaged where it passes between the landing gear and the fuselage member; This condition is aggravated on some airplanes by the omission of the flattening operation on the starter cable (tube) at this point.

CHECK STARTED CABLE FOR INSULATION DAMAGE: FLATTEN AS SHOWN.

We, therefore, recommend that an immediate inspection be made of the starter cable insulation at this point. Flatten cable, as shown on sketch, if this has not been accomplished; and, where damage or wear is found, wrap with several layers of tape.

REMOVE CABLE FROM CLIP & FLATTEN AS SHOWN. USE WOODEN BLOCKS TO AVOID DAMAGE TO INSULATION.

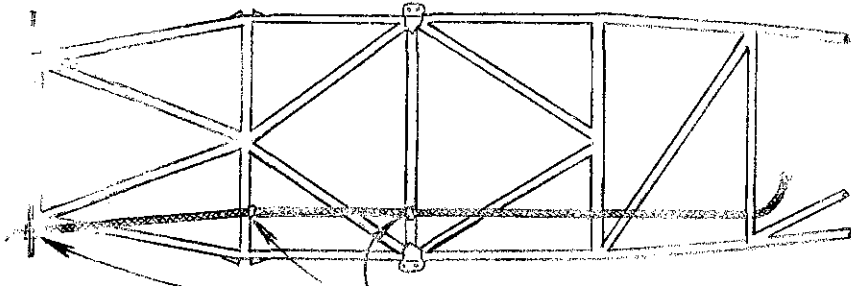
FIGURE 1b

- b. Check all other attachments of the starter cable to fuselage members, and where it passes through firewall; reinforcing these areas with tape, as in point 1a.
- c. An interference has occurred on some installations between the joint in the starter cable and the cowl channel just forward of the firewall. Bend the cable to provide 1/2" clearance with cowl channel.

CHECK THESE POINTS FOR INSULATION DAMAGE

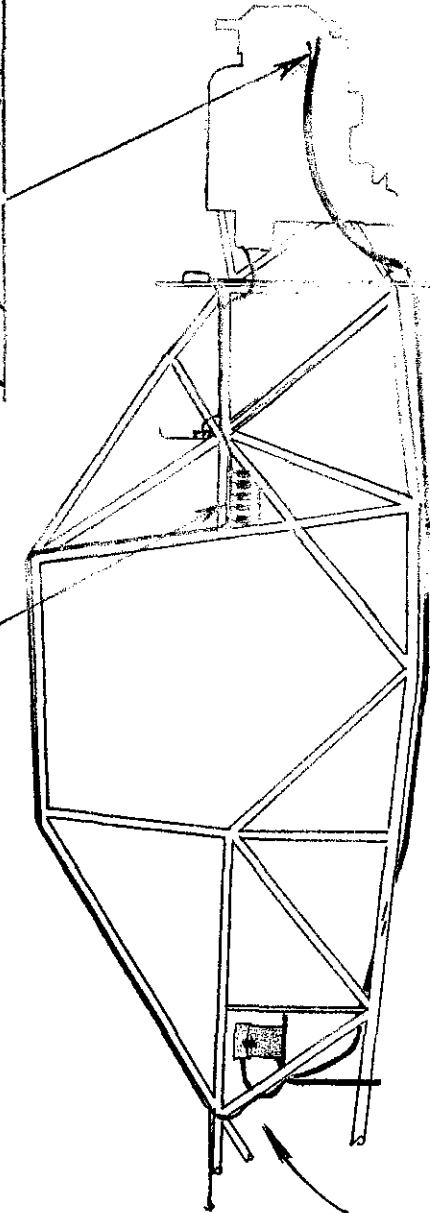
FIGURE 2

2. An inspection should be made of all other wiring in the fuselage and engine compartment, especially at attachments. Critical points are shown on sketch. Worn or damaged insulation should be generously wrapped with tape.

3. It has been found that when starting the engine with a partially discharged battery, the starter solenoid, Part No. 1456, contacts have a tendency to arc and occasionally to stick. A replacement solenoid, Part No. 1453, which will correct this trouble, is available through the engine manufacturer on a no charge basis providing the old solenoid, Part No. 1456, is returned for credit. We recommend that this change be made as soon as possible.

4. The battery box drain should be inspected to assure the proper attachment of the hose to the drain tube. Neglecting to replace the hose after a battery change has resulted in acid damage to the structure and fabric on a number of airplanes.

CHECK SWITCH PANEL FOR  
TERMINAL & WIRE CLEARANCES  
WITH ADJACENT STRUCTURE

CHECK GENERATOR WIRE  
FOR CLEARANCE WITH  
ADJACENT PARTS.

CHECK WIRE INSULATION AT  
FIREWALL GROMMETS &  
ATTACHMENT POINTS.

BATTERY BOX  
DRAIN TUBE - SEE  
PARAGRAPH 4

SOLENOID - SEE PARAGRAPH 3
