SERVICE

BULLETIN

Bulletin No. 105

SUBJECT: MODEL PA-12 BATTERY HOLD-DOWN AND FUSE BLOCK

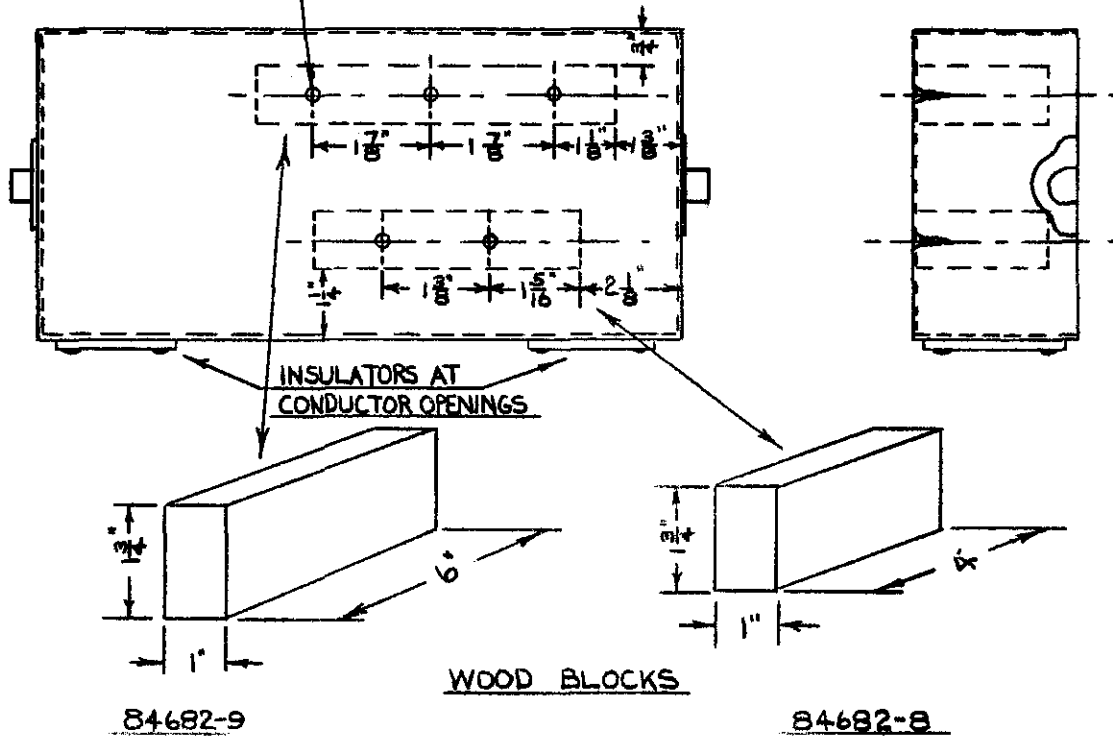
BATTERY BOX COVER ASSEMBLY

On early model PA-12 airplanes the BATTERY HOLD-DOWN, when provided, consists of a metal bracket with fibre insulation at its lower end.

Reports have been received that the insulation in some cases has deteriorated, allowing the bracket to contact the battery terminals causing a short circuit.

To avoid the possibility of this occurring, we recommend that on all airplanes listed above, wooden blocks be installed as shown on the sketch on reverse side this bulletin.

These parts, numbers 84682-09 and 84682-08, one each required, are available through your local Piper Distributor or Dealer, at cost.

1/13 HOLE IN COVER
*4 WOOD SCREW, 5 REQ.

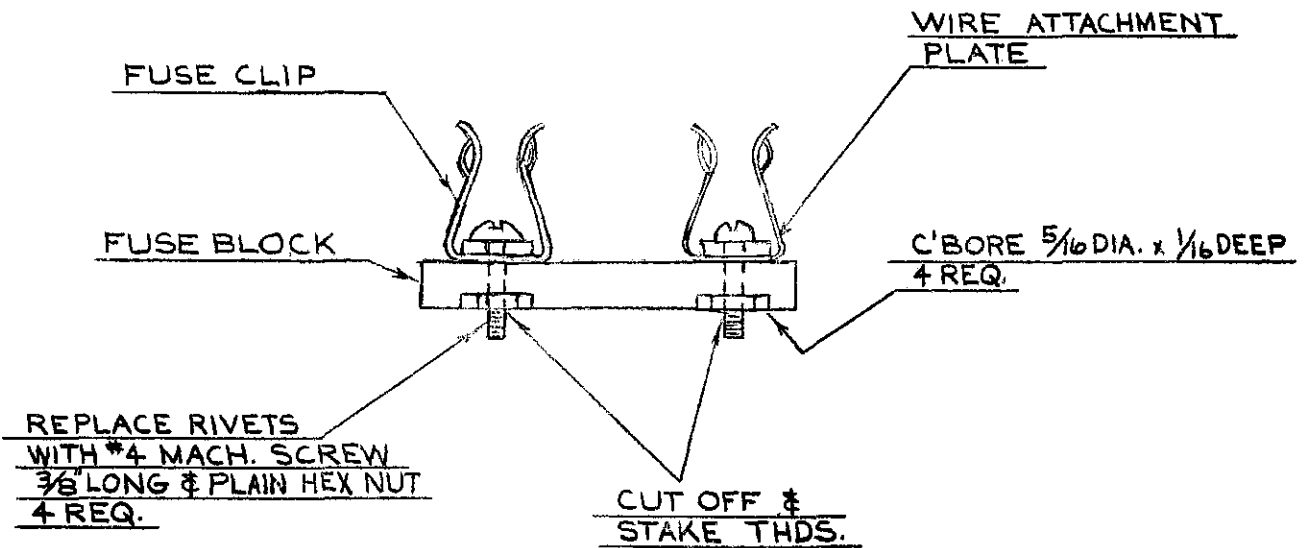
FUSE BLOCK ASSEMBLY

Reports have been received of arcing occurring between the fuse-clip and the wire attachment plate on the fuse block. These parts are held in contact by a rivet, which in some cases becomes loosened. As the arcing may cause premature fuse failure, we recommend the fuse block be removed from the airplane and revised as shown on sketch on reverse side this bulletin, or replaced with reworked part.

After removing fuse block from plane, the reworking may be done as follows:

1. Punch out clip attaching rivets.
2. Counter bore fibre block 5/16 dia. x 1/16 at rivet holes. (Continued)

3. Re-assemble using #4 machine screws and plain hex nuts in place of rivets.
4. Cut off excess screw length.
5. Stake threads (support screw head while staking).

New fuse blocks, of the reworked type, Part No. 11718-00, one required, are available through your local Piper distributor or dealer, at cost.
