Service Bulletin No. 106

August 4, 1948

SUBJECT: MODEL PA-14 REAR FLAP PULLEY BRACKET REINFORCEMENT

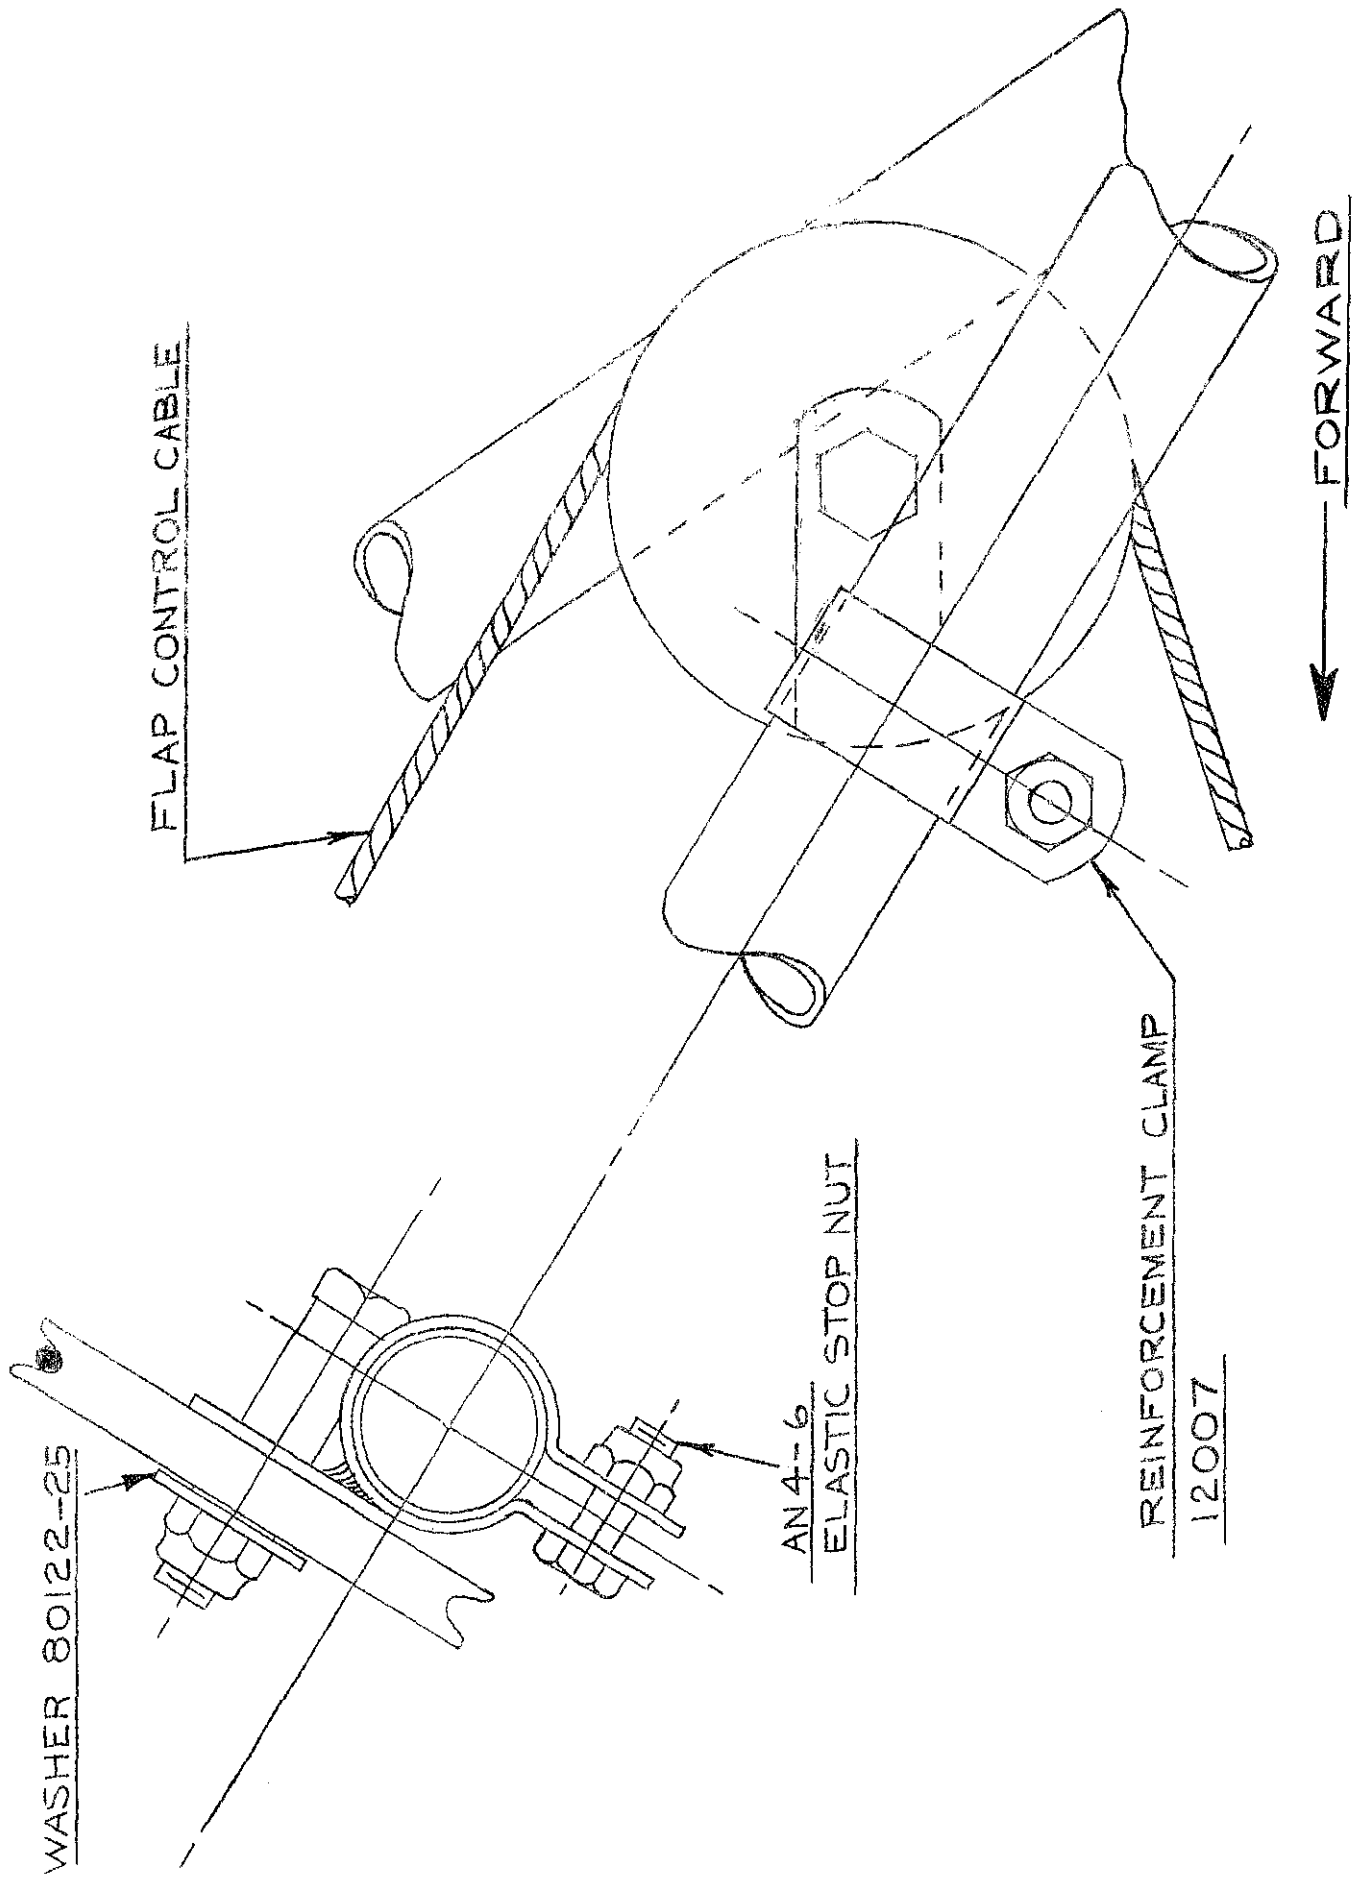
A few reports have been received from the field regarding failure of the rear flap pulley bracket probably due to insufficient weld area in conjunction with operation of flaps at excessive speeds.

Directions for installation (see sketch on reverse side):

1. Remove rear seat back cushion.
2. Remove rear deck and trim panel.
3. Pull headlining material away from channel, at left rear corner of baggage deck, to provide access to the flap pulley.
4. Remove pulley and washers.
5. Install clamp as per sketch, but do not tighten bolt.
6. Install pulley, special washer tighten nut and cotter.
7. Tighten clamp bolt.
8. Cement headlining back in place and dampen lightly to remove any wrinkles that might have appeared.
