Service Bulletin #109

November 9, 1948

**SUBJECT:** CRACKING OF WING AILERON BELLCRANK (PIPER PART NO. 40092 Left, 40092-1 Right)  
AND FLAP BELLCRANK (PIPER PART NO. 40092-10 Left, 40092-9 Right)  
LOCATED AFT OF REAR SPAR.

**TO:** OWNERS OF PIPER AIRPLANES MODELS PA-12 SERIAL NOS. 12-1 and up,  
AND PA-14 SERIAL NOS. 14-1 to 14-193 Incl.

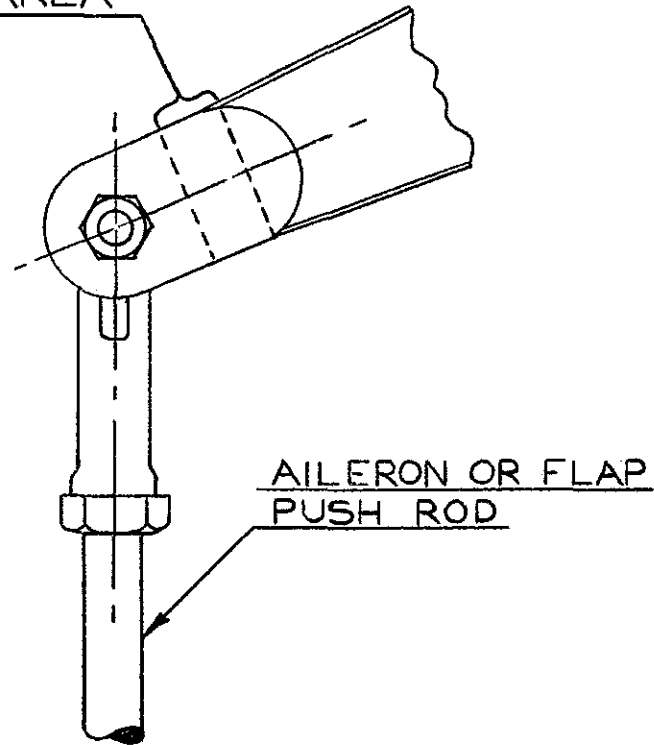
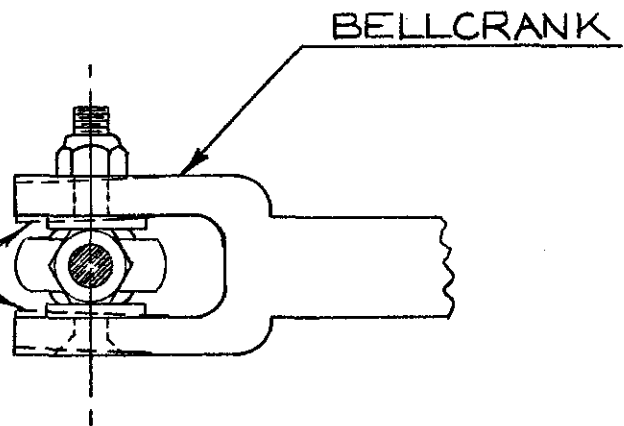
FIG.1  
INCORRECT ATTACHMENT

Several reports have been received of cracks in the cast aluminum aileron bellcranks installed in the Model PA-12 airplanes.

These cracks are due to excessively tightening of the bolt which attaches the aileron push rod to the bellcrank thereby bending the ears on the casting causing them to crack. (See Fig. 1).

INSPECT FOR  
CRACKS WITHIN  
THIS AREA

EARS BENT  
AS SHOWN  
DOTTED  
DUE TO  
EXCESSIVE  
TIGHTENING  
OF BOLT

It is requested that you inspect your airplanes and if the ears of the casting appear bent inspect the castings for cracks in the areas shown on the sketch. If the casting is cracked it should be replaced.

Inspection can be made with a light and mirror through the rectangular openings provided in the wing. The use of any penetrating oil with a fine red or blue powder will show up the crack if present. Wipe casting clean, rub oil on ears of casting and then rub on the powder. Wipe clean. If casting is cracked the colored powder carried into the crack by the oil will show very clearly.

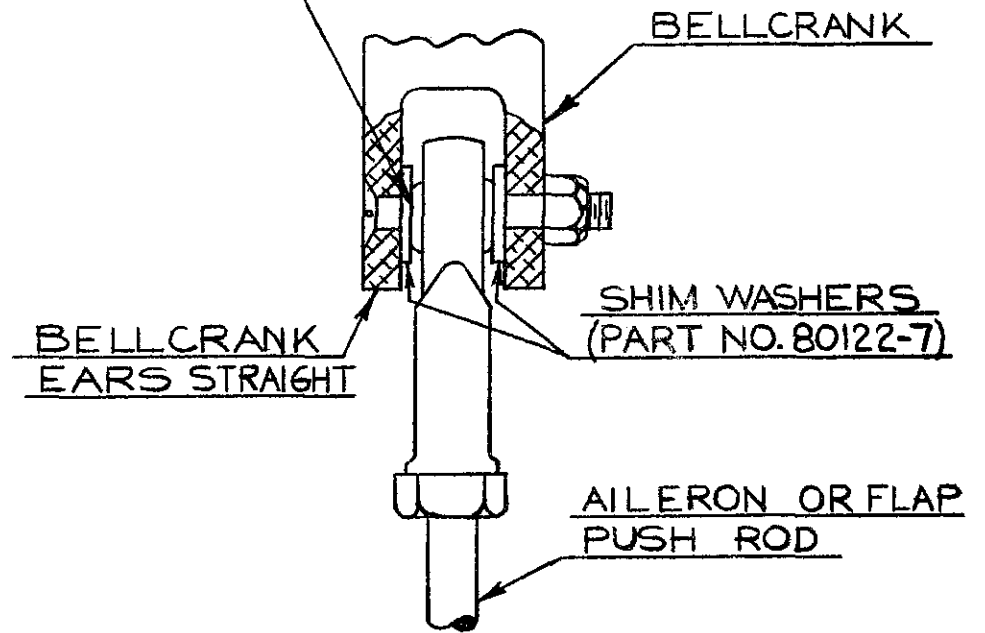
FIG.2  
CORRECT ATTACHMENT

TOTAL CLEARANCE  
.015 MAX.

**NOTE:** When installing push rods in the aforementioned bellcranks, do not tighten up bolt enough to bend the ears on the casting. Also see that shim washers are properly installed. (see Fig. 2).
