Service Letter No. 400

March 20, 1963

SUBJECT: Tail Brace Rods

MODELS AFFECTED: All PA-12, PA-14 and PA-20 Aircraft and
PA-22 Tri-Pacer Aircraft Serial Nos. 22-1 to 22-7999 incl.

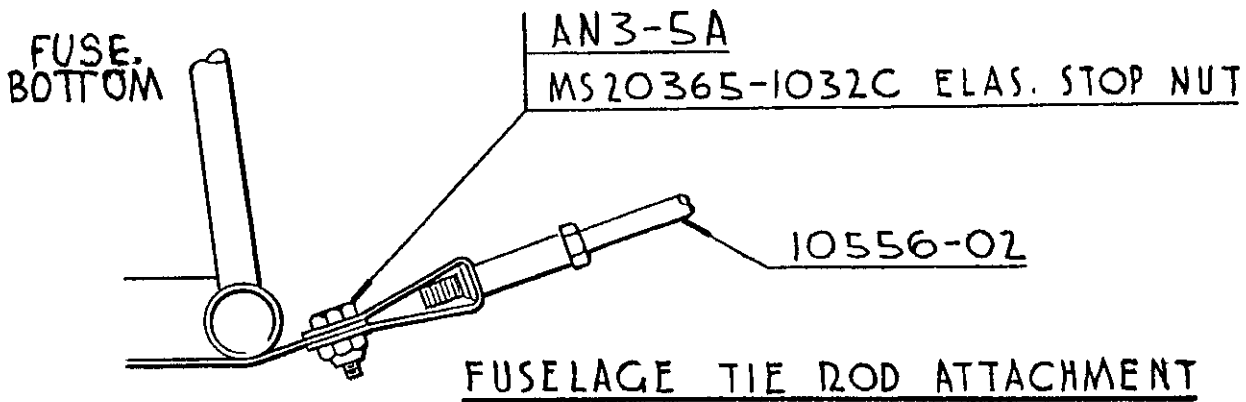
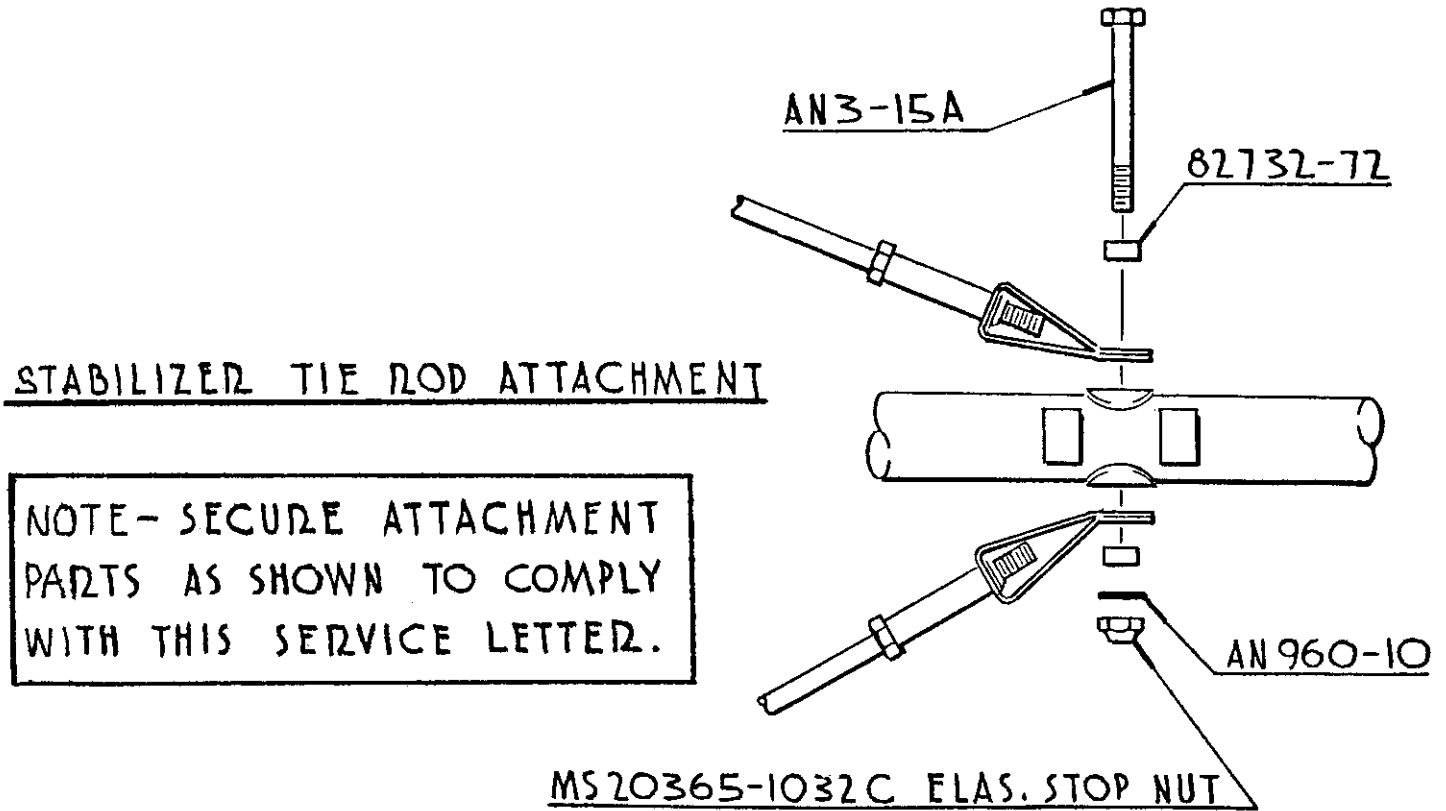
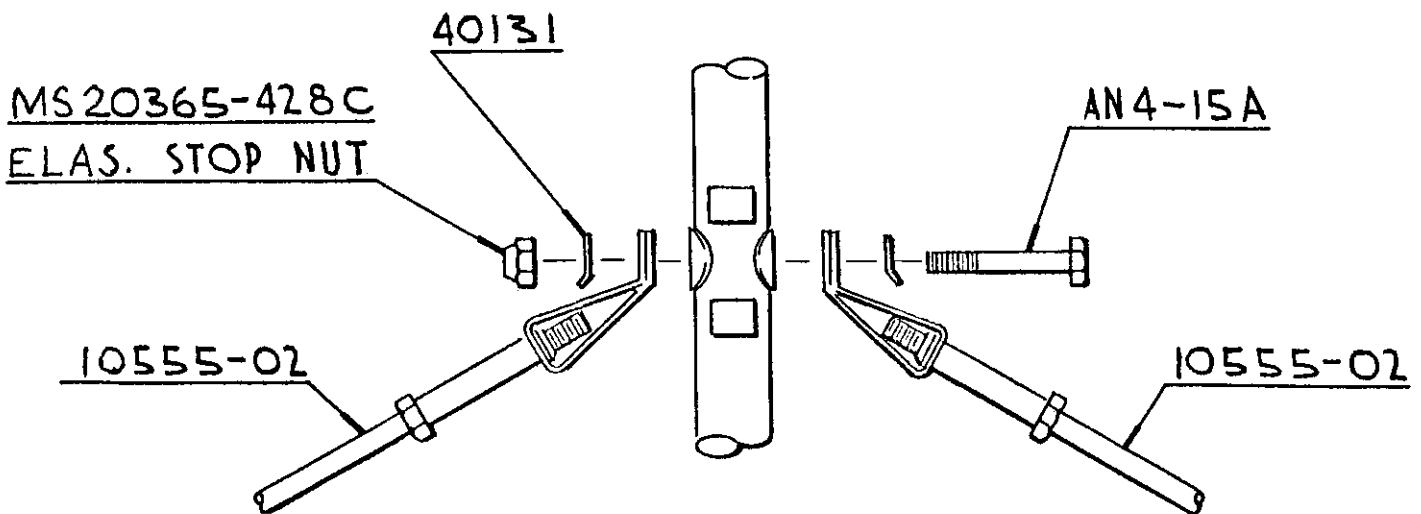
FIN TIE ROD ATTACHMENT

We wish to announce that the round upper and lower tail brace tie rod assemblies, part numbers 10555-02 and 10556-02, respectively, have been approved to replace the upper and lower streamline tail brace tie rod assemblies, part numbers 10074-02 and 10074-03, on PA-12, PA-14, PA-20 and PA-22 aircraft, serial numbers listed above.

The installation of the round tail brace tie rods will eliminate compliance with Piper Service Bulletin No. 183 and F.A.A. AD-60-1-7. Therefore, it is recommended that as the streamline tie rods are retired from service, the round tie rods be installed as a replacement. See Sketch on reverse side for complete details.
