# SERVICE LETTER

No. 718

Piper Aircraft Corporation

Subject: Bendix Magneto Bulletin No. 566 -- reference attached Avco Lycoming Service Bulletin No. 373, dated March 22, 1974.

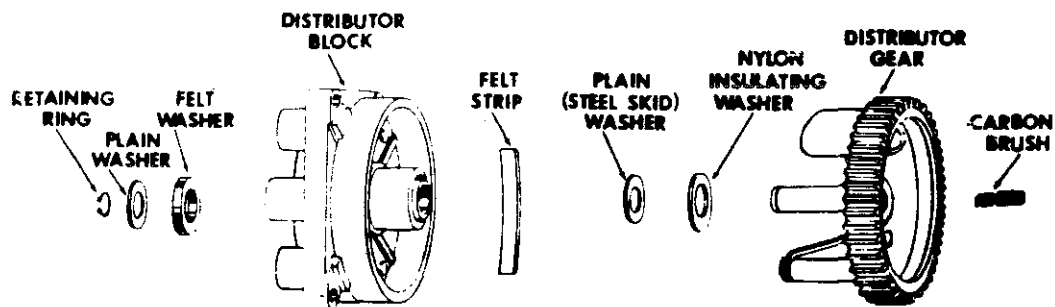
Figure 1.

**Detailed Instructions:**  
It has been found that the addition of a nylon insulating washer and steel skid washer between the distributor gear electrode and the block bushing, as shown in figure 1, reduces the possibility of deterioration of the lubricant and possible seizure of the parts.

Assemble large distributor gear, nylon and steel washers to new or reworked block as follows using figure 1 as a guide.

Once modified, the distributor block can be used only with a gear having the nylon and steel washer installed over the shaft as shown in figure 1.

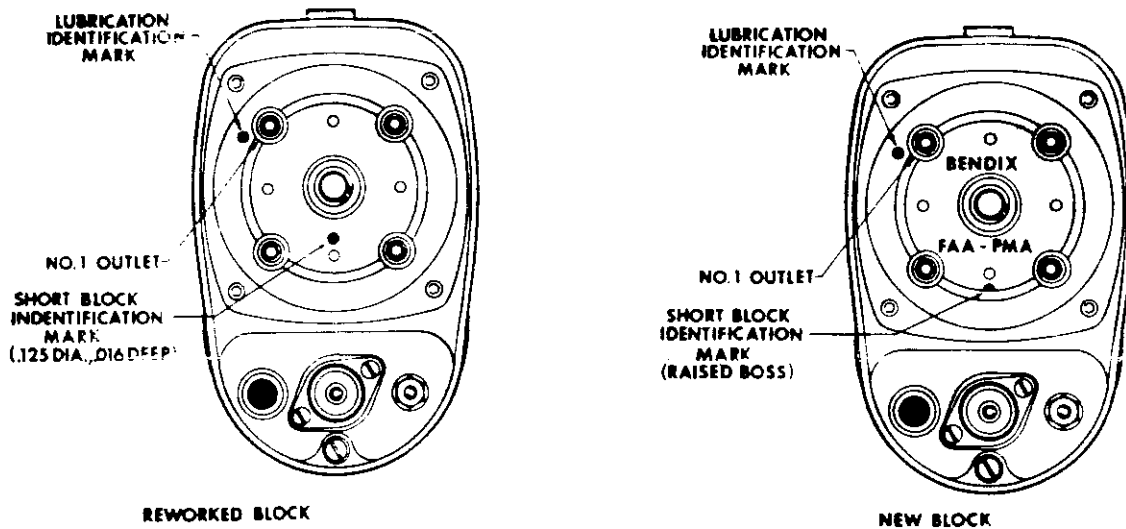
Figure 2

The addition of the washers make it necessary to shorten the gear end of the bushing and block. New production blocks incorporating the change are identified by a raised

boss between the high tension towers at the six o'clock position and molded in letters as shown in figure 2. Reworked blocks are identified by a drill point indentation in the same location. New and reworked blocks both have different part numbers from the current (old) block. See Table 1.

7. Identify reworked blocks by drilling a flat bottomed hole .125" diameter and .016" deep in the six o'clock position as shown in figure 2.

(3) Identify distributor block by drilling flat bottomed indentation 0.125 inch diameter and 0.016 inch deep located as shown in figure 2.
