# SERVICE

NUMBER 110

SUBJECT: WINDSHIELD ATTACHMENT

MODELS AFFECTED: PIPER AIRPLANES MODELS PA-15 SERIAL NUMBERS 15-1 TO 15-387 INCL., AND PA-17 SERIAL NUMBERS 17-1 TO 17-214 INCL.

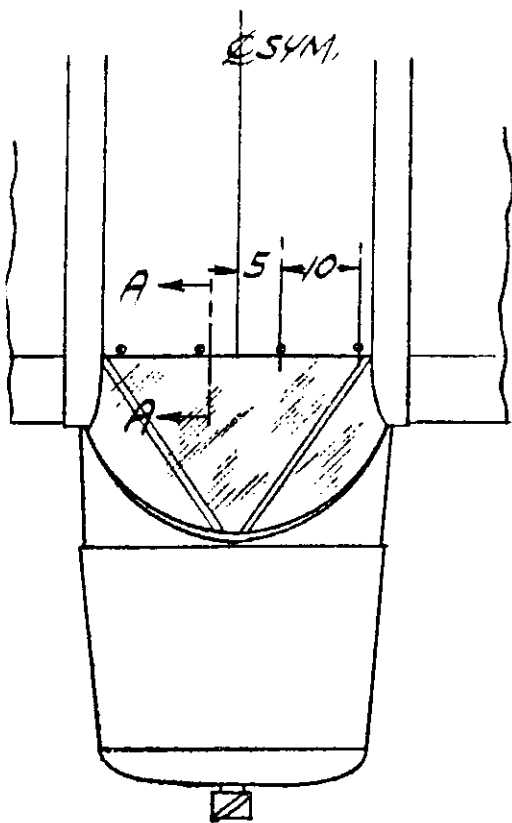
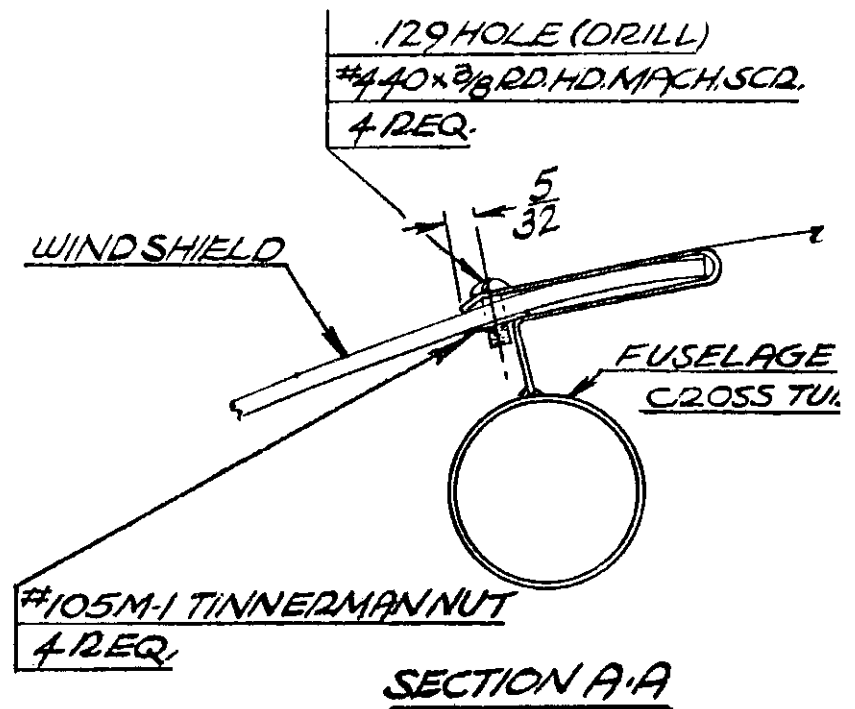
In order to eliminate the possibility of the windshield coming out of its top retaining channel (channel located on tube between front wing hinge fittings) it is strongly recommended that the windshield attachment be reworked to incorporate the use of four machine screws installed in accordance with the sketch below.

DO NOT FORCE DRILL THRU PLEXIGLAS

An appropriate entry should be made in the aircraft log book when the recommended change has been made.
