Service Bulletin No. 118

September 21, 1951

SUBJECT: Battery Box Lid Modification

MODELS AFFECTED: PA-16 Airplanes with Serial Numbers 16-1 and up; PA-20 Airplanes with Serial Numbers 20-1 thru 20-802 inclusive; and PA-22 Airplanes with Serial Numbers 22-1 thru 22-348 inclusive.

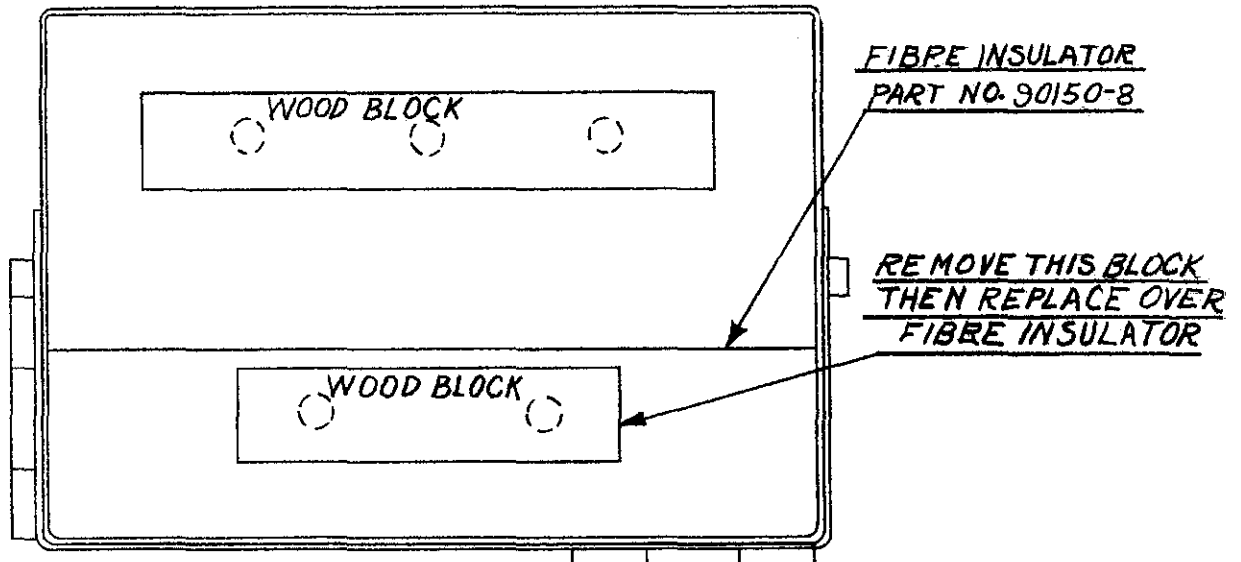
It is necessary that the battery box lids in the above listed airplanes be modified in accordance with the following instructions, to eliminate the possibility of "shorting" the battery terminal wing nuts.

Remove the wood block located between the battery cable openings. Place the fibre insulator, Piper Part Number 90150-8, inside the lid as shown in the following sketch. Replace the wood block using the same screws.
