(Special Advisory No.18-2A supersedes and voids Special Advisory No.18-2 dated September 19, 1989)

SUBJECT: Aileron and Flap Hinge  
Bracket Attaching Hardware

MODELS AFFECTED: PA-18-150 Super Cub  
SERIAL NUMBERS AFFECTED: 1809002,1809004 through  
1809022

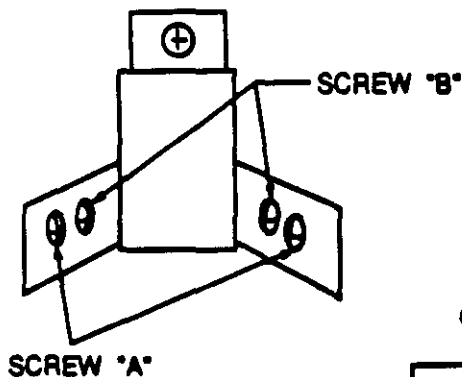
FIG. 2

11. Install one (1) each rivet, Piper Part Number 523-121 (NAS1768D-4-2) in each hole where a screw was removed.
12. If it is necessary to remove all four (4) screws in any one bracket, refer to Sketch "A", Fig. 2. Remove screws "A" first and install rivets. Then remove screws "B" and install rivets.

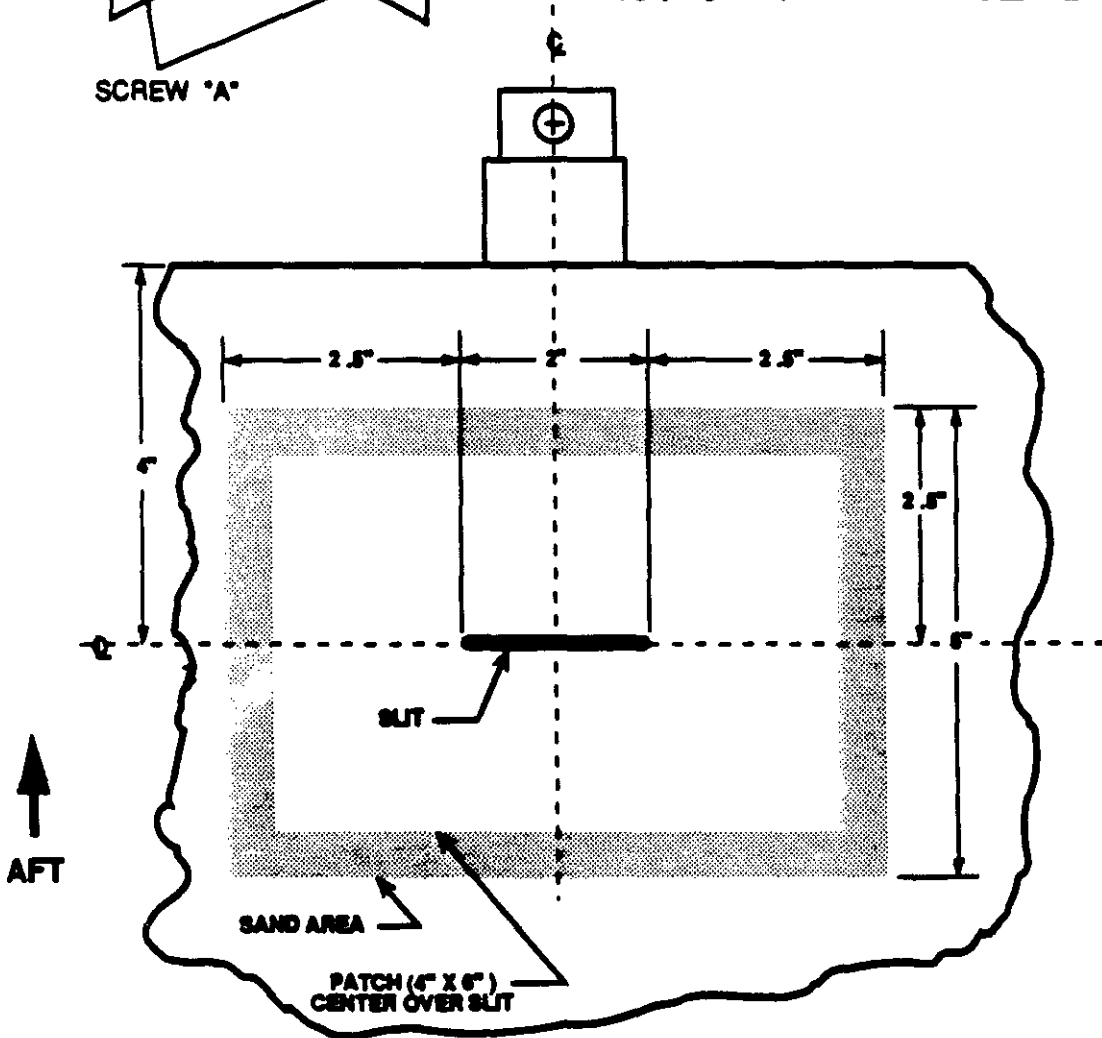
FIG. 1 VIEW OF TRAILING EDGE OF WING  
LOOKING UP

Prior to cutting an inspection slit, check the airframe logbook for type of finish, then clean and sand the area per the instructions on Sketch "A", Fig. 1.

If the finish coat is Flexi-Gloss, the area must be thoroughly cleaned to remove any waxes, silicones, or contaminants which might be present. Scuff sand. Apply two coats of 7602 Cement in the area sanded around the slit. Allow this to dry completely before activating and applying the patch. Brush a second coat of activator on the patch and wipe off with a paper towel or soft cloth. Allow to dry overnight and then heat tauten the center area over the hole only. Apply filler coat, sand and spray with Flexi-Gloss. If the top coat is not Flexi-Gloss, you must sand down to the filler coat before applying the patch. Refinish with matching final finish.
