SUBJECT: Textron Lycoming Service Bulletin Number 486

SERVICE BULLETIN

Service Bulletin No. 486
Engineering Aspects are
FAA Approved

Inspection of **Single Belt Driven Ring Gear Support Assemblies**

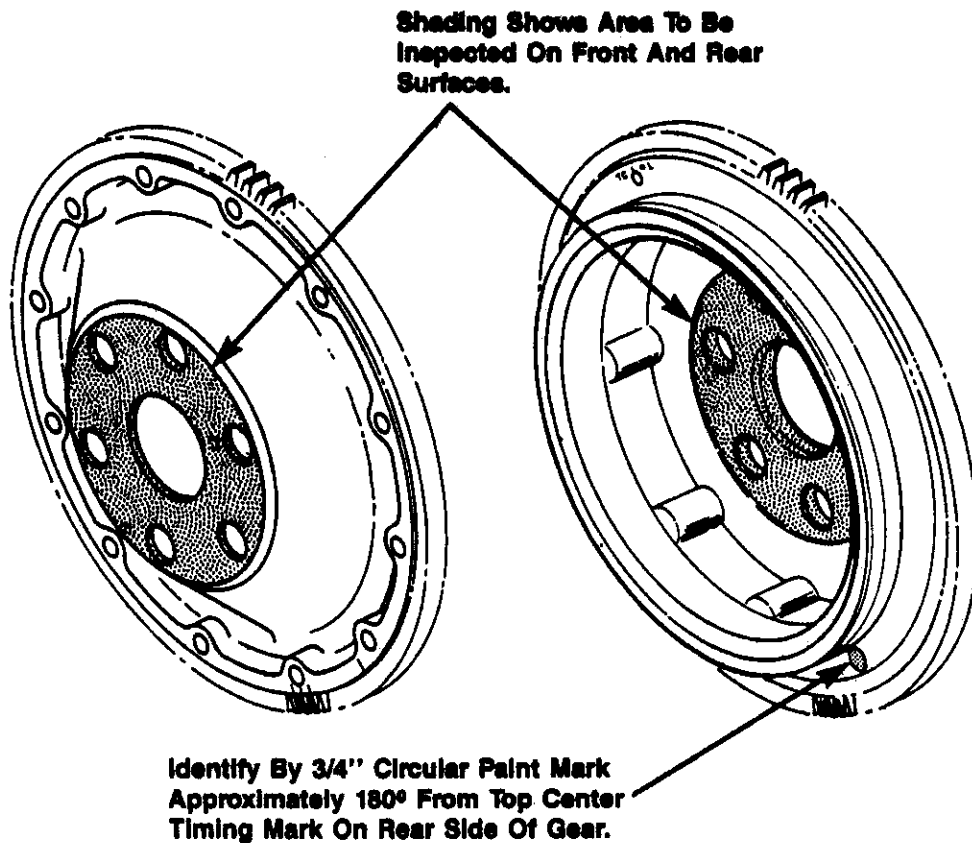
Figure 1. Starter Ring Gear Inspection Areas

It has been discovered that a small quantity of Starter Ring Gear Support Assemblies installed on engines and shipped as spares between January 1, 1988 and June 12, 1989 may exhibit one or more cracks on the front and/or rear machined surfaces. The crack or cracks may appear at any point on the surfaces mating with the crankshaft/propeller flange. See Figure 1, Page 5.

After removal of the starter ring gear support, inspect the support assembly in the areas shown in Figure 1, Page 5, using a dye penetrant to insure no cracks are evident. Follow the penetrant manufacturer's instructions to perform the inspection.

If a crack is evident, the starter ring gear support assembly must be returned to Textron Lycoming through an authorized Textron Lycoming distributor for warranty consideration.

If no cracks are found, the starter ring gear support assembly must be identified with a yellow circular paint mark approximately 3/4 inch in diameter located 180 degrees from top dead center mark on the rear side of the support assembly. See Figure 1, Page 5.
