# SERVICE No. 207A BULLETIN

Piper Aircraft Corporation

**SUBJECT:** Inspection of Weld at Rudder Pedal Assembly  
(Part Nos. 40842-04 and 40842-05)

**MODELS AFFECTED:** PA-18 and PA-18A Super Cub - Serial Nos. 18-1 thru 18-7768  
inclusive

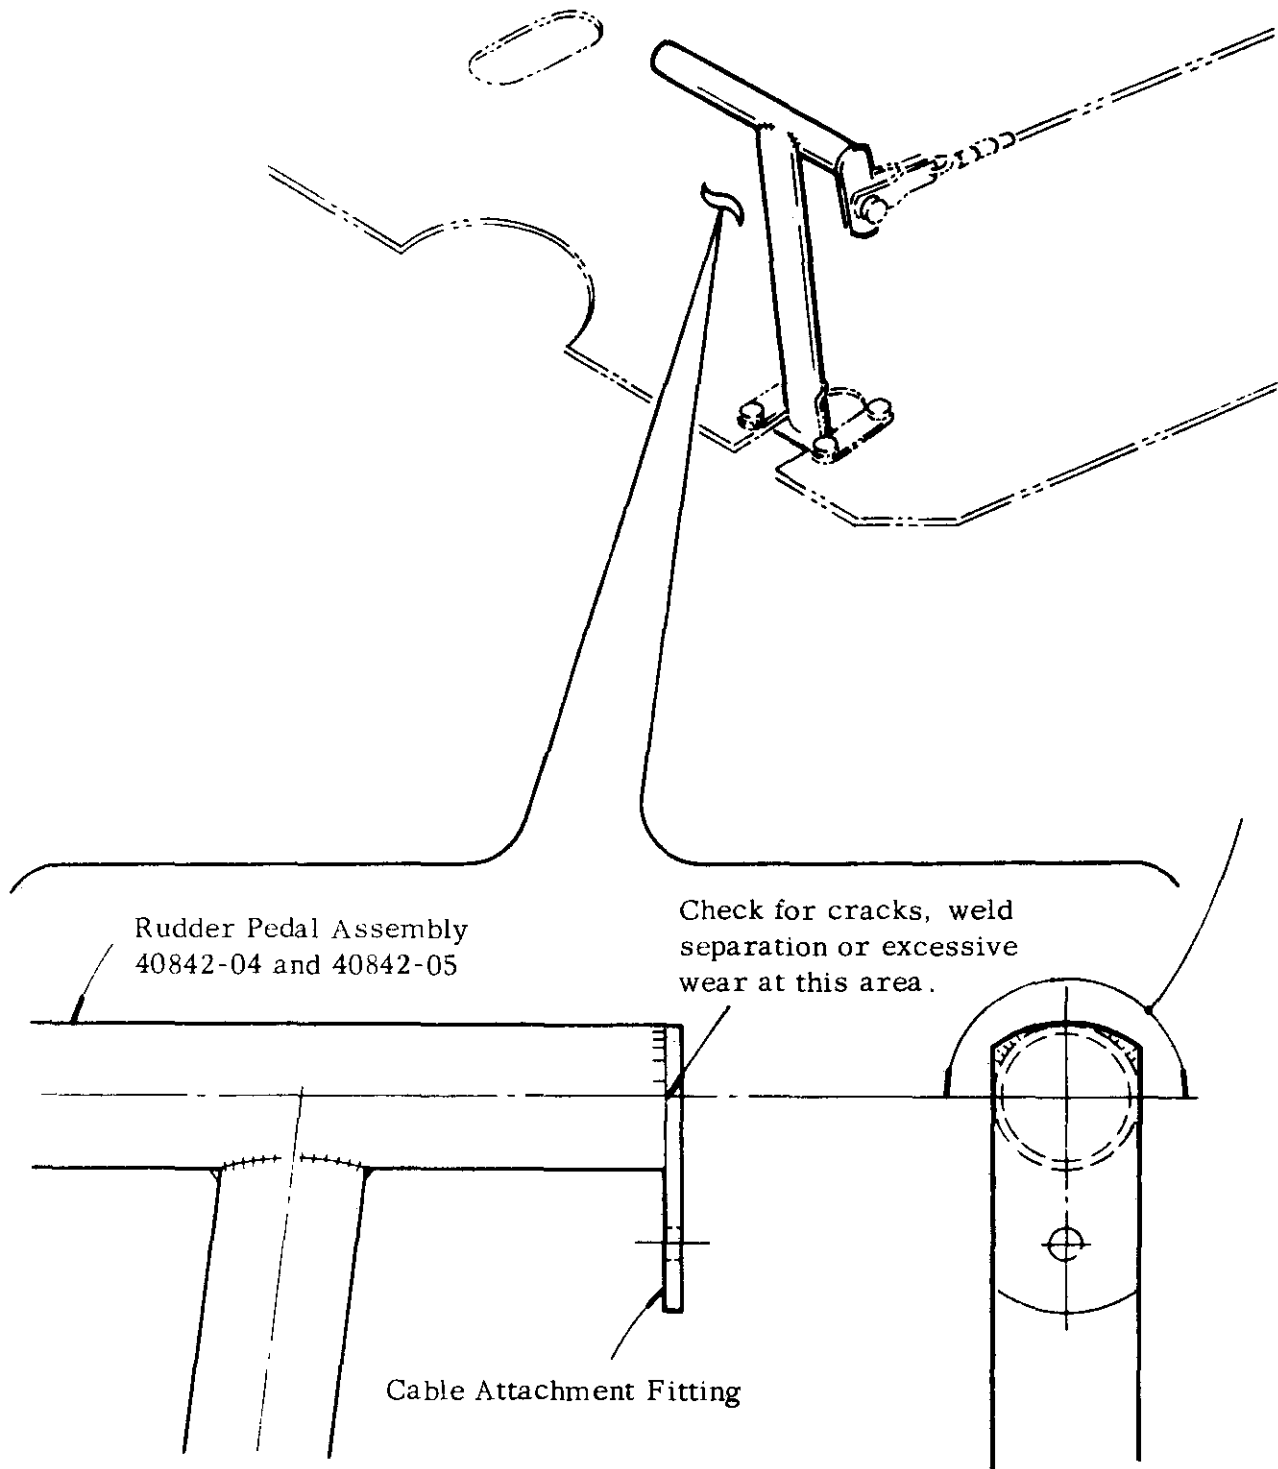
# SERVICE BULLETIN # 207A

Field service reports indicate that there have been a few instances of weld separation where the rudder pedal cable attachment fitting is welded to the rudder pedal.

It is requested that a visual inspection be made of this weld for any evidence of separation, cracks in the weld, or excessive wear due to long time usage, in area referred to on the reverse side of this Service Bulletin.

If there is no evidence of weld separation, cracks or wear, the length of the weld should be inspected and if the length of the weld conforms to the dimensions shown in the sketch on the reverse side of this Service Bulletin, no further action is required.

Any cracks in weld, regardless of length of weld or location of crack, shall be cause for rejection of rudder pedal assembly.

If there is evidence of weld separation, cracks, excessive wear, or the length of the weld does not conform to the dimensions referred to on the sketch; the rudder pedal must be replaced prior to further flight.
