SERVICE No-324 BULLETIN

Piper Aircraft Corporation

September 29, 1970 S/M

Vacuum Pump Adapter Drive Assembly

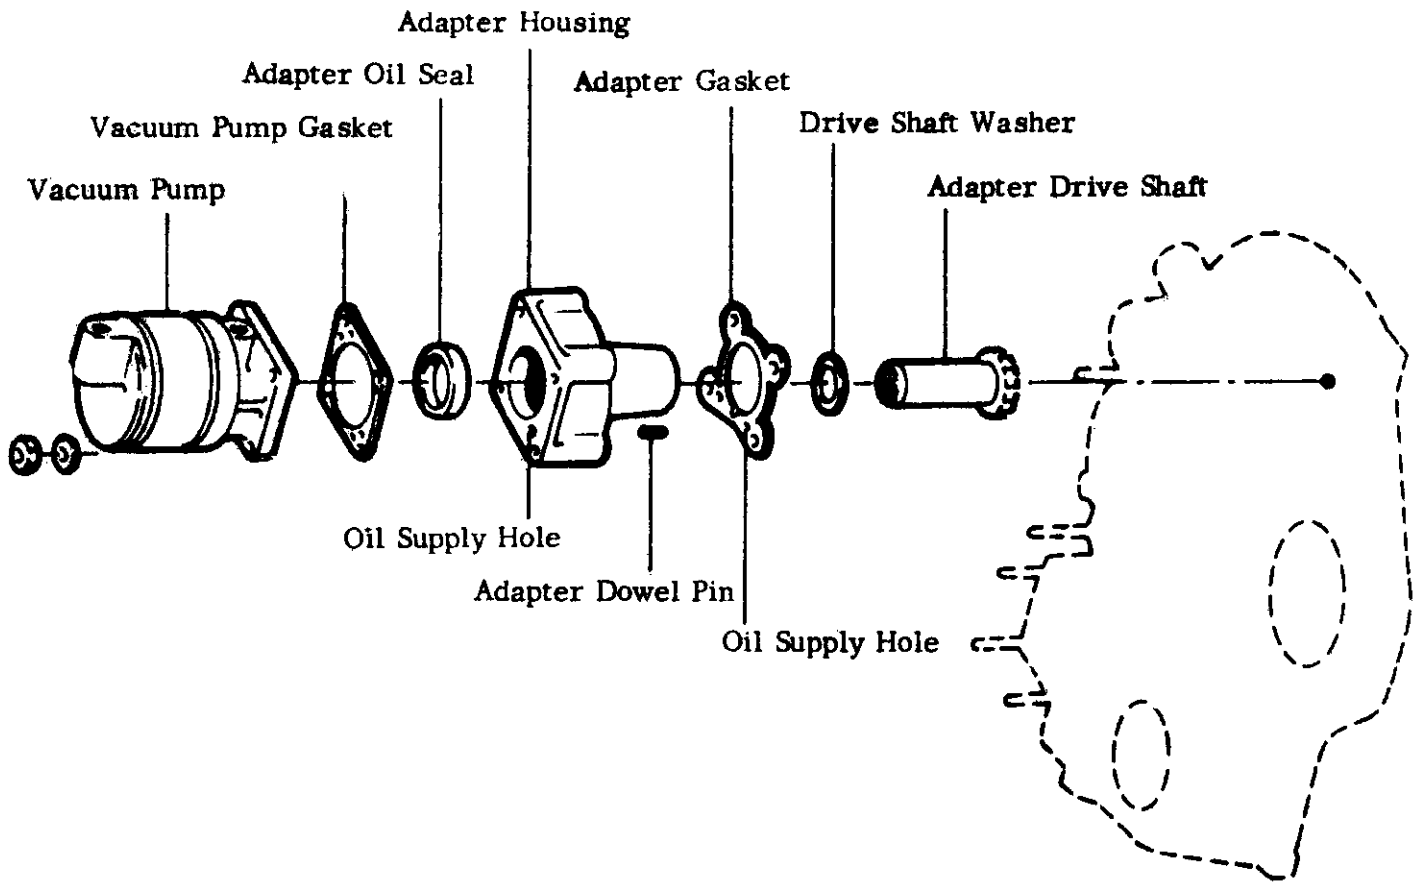
Service Bulletin 324

To provide instructions for an inspection of the vacuum pump adapter drive assembly (reference attached sketch for an illustration of the area to be inspected).

- I. Remove vacuum pump and vacuum pump adapter assembly from engine.
- II. Remove drive shaft from adapter housing and inspect the shaft for any sign of aluminum pick up on shaft at either end of shaft where it contacts adapter bearing bore.
- III. Inspect the adapter housing for the following:
 - a. Any evidence of inadequate lubrication resulting from foreign chips in oil supply hole.
 - b. Omission of oil supply hole.
 - c. Improper location of dowel.
 - d. Improper indexing of drive adapter assembly to accessory pad.
- IV. Inspect gasket, Lycoming part number 61183, for omission of oil transfer hole.

IF ANY DISCREPANCIES ARE FOUND, DO NOT ATTEMPT TO REPAIR. Contact your local Lycoming Regional Representative or Lycoming Service Department for further instructions.

- V. If the above referenced inspection procedure discloses no discrepancies, clean and lubricate (with SAE 50 oil) all parts that were inspected and reinstall on engine torque all nuts to 50 to 70 inch pounds.
