SERVICE BULLETIN

No. 354B

Piper Aircraft Corporation

Subject: Fuel Selector Valve Lubrication

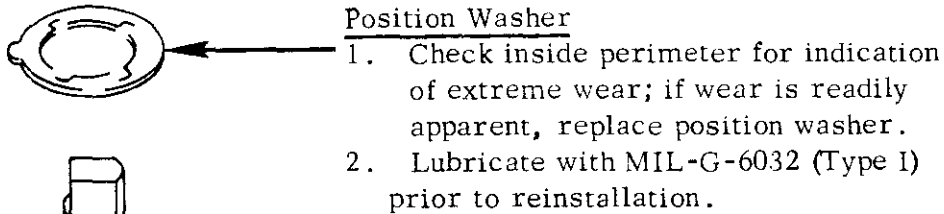
Position Washer
1. Check inside perimeter for indication of extreme wear; if wear is readily apparent, replace position washer.
2. Lubricate with MIL-G-6032 (Type I) prior to reinstallation.

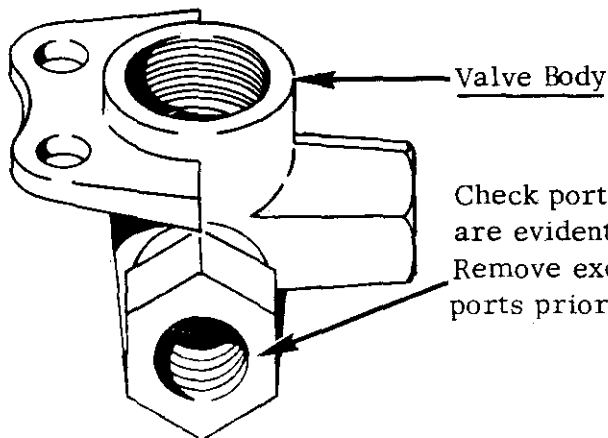
Valve Body

Check ports for cracks; if cracks are evident, replace valve. Remove excess grease from ports prior to reinstallation.
