# SERVICE BULLETIN

No 445

Subject: Fuel Cap Inspection

Models Affected: PA-18 Super Cub

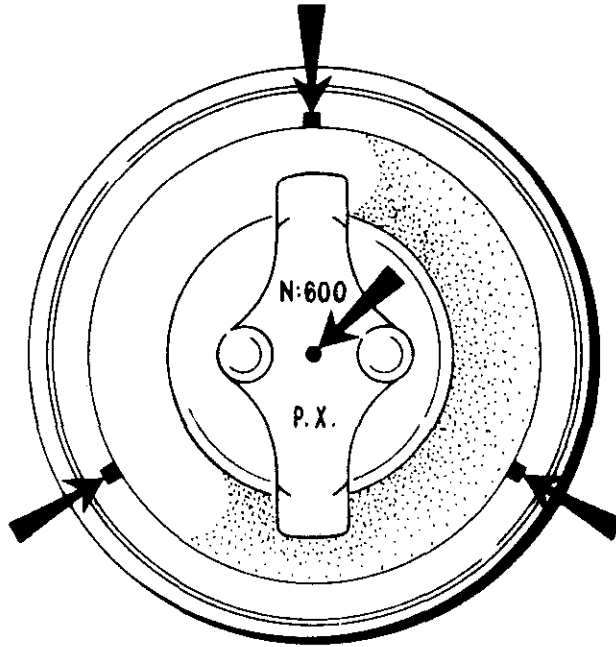
Purpose: To provide instructions to inspect the fuel tank filler caps for presence of a vent hole in the cap dome. Fuel starvation could occur if one or both fuel cap (s) are non-vented.

1. Visually inspect the fuel tank filler caps; properly vented caps will have a vent hole in the cap's center, with three (3) smaller apertures around the cap circumference. Refer to attached sketch for an illustrated description of the proper cap.
2. If proper caps are installed, no further action is required.
3. If existing caps do not appear as illustrated on the attached sketch, replace cap (s) - Reference Material Required, below.
4. Make appropriate log book entry.

Material Required: Fuel Tank Filler Cap, Piper part number 454-039; one (1) each or two (2) each required per aircraft, depending on the number of tanks installed - as required per Instructions, above.
