# SERVICE No. 485 BULLETIN

Subject: Rerouting of Rudder Control Cables.

PA-18-150 Super Cub

18-7309016 to 18-7609001 Inclusive

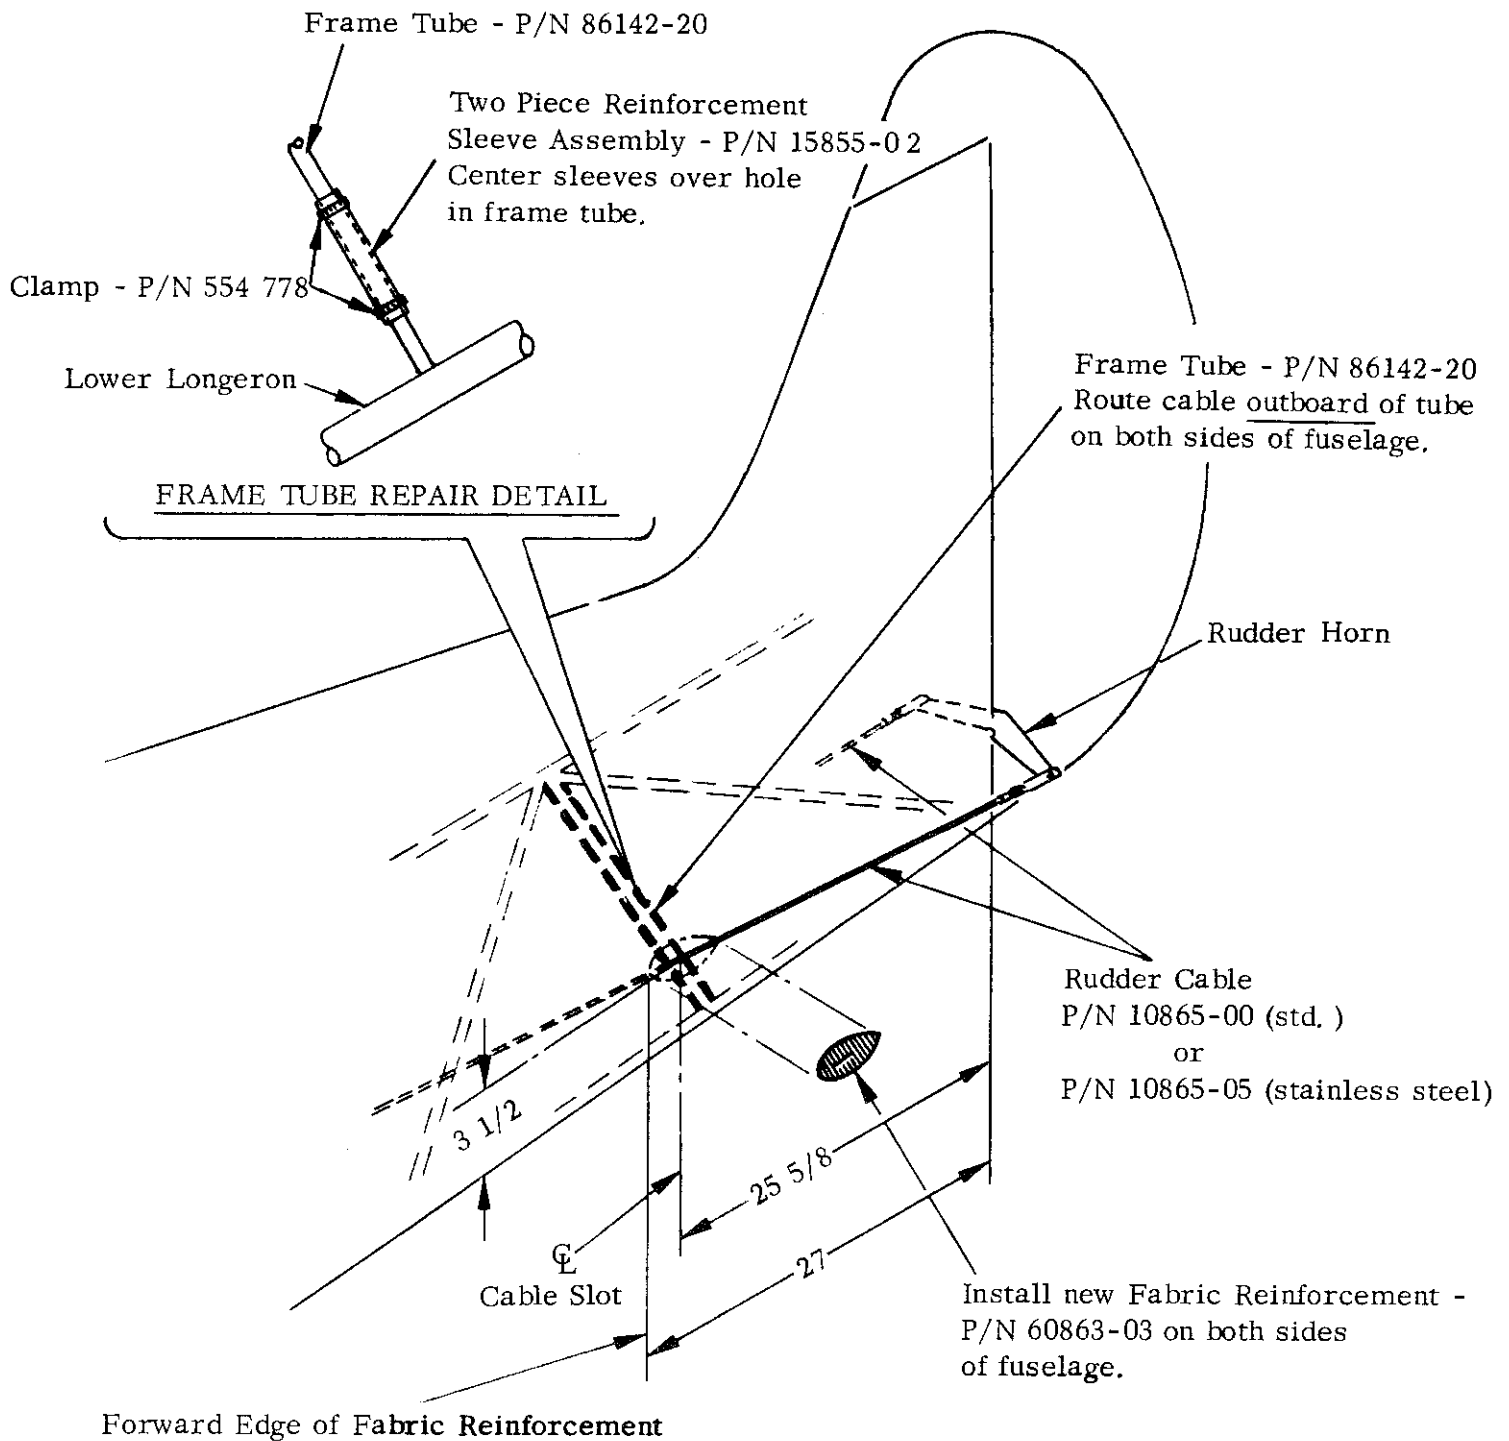
Purpose: Reports from the field indicate that the left and right rudder control cables were misrouted inboard of the vertical frame tubes in the optional Metal Fuselage Bottom Panels which allows the possibility of cable contact with the tubes. This condition can cause premature wear, fraying, and possible parting of the cable resulting in loss of rudder control.

- Instructions:
1. Refer to attached sketch/instruction sheet.
  2. Inspect Rudder Control Cables and adjacent vertical fuselage frame tubes to determine cable/frame tube wear:
    - a. If indications of cable wear (fraying and/or parting of the strands) are evident, replace cable(s).
    - b. If tube is worn through (has a hole in it), install the reinforcement kit. If no hole exists, the tube may be painted and used as is.
    - c. If no indications of cable or tube wear are evident, or if steps a. and b. above have been completed, reroute cables in accordance with the attached sketch/instruction sheet.

1. Remove left and right rudder control cables from rudder horn at lower end of rudder post.
2. Working thru access holes in side of fuselage, pull cables back thru fabric into interior of fuselage.
3. Locate and install new fabric reinforcement P/N 60863-03 in new location on both sides of fuselage. Open fabric at reinforcement slot.
4. Reroute cables outboard of P/N 86142-20 frame tubes and out thru the slot in the new reinforcement. (Replace cable(s) if indications of wear are evident.)
5. Attach cables to rudder horn and safety.
6. Make standard fabric repair at original reinforcement location.
7. If rudder cable(s) has worn through the frame tube(s), install reinforcement sleeve assembly P/N 15855-02 as shown in repair detail above.
