Piper Aircraft Corporation
Vero Beach, Florida, U.S.A.

SERVICE *No. 706B* BULLETIN

SUBJECT: Tail Brace Wire Support Installation

PA-18-150 Super Cub
PA-18-150 Super Cub

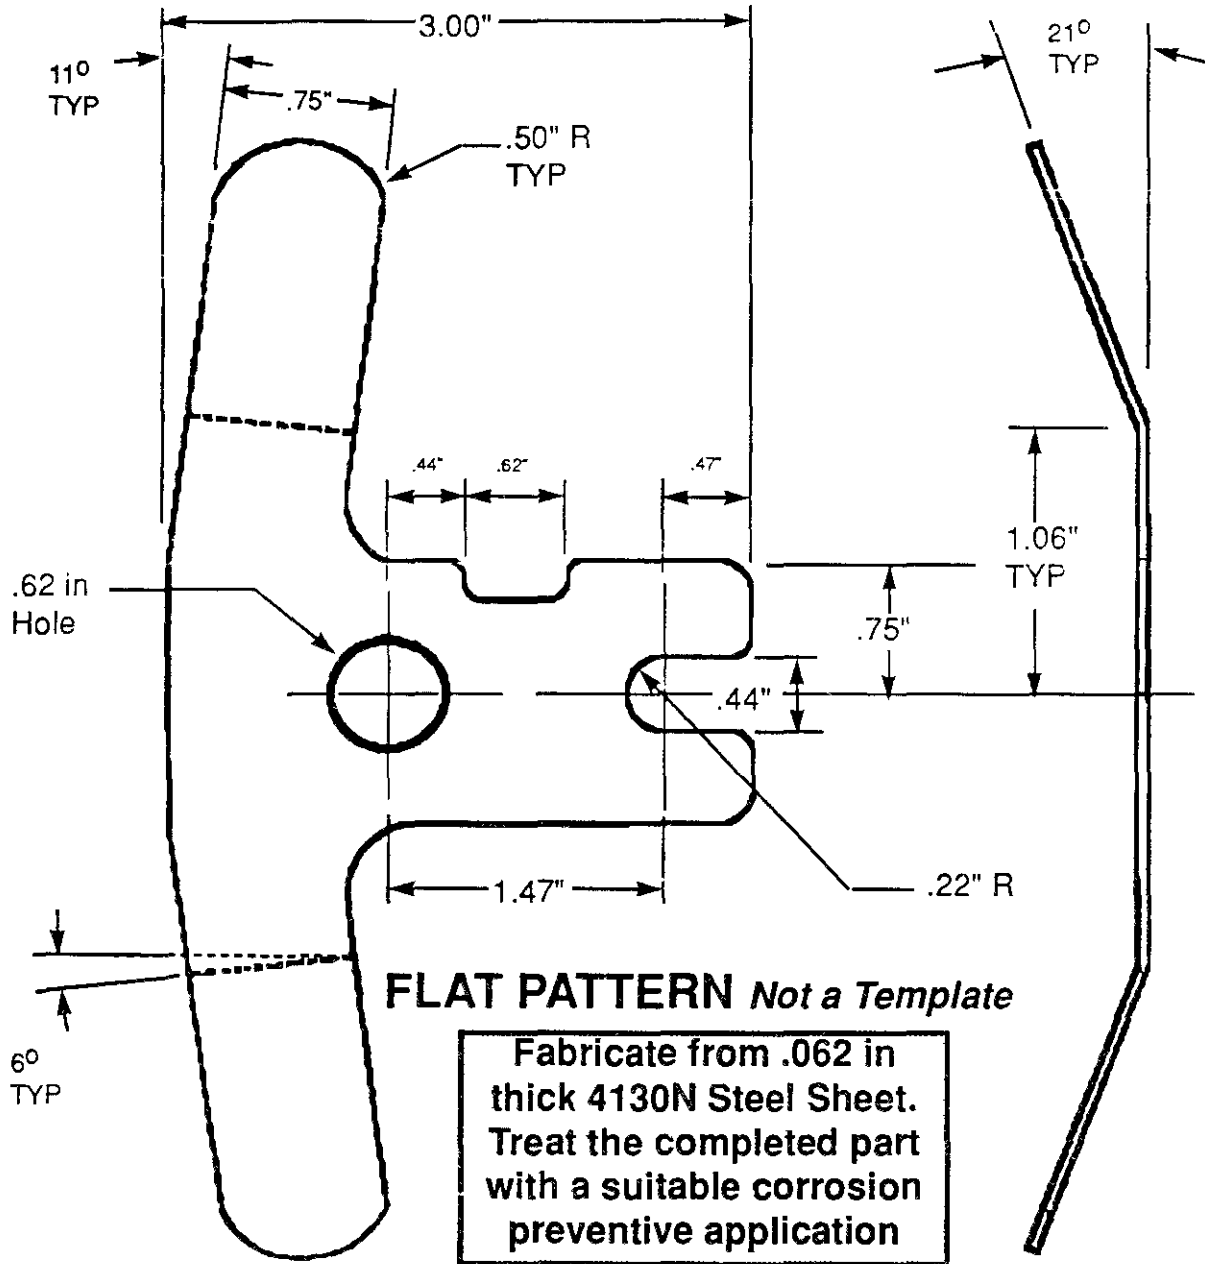
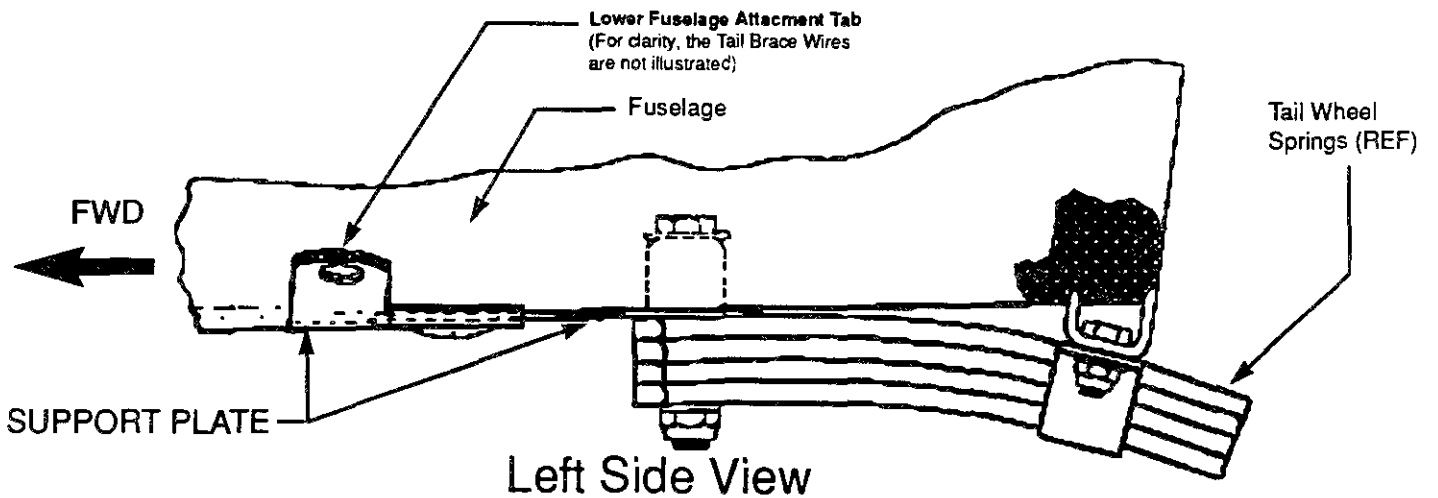
SKETCH A

Reports have been received of failure of the lower horizontal stabilizer brace wire fuselage attachment tab. This tab connects the lower horizontal stabilizer brace wire to the lower fuselage. Separation of the tab and subsequent loss of brace wire support could result in damage to the stabilizer and possible loss of control.

1. a. For PA-18-150 Super Cub aircraft, Serial Numbers 18-8602 through 18-18-8109013 only, fabricate a support plate from .062" thick 4130 N Steel sheet (6.5" x 3.0") using the template shown on sketch "A", or procure one each, Piper Part Number 60764-02 or Piper Part Number 60764-03 Support Plate.
