SERVICE No. 759 BULLETIN

Subject: Exhaust muffler inspection and modification, Piper Part Number 12433-00, 12433-14, 12232-00.

Models Affected: PA-18 Series Super Cub

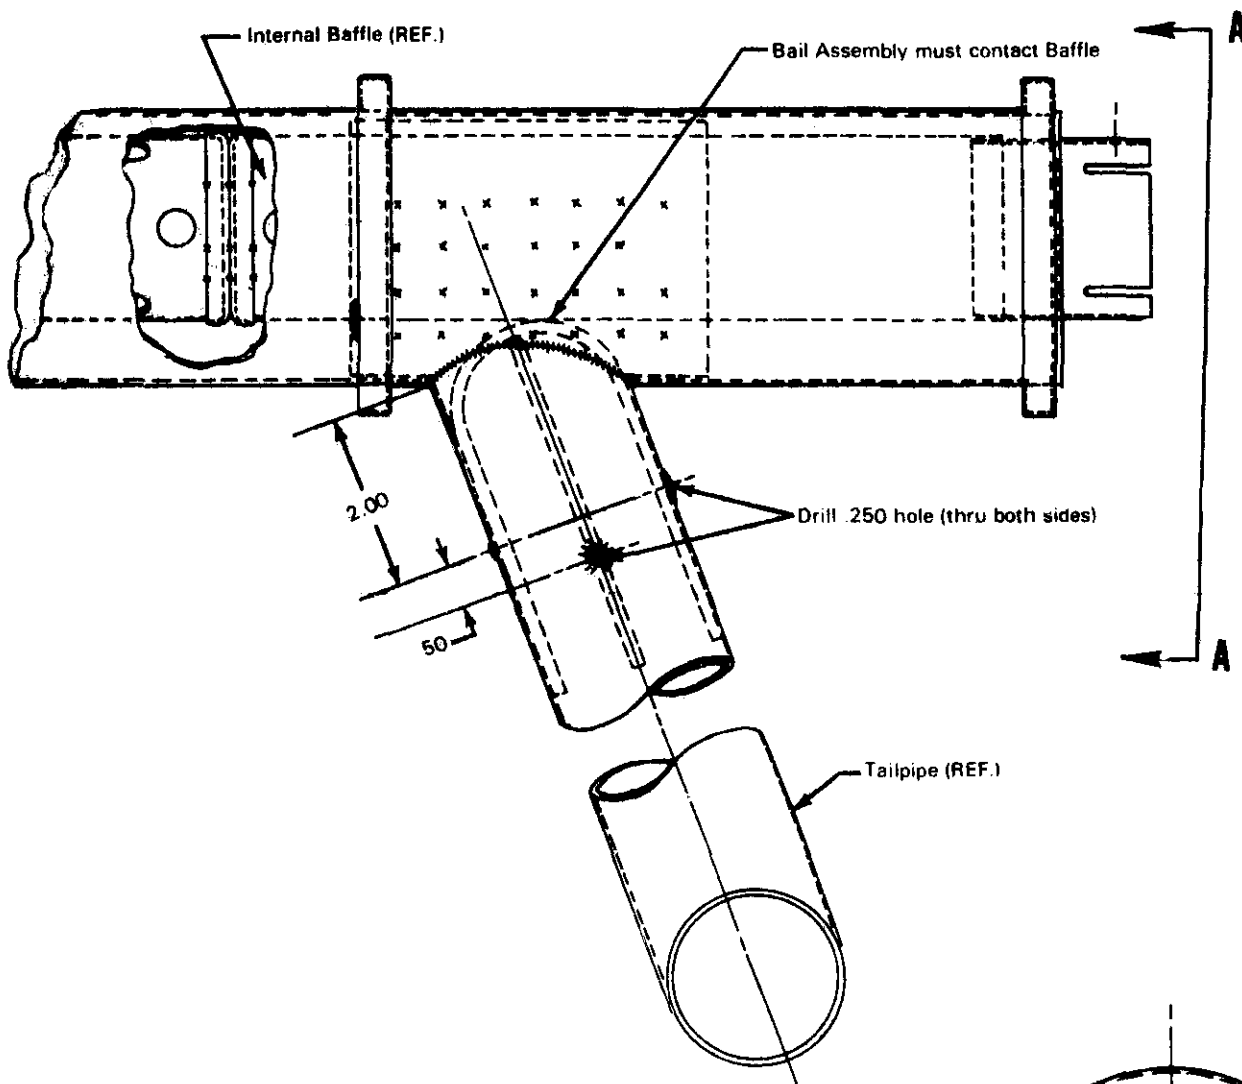
It has been determined that if the internal baffle in the mufflers of the above referenced aircraft fails, a restriction of the muffler outlet may occur. The resulting engine power loss may be enough to prevent continued flight.

7. Remove shroud from muffler assembly and comply with AD 68-05-01.
8. Drill two 1/4 inch (.250) holes through the tailpipe as shown in the following sketch.
9. Install bale assembly, Piper Part Number 452 093 into tailpipe, curved end toward the muffler until contact is made with the internal baffle. The deflector must be installed so that the opposing legs cover the four holes that have been previously drilled.

10. Rosette weld by suitable method the bale through the four 1/4 inch holes in tailpipe.
11. Reassemble muffler assembly and reinstall on aircraft. Install exhaust system components and reconnect any lines, wire, and hoses that were removed. Attach engine properly and reinstall engine cowling that was removed.
12. Make appropriate log book entry stating compliance of this Service Release.

Rosette Weld (4 Required)

Bail Assembly (P/N 452 093)
(Should Be A Light Press Fit With The Four Rods Making Contact With Inside Wall Of Tailpipe. Slight Reshaping May Be Required)
