Piper Aircraft Corporation  
Vero Beach, Florida, U.S.A.

# SERVICE No. 910A BULLETIN

Date October 10, 1989 S

SUBJECT: Wing Lift Strut Assembly  
Inspection/Replacement

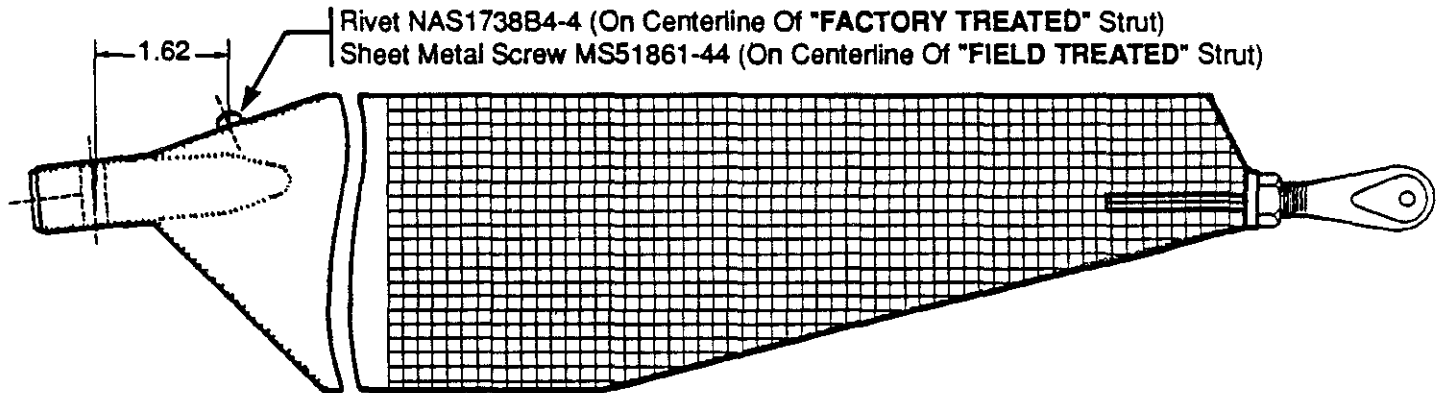
**VIEW OF MAULE FABRIC TESTER**

1. Securely tape a sheet of thin 1/4 inch graph paper to the lower 11 inches of the top and bottom surface on all wing lift struts.
2. Using a Maule "Fabric Tester" and holding tool normal to strut contour, apply pressure at a scale reading of 80 in each of the grid blocks.
3. Remove the paper and inspect the lift strut tubes. A perceptible dent will appear if internal corrosion is present. If any dents are found, be certain the dent are in the metal by carefully removing the paint.
  - a. Lift strut tubes indicating the presence of any perceptible dent in the metal must be replaced with a new lift strut assembly before further flight.
  - b. If no dents appear in the metal, the lift strut may be considered airworthy.

- a. Remove lift strut from aircraft.
  - b. Inject one quart of Valoil, Lionoil Multi-Purpose L-1, Linseed Oil, Paraketone or any alternate preservative conforming to Federal Specification TT-S-176D, into the bolt hole at the top of the strut.
  - c. Plug the bolt holes and slosh oil until interior of strut is thoroughly coated.
  - d. Drain oil from strut (through bolt holes) and install MS51861-44 sheet metal screw, as shown, for future identification.
  - e. Reinstall strut to aircraft and rig.
4. Record lift strut inspection in aircraft logbook.
