SERVICE No. 1020 BULLETIN

DATE: July 10, 1998 (S/M)

**Inspection of the ARTEX 110-4 ELT and
 ELT Attachment Bracket**

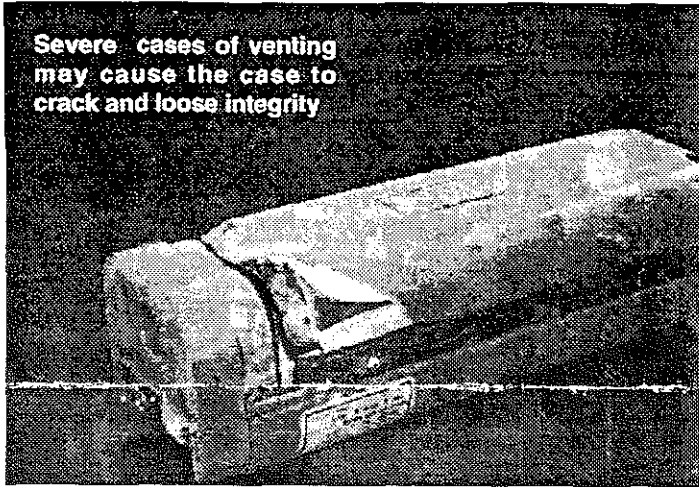
**ELT Battery Pack
(Severe Damage from Battery Venting)
REPLACE UNIT**

3. If the ELT battery pack does not pass the criteria as set forth in the ARTEX publication, the ELT battery pack must be replaced with a new ELT Battery Pack, Piper Part Number 758-696. *(See the data tag and corrosion photographs on page 3.)*

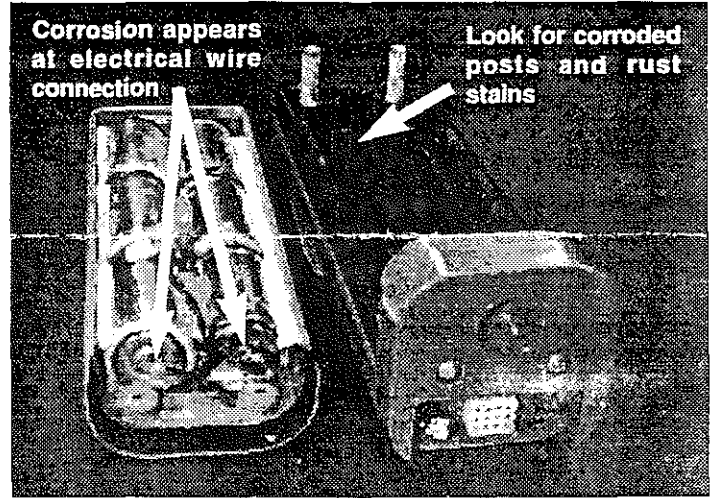
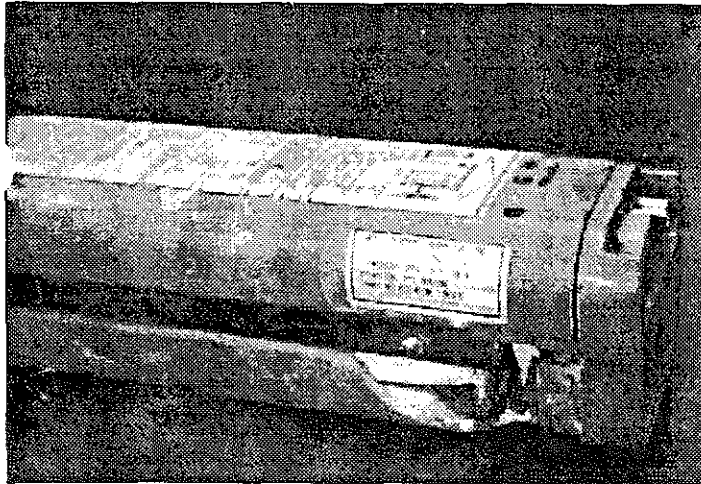
**ELT Battery Pack
(Light Damage from Battery Venting)
REPLACE UNIT**

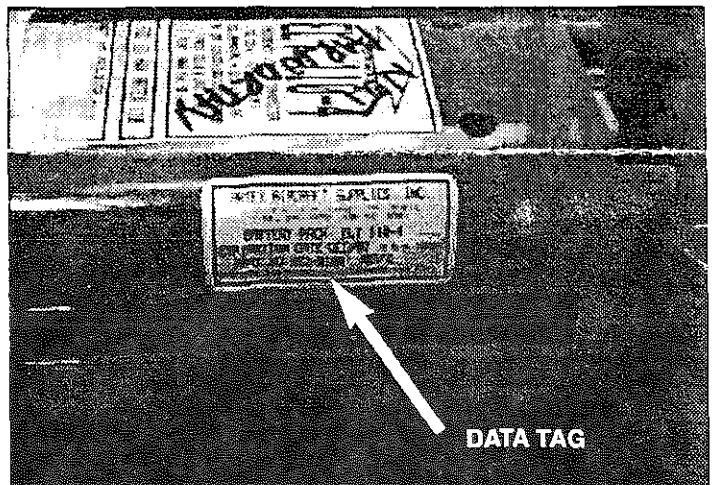
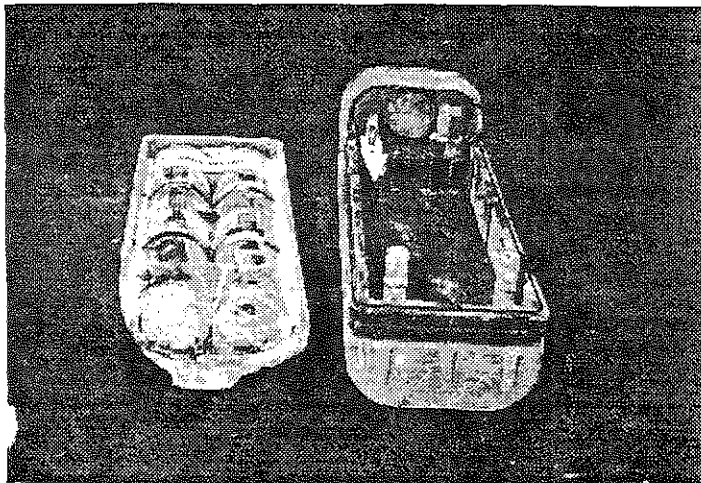
**ELT Battery Pack with Data Tag
(Identifies Unit and shows Expiration Date)
If Beyond Expiration Date REPLACE UNIT**

4. If the ELT battery pack is not defective, return it to service for use until the expiration date listed on the data tag. *See the data tag photograph on page 3.*
