Service Letter No. 150

July 10, 1950

SUBJECT: Bungee Cable PA-18 "105"

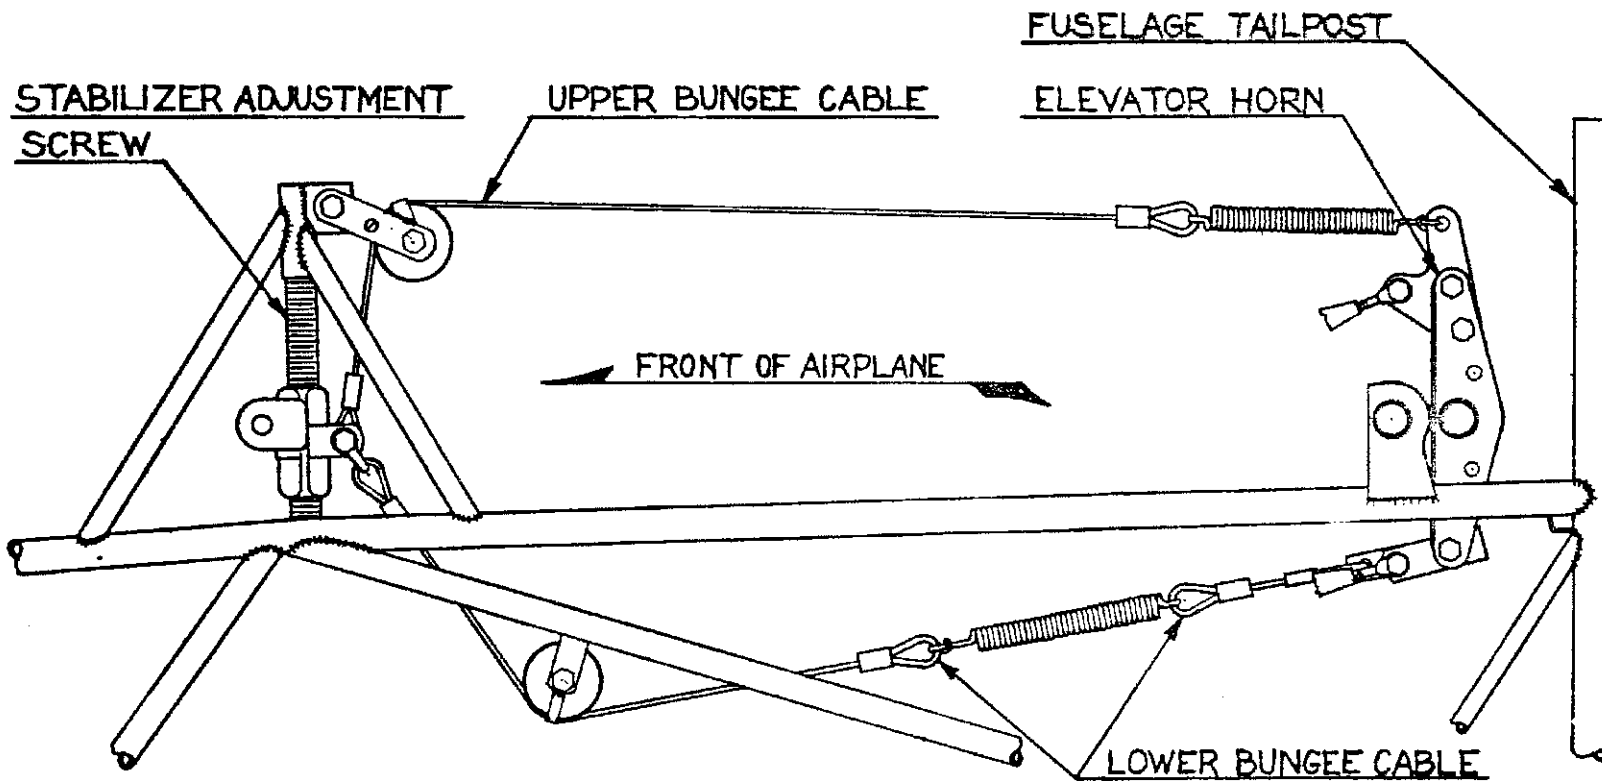
BUNGEE INSTALLATION
MODEL PA-'S "105"

In view of the many comments which we have received from the field, relative to the extremely stiff elevator action on the PA-18 "105" our Engineering Department has issued approval to remove the lower bungee cable, as indicated in the sketch on the reverse side of this letter.

After removal of the lower bungee cable, the proper entry should be made in your log book.
