Service Letter No. 213

SUBJECT: Primer Lines

MODELS AFFECTED: All PA-18, PA-20 and PA-22 Airplanes

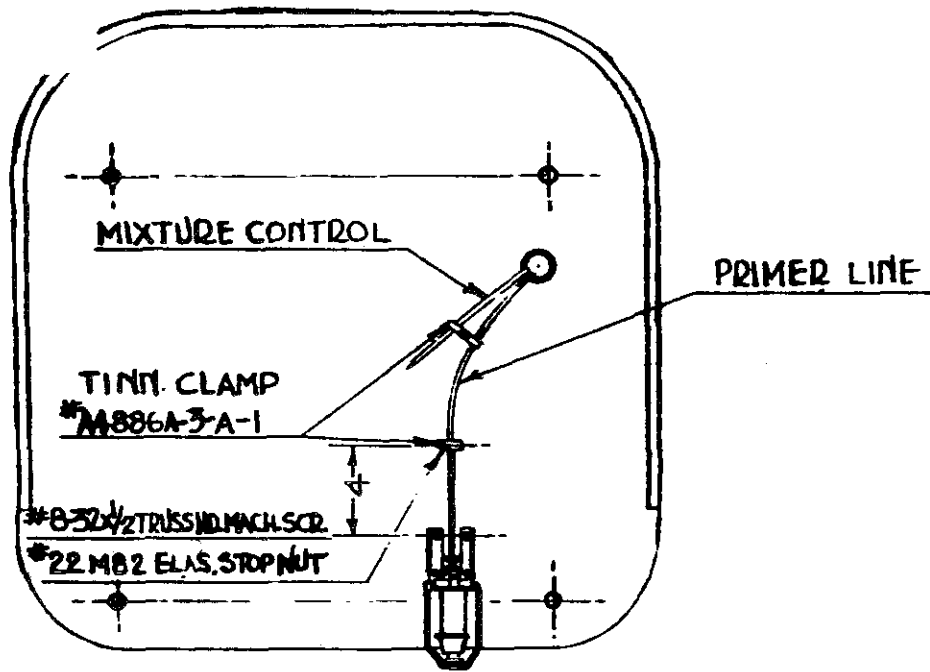
PA-18 (LYCOMING ENGINE)

It has been brought to our attention by our field organization and by the Civil Aeronautics Authority that the primer line which runs adjacent to the firewall had, because of vibration, rubbed against the firewall and muffler and had worn through to such an extent that gasoline leaked out and seeped through the firewall onto the floorboards and carpet.

In order to prevent possible occurrences of this type in other airplanes it is recommended that the primer lines on all of the above model aircraft be clamped and/or re-routed per the sketch on the reverse side of this letter.

There is one (1) Tinnerman clamp number A4886A-3-A-1 required on the PA-18. There is one (1) Tinnerman clamp number A4886A-3-A-1 and one (1) 80032-51 clamp required on the PA-20's and PA-22's. These clamps will be furnished No Charge and they may be obtained through the Piper Distributor in your area.
