Service Bulletin No. 116

March 9, 1951

Subject: Battery Box Lid

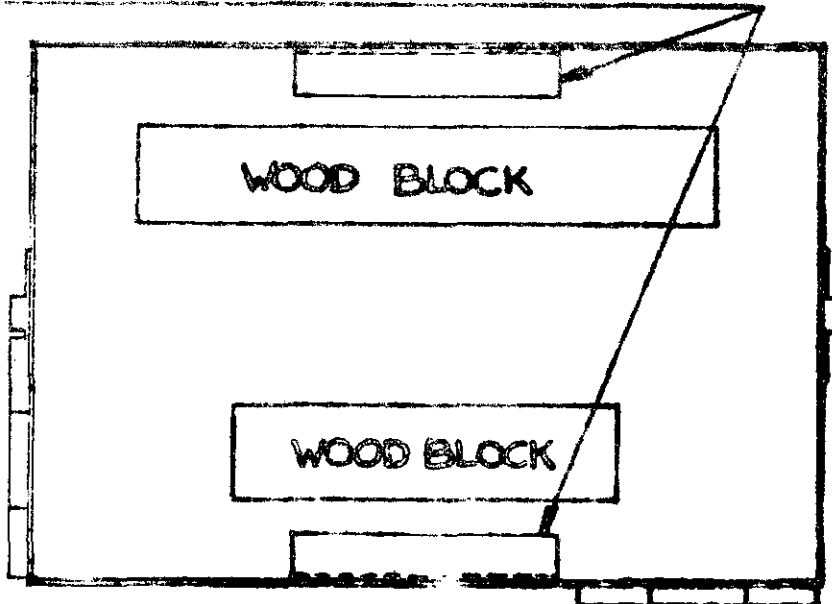
SKETCH NO. 1

ANGLE SPOTWELDED TO INSIDE OF LID

Lids of the type construction shown in Sketch No. 1 are satisfactory without rework.

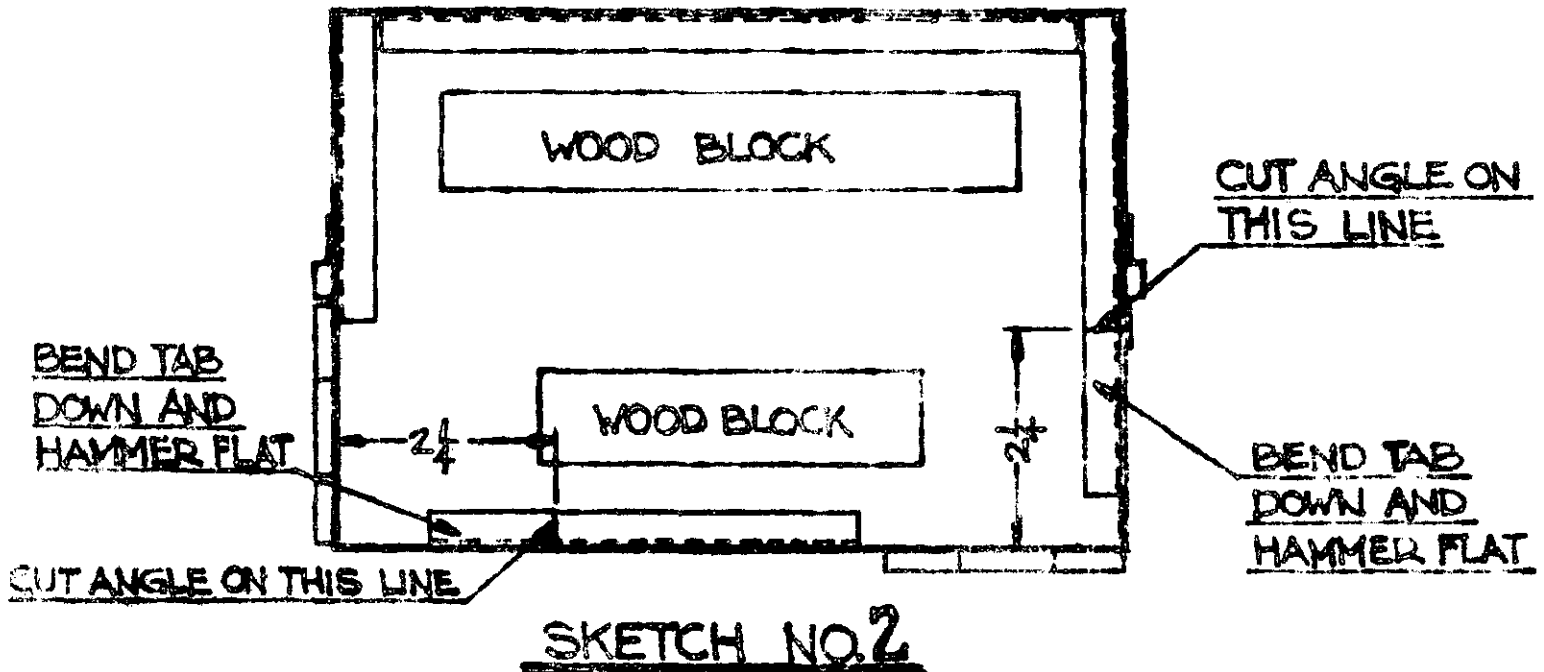
FOUR ANGLES SPOTWELDED TO INSIDE OF LID

Lids of the type construction shown in Sketch No. 2 must be reworked as indicated.
