Service Bulletin No. 119

November 7, 1951

SUBJECT: Freezing of Nose Wheels

MODELS AFFECTED: PA-22 airplanes with serial numbers 22-1 to 22-354 inclusive

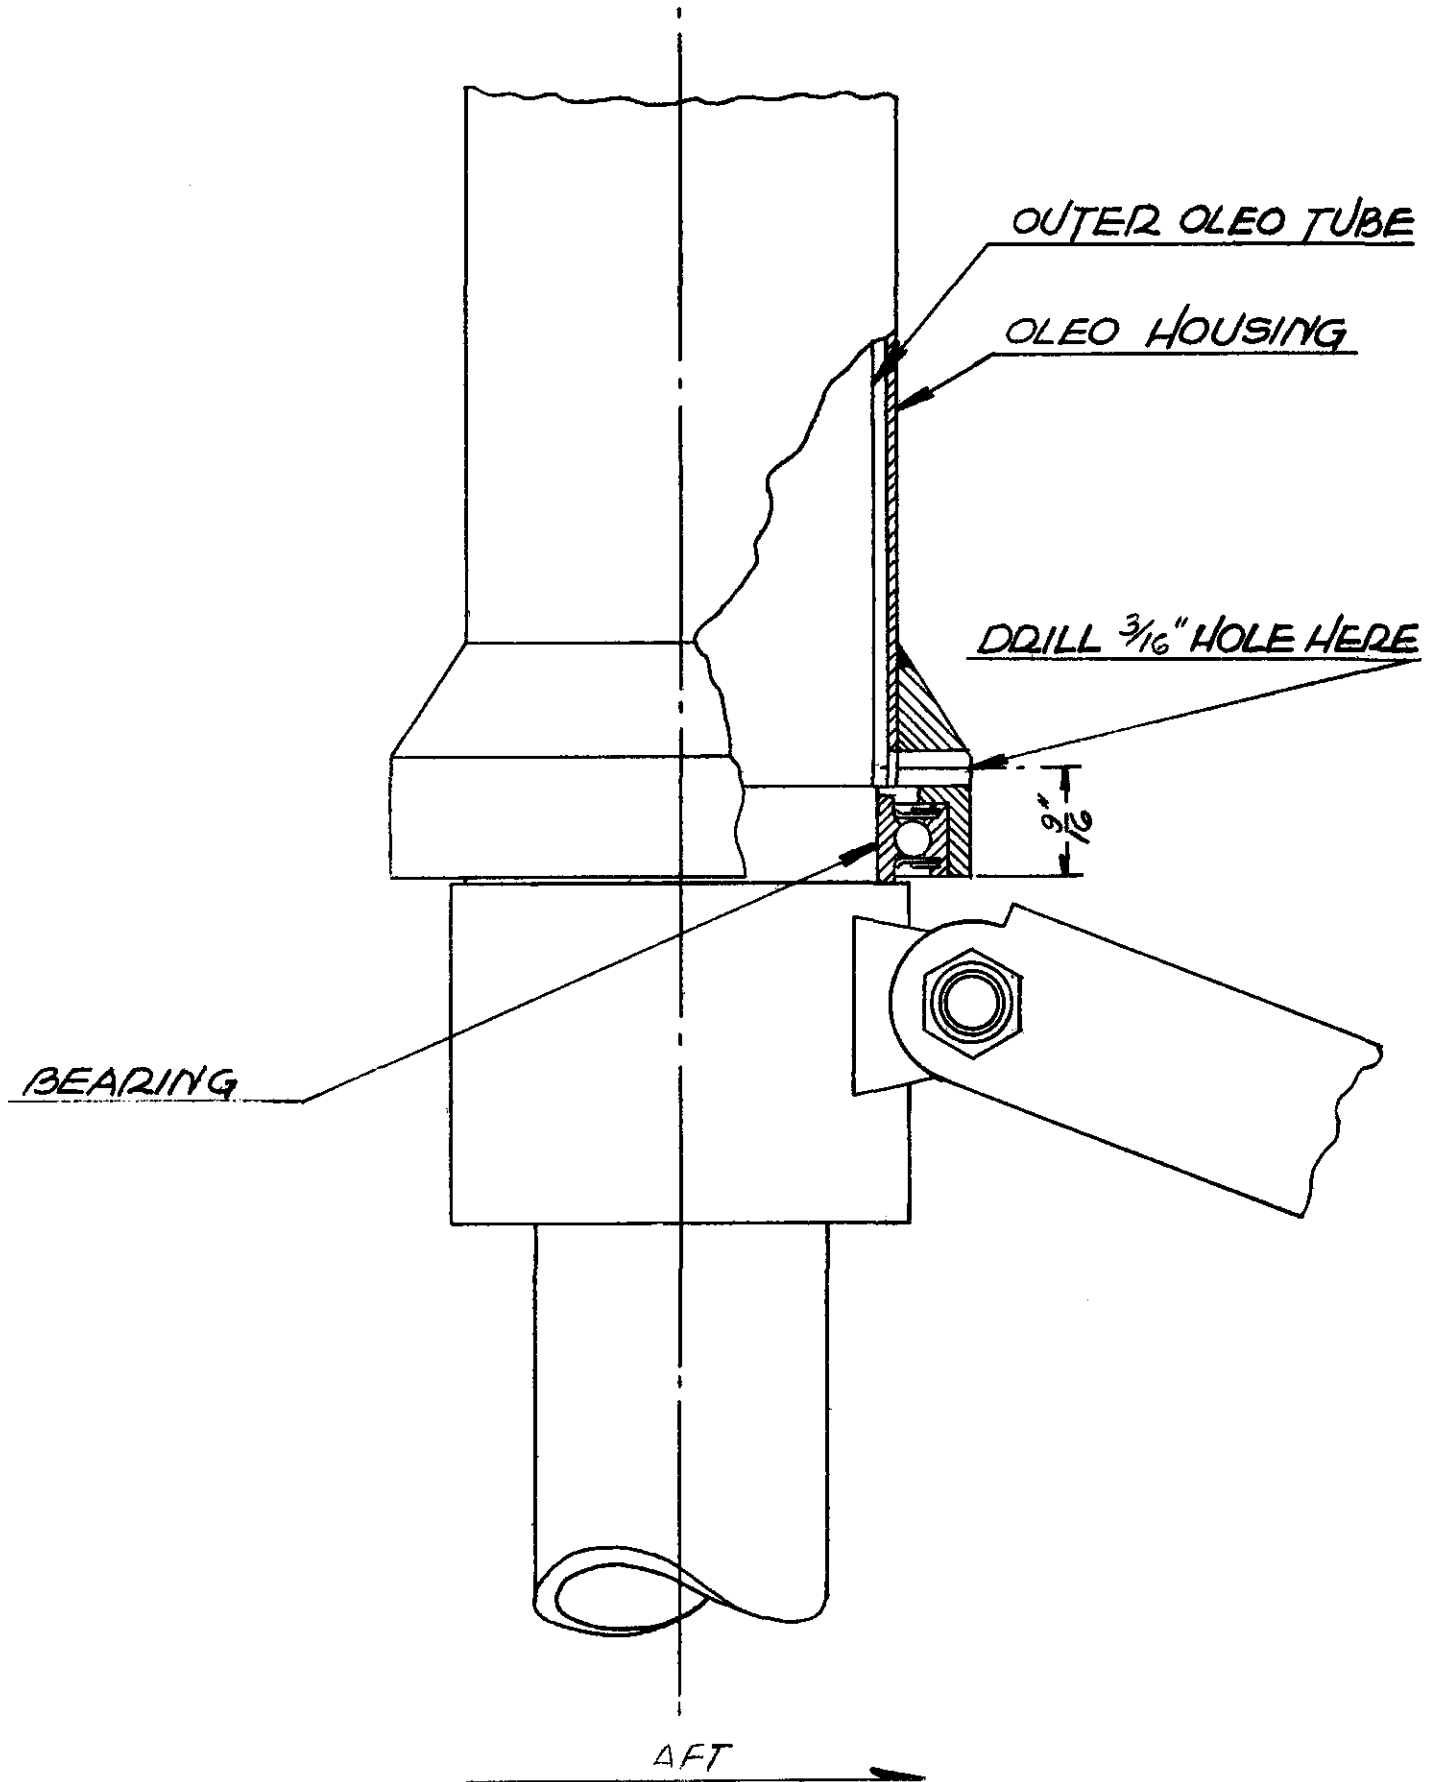
It has been found that when operating in hard driving rain or when washing the airplane water can enter the oleo housing through the upper bearing.

During freezing weather any water which may have entered the 1/16" space between the housing and the oleo will freeze causing the nose wheel to become inoperative insofar as directional steering is concerned, both on the ground and in the air.

1. Using a small punch and hammer make a mark 9/16" above the bottom edge of the lower bearing retainer ring which is located at the lower end of the nose wheel mount housing. The punch mark is to be made on the rearward side of the retainer ring (see sketch on the reverse side of Page 2).

2. Using a Number 30 drill, drill a small pilot hole through the retainer ring, being very careful not to drill the oleo tube. The thickness of the material at this point is 13/32". There is only 1/16" clearance between the housing and the oleo. Do not drill into the oleo tube.

3. Using a Number 11 of 3/16" drill enlarge the size of the pilot hole which was drilled in accordance with Step 2. The purpose of the 3/16" hole is to provide a drain for any water which might have found its way into the oleo housing.

4. The airplane should be placed in a warm hangar to make sure that all traces of ice have melted and drained out of the oleo housing.

5. Apply a generous quantity of cup grease to the top of the oleo housing to prevent further seepage of water. The upper bearing and retainer nut should be completely covered.
