Service Bulletin No. 123

SUBJECT: Front Spar Interference

MODELS AFFECTED: All PA-20 and PA-22 Model Aircraft

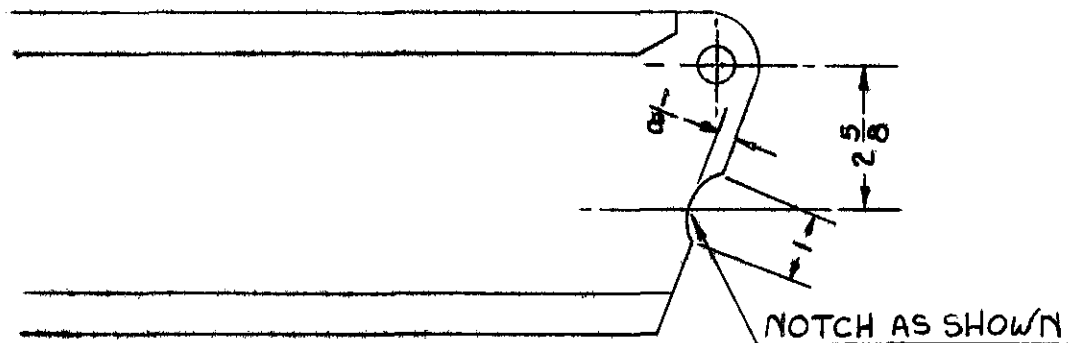
It is requested that an inspection be made to determine whether or not there is interference between the inboard end of the front spar web and the aileron pulley attachment bolt in the area of the front wing hinge fitting.

If there is less than one-eighth inch clearance between these two points, then the spar web should be filed out and sanded smooth in accordance with the attached sketch.
