Service Bulletin No. 124

August 30, 1954

SUBJECT: PA-22 Landing Gear
TO: All Distributors, Dealers, Owners and Operators
MODELS AFFECTED: All Model PA-22 Airplanes

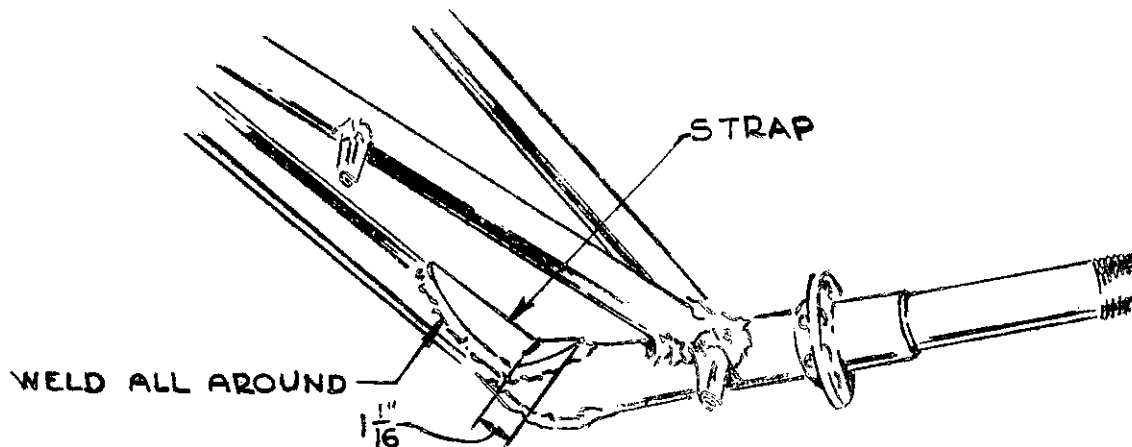
A number of field service reports have been received to the effect that cracks have been appearing in the leading edge of the streamlined tube of the PA-22 landing gears at a point where it joins the inboard end of the axle.

Indications are that this is a fatigue failure and it is requested that all Model PA-22 airplanes listed above be modified by installing a reinforcing strap, part number 14415-00, as per the sketch below.

The reinforcement strap can be obtained from the Service Department of the Piper Aircraft Corporation, free of charge.
