# SERVICE BULLETIN

No. 161A

**SUBJECT:** Fire Hazard

**MODELS AFFECTED:** All PA-16, PA-20 and PA-22 Airplanes, serial numbers 22-1 to 22-6194 inclusive

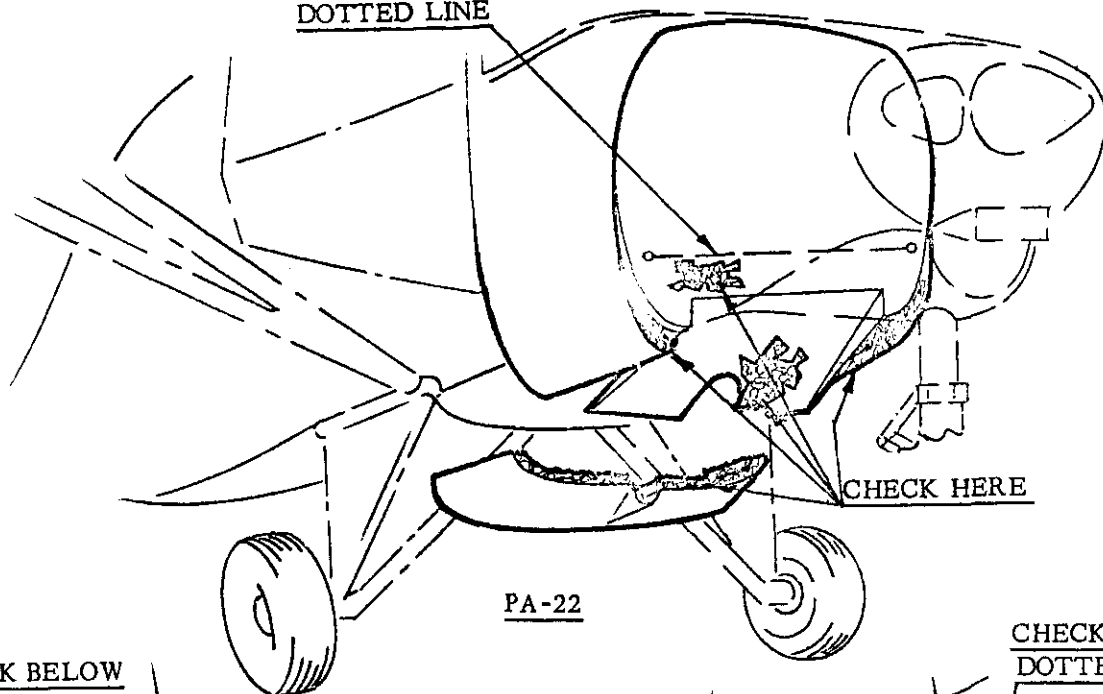
PA-22

CHECK BELOW  
DOTTED LINE

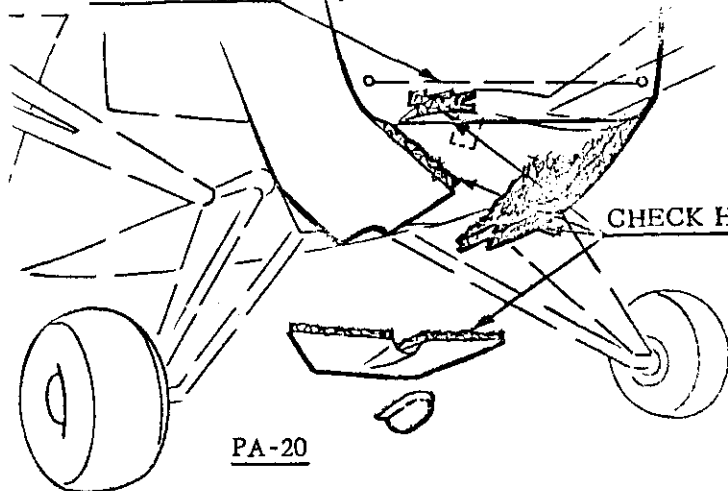
PA-20

CHECK BELOW  
DOTTED LINE

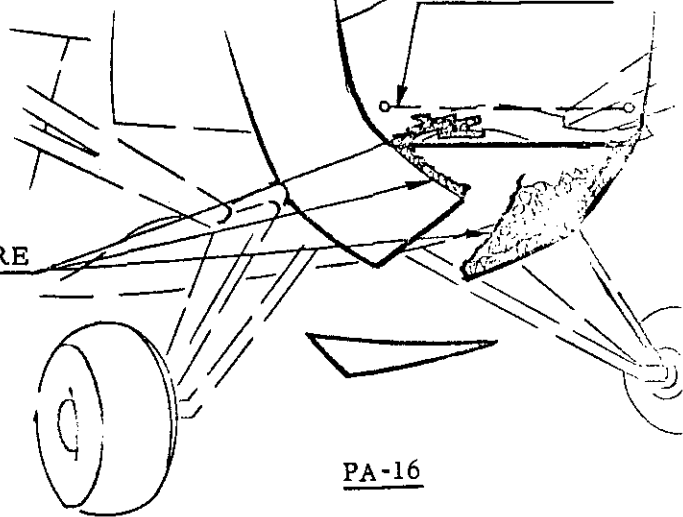
PA-16

CHECK BELOW  
DOTTED LINE
