SERVICE No-351 BULLETIN

Piper Aircraft Corporation

Subject: Fuel Line Replacement

Models Affected: PA-20-115, PA-20-125, and PA-20-135 Pacer
PA-22-108, PA-22-125, PA-22-135, PA-22-150, PA-22-160
Tri-Pacer

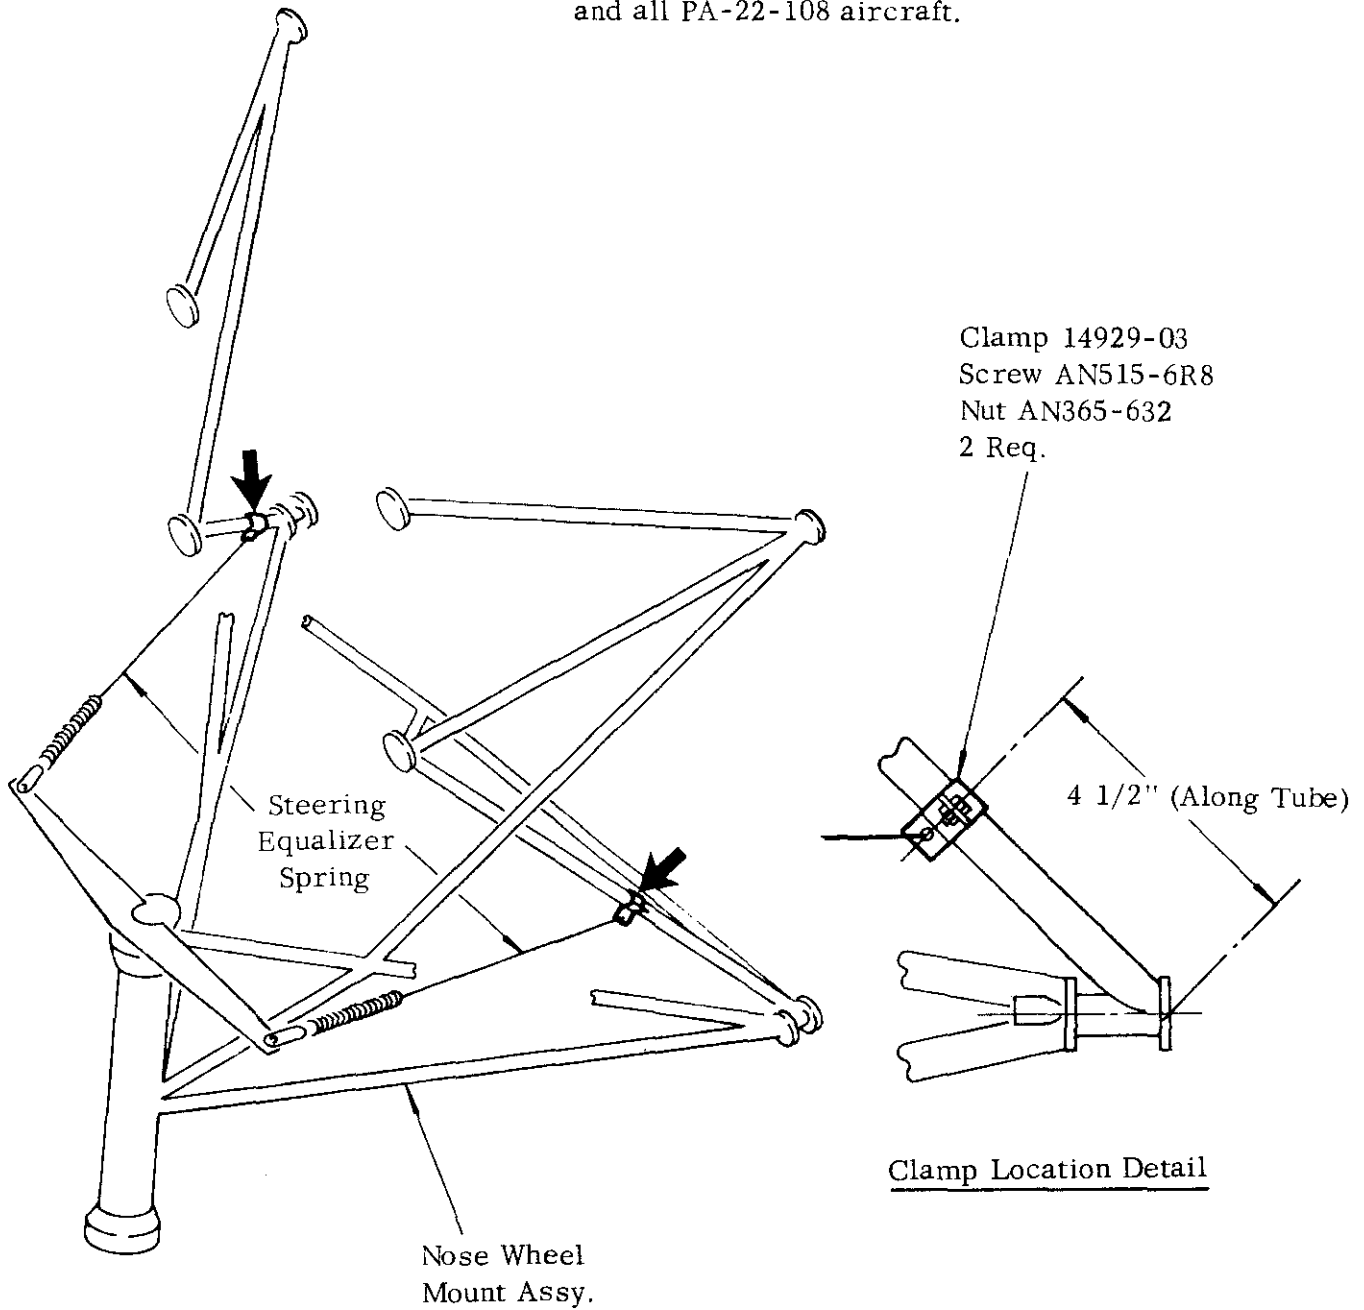
Service Bulletin 351

Install clamps 14929-03 as shown on all utility category PA-22-150 and PA-22-160 aircraft and all PA-22-108 aircraft.

1. When replacing original fuel line assembly, Piper part number 70322-32 with newer type fuel line assembly, Piper part number 17766-66, installation kit Piper part number 754 439 is also required (one each per aircraft) @ suggested unit retail price \$1.73C.
2. When replacing the originally installed Piper part number 70322-32 flexible fuel line with the new flexible fuel line, Piper part number 17766-66 on all utility category PA-22-150 and PA-22-160 Tri-Pacers and on all PA-22-108 Colts, serial numbers 22-8000 and up, in addition to the installation kit referenced in Note 1, above, two (2) each clamps Piper part number 14929-03 are required (see sketch on page 3 of this bulletin) @ suggested unit retail price \$4.06.
