SERVICE No. 924

Piper Aircraft Corporation
Vero Beach, Florida, U S A

SUBJECT: Shimmy Dampener Replacement

PA-22-125/135/150/160 Tri-Pacer	22-1 through 22-7642
PA-22-108 Colt	22-8000 through 22-9848

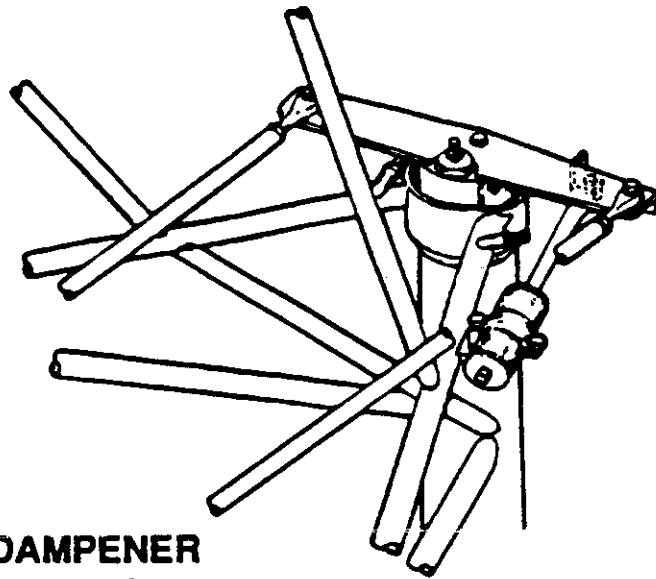
SKETCH "A"

PURPOSE: It is possible that through improper installation or by the lack of maintenance and lubrication that the shimmy dampener may bind or become unserviceable. Should this occur, especially on aircraft equipped with the early model shimmy dampeners, the possibility exists that during a maximum left turn the shimmy dampener shaft may jam or bend, causing loss of nose wheel steering. This condition could possibly lead to partial or total loss of rudder control.

**SHIMMY DAMPENER
(EARLY MODEL)
TRI-PACER - PART NO. 13086-00
(IDENTIFICATION)**

**CHECK FOR
FREEDOM OF
ANGULAR TRAVEL**

1. Remove cowling as necessary to gain access to nose wheel shimmy dampener. Refer to applicable Owners Manual or Parts Catalog.
2. Shimmy Dampeners with Piper Part Number 13086-00, as identified on Sketch A (attached), should be removed, discarded and replaced by Piper Part Number 21701-06.

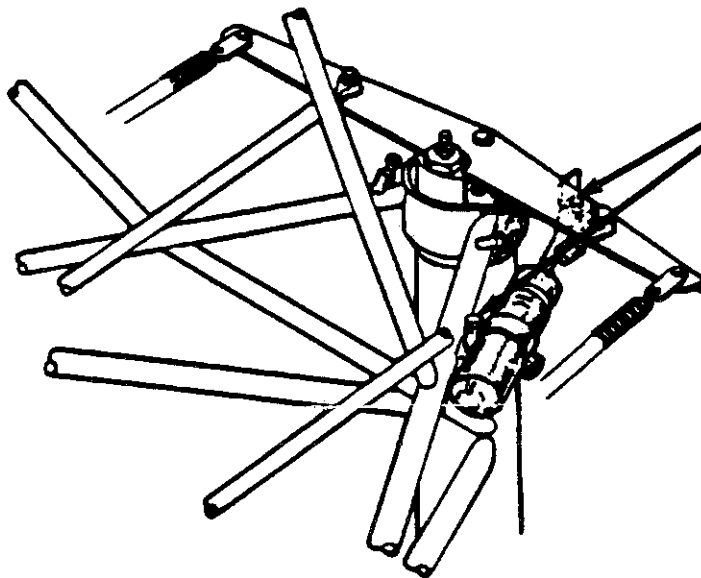
SKETCH "B"

**SHIMMY DAMPENER
(LATER MODEL)
TRI-PACER - PART NO. 21701-02
COLT - PART NO. 21701-04
(IDENTIFICATION)**

3. If the shimmy dampeners with Piper Part Numbers 21701-02 and 21701-04, Sketch B (attached), are inspected and determined to be serviceable and airworthy and the instructions below are complied with, those shimmy dampeners may be returned to service.

4. Determine that nose wheel travel is 20 degrees left and right of center.
5. Determine that the shimmy dampener rotates freely on the axis of its attachment bolt throughout its full travel, especially as it approaches the limits of nose wheel travel.

6. Determine that the attachment of the shimmy dampener rod end to the nose wheel steering arm is free to accept angular travel in either direction.
7. Should any stiffness, restrictions, or other maladies be noticed, correct by replacing parts and adjusting as necessary until proper fit and function is obtained.

8. A regular maintenance routine of inspection, cleaning, and lubrication should be performed at each one hundred (100) hours of operation or at any inspection event. Lubricate shimmy dampener rod end and pivot point using general purpose low temperature oil (MIL-L-7870 or equivalent). Wipe shimmy dampener shaft using a clean cloth saturated with MIL-H-5606 hydraulic fluid.
