TO: All Distributors

SUBJECT: Rudder Cable Rub Block - PA-20 Airplanes serial 20-1 to 20-48 incl., 20-50, 20-52 to 20-83 incl., 20-85 to 20-88 incl., 20-90 to 20-94 incl., 20-96, 20-98 to 20-104 incl., 20-106 to 20-109 incl., 20-112, 20-114, 20-116 to 20-118 incl., 20-121 and 20-128.

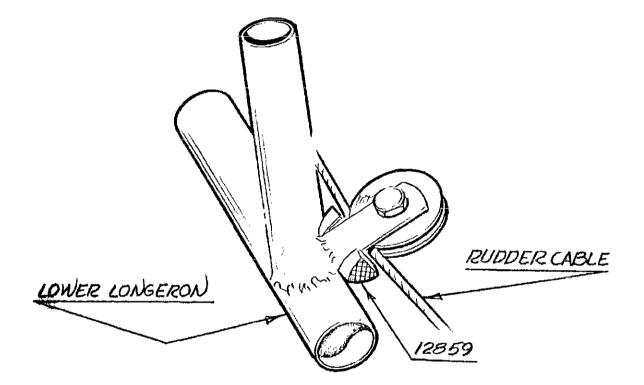
It has been brought to our attention that there is sufficient slackness in both the right and left rudder cables of the PA-20 to permit the cables to ride on the edge of the four pulleys located under the front and rear seats on both sides of the cockpit. In order to eliminate the aforementioned condition, we are sending to you, at no charge, four cable rub blocks, Part Number 12859-00, which should be installed using the following procedure. (See Sketch opposite side.)

- 1. Remove the rear seat cushion and frame.
- 2. Fold the edge of the cockpit back so as to permit easy access to the screws which hold the pulley guards.

- 3. Remove the four rudder cable pulley guards.
- 4. Remove the four pulleys, being careful not to lose the small bushings or washers. It may be necessary to loosen the forward end of both rear tunnels to permit removal of the cable from the pulley housing.

- 5. Lift the cable out of the pulley housings. Insert a cable rub block, number 12859-00, into each of the four pulley housings, making certain that the block seats properly. It is only necessary to have sufficient clearance between the pulley and block to allow the pulley to rotate freely. (It is imperative that the pulley runs freely.) It may be necessary to file the fibre block slightly to insure proper fit. The rub blocks will hold the cable in the pulley groove at all times.

- 6. Reinstall the cable and pulleys; rudder pedal guards and seat.
