# SERVICE LETTER

No. 186

SUBJECT: Clearance between the Engine Mount and the Exhaust Tail Pipe and  
Clearance in the Nose Wheel Steering Mechanism

MODELS AFFECTED: All Model PA-22 Airplanes

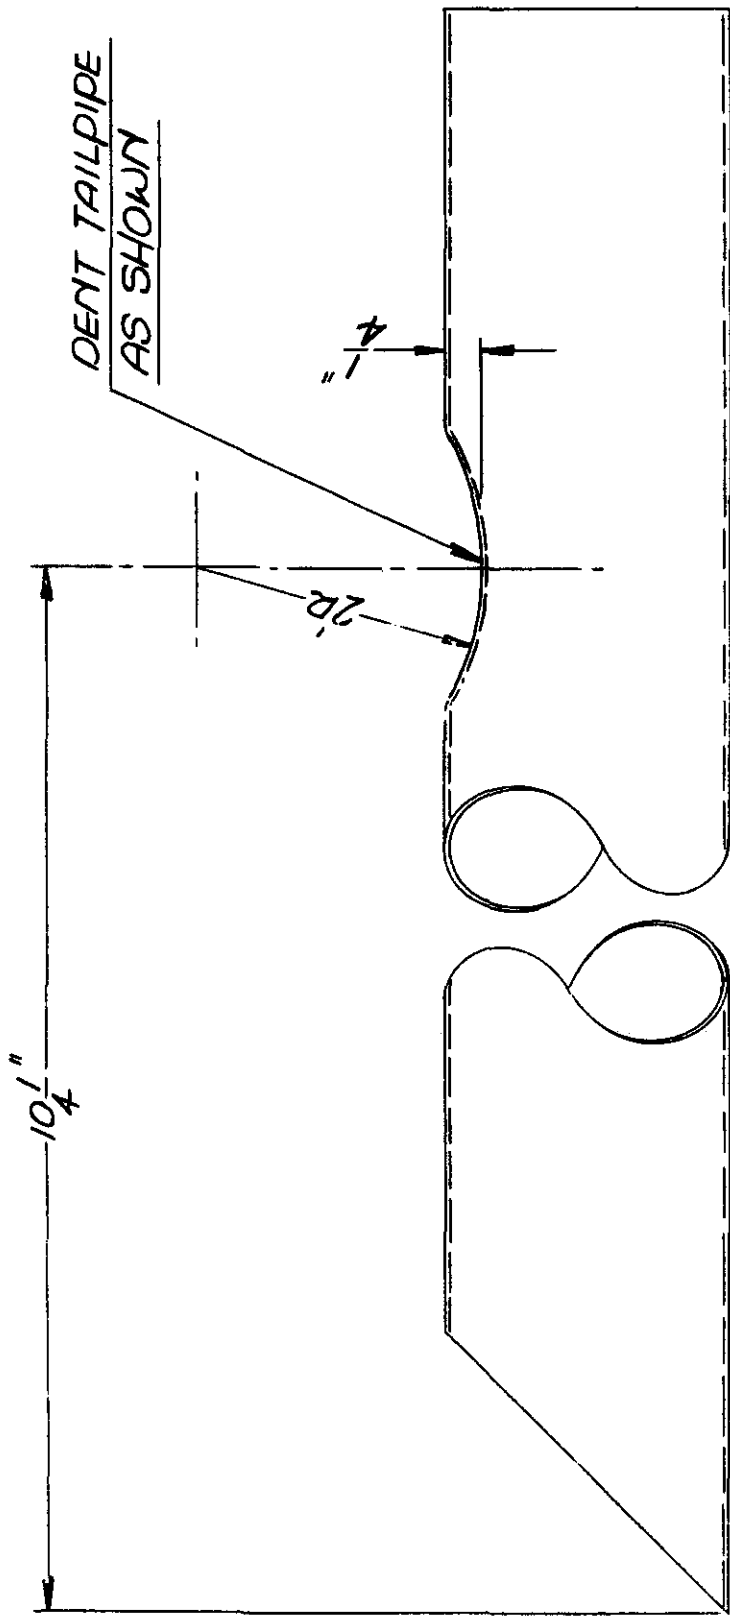
Sketch for Service Letter No. 186

It has been brought to our attention that the clearance between the engine mount and the tail pipe on the subject model airplane is not adequate and in some cases the tail pipe has rubbed the diagonal motor mount tube causing the tube to become somewhat grooved, due to the rubbing and scrubbing action of the tail pipe.

In the event it is impossible to obtain the proper clearance then the tail pipe should be modified in accordance with the attached sketch.

It has been reported that there have been cases of interference between the cross-over exhaust stacks and the nose wheel steering rod ends. We suggest that you investigate the possibility of this condition existing in your airplane and take corrective action if necessary. Proper clearances can be obtained by denting the exhaust stack tubes at the points of contact by using the same steps and dimensions as shown in the tail pipe sketch.
