Service Letter No. 212

October 7, 1953

Subject: Nose Wheel Shimmy Dampener, Part No. 13086-00

Models Affected: All 1953 Model PA-22's with serial numbers 22-807 to 22-1614 inclusive, 22-1616 to 22-1631 inclusive, 22-1633 to 22-1635 inclusive, 22-1638, 22-1642, 22-1646 to 22-1648 inclusive, 22-1651, 22-1653, 22-1655, 22-1656, 22-1658 to 22-1661 inclusive, 22-1666, 23-1667, 22-1672, 22-1678, 22-1680, 22-1682 and 22-1683.

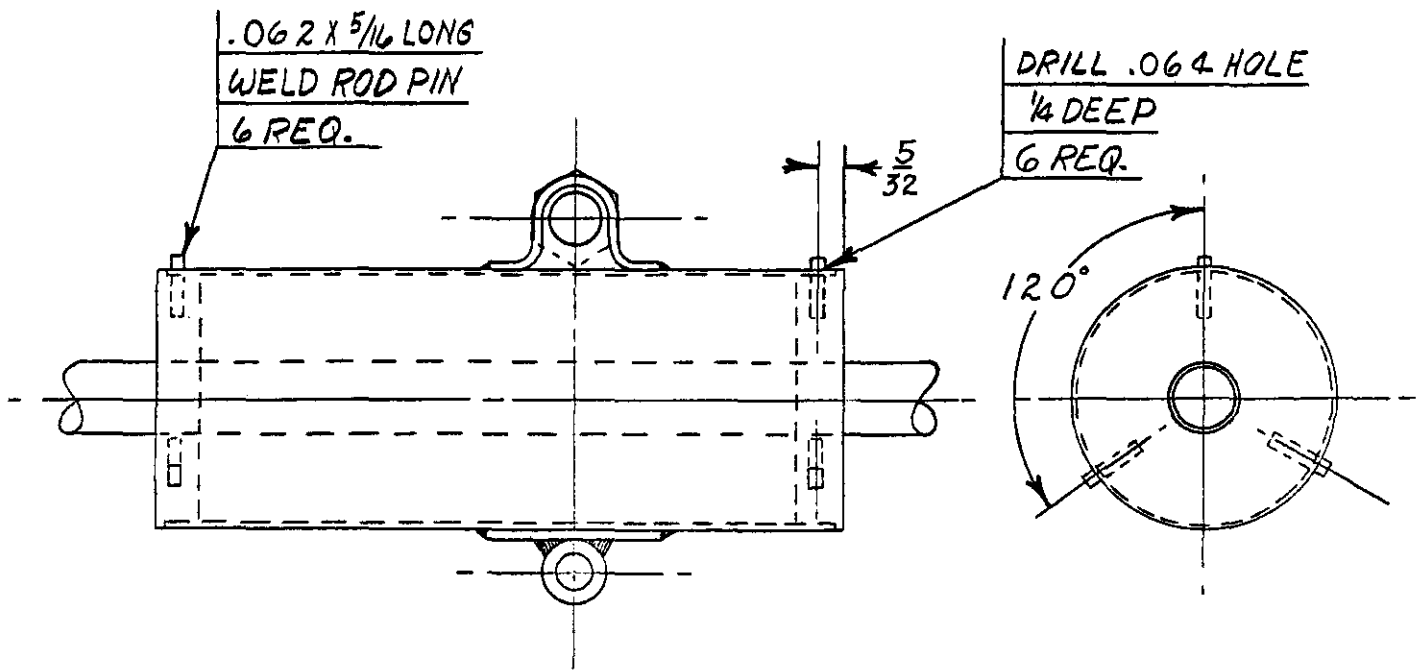
During the past few months we have received from the field a number of shimmy dampeners, part number 13086-00, on which a separation has occurred between the assembly body and the end plate. This separation was due to solder breaking loose and the internal fluid pressure plus the friction of the plunger forcing the end plate outward.

All production airplanes have been modified in accordance with the sketch shown on the reverse side of this Letter and it is felt that this modification can be satisfactorily executed in the field as a service-fix. Upon inspection if the shimmy dampener shows signs of separation, it will be exchanged free-of-charge at the nearest Piper Distributor or Dealer.

DRIVE PIN INTO EACH HOLE AND SOLDER END, COVERING  
PIN WITH SOLDER.
