SERVICE LETTER

No. 373

Piper Aircraft Corporation

SUBJECT: Installation of Oil Shields on Airborne Mechanisms Dry Vacuum Pumps, Models 113A1 and 113A5

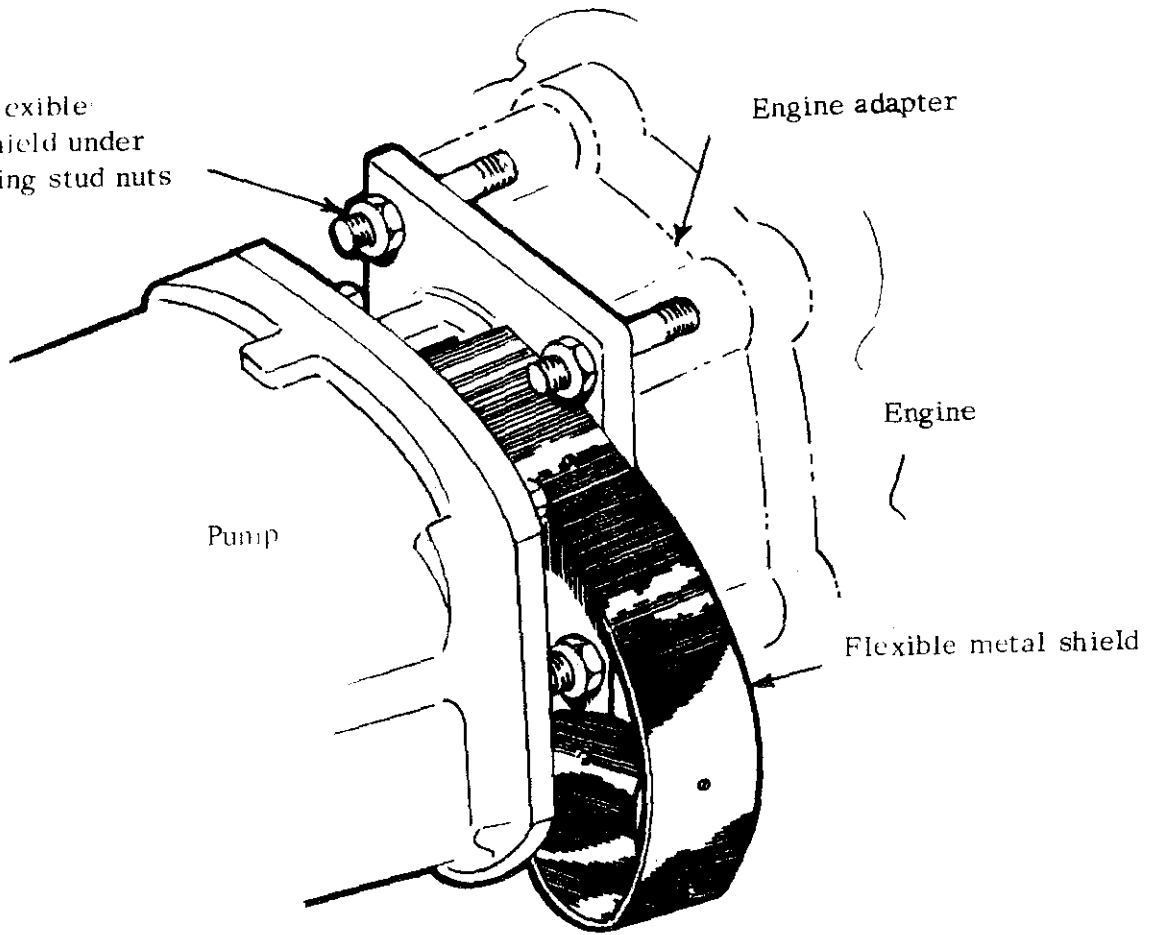
It has been determined that occasionally oil or cleaning solvents have entered the vent holes in the face of the mounting flange of the 113A1 and 113A5 Airborne Mechanisms dry vacuum pump.

Install flexible
metal shield under
4 mounting stud nuts

A flexible metal shield, part number 756 143, which is easily installed by threading under the pump mounting bolts, has been designed to protect these openings. Removing the pump is not necessary and the shield does not require fastening as the spring tension of the shield will hold it in its proper position, once installed. Installation of this shield is recommended on the subject aircraft equipped with Airborne Mechanisms Dry Vacuum Pumps. See sketch on the reverse side of this letter.

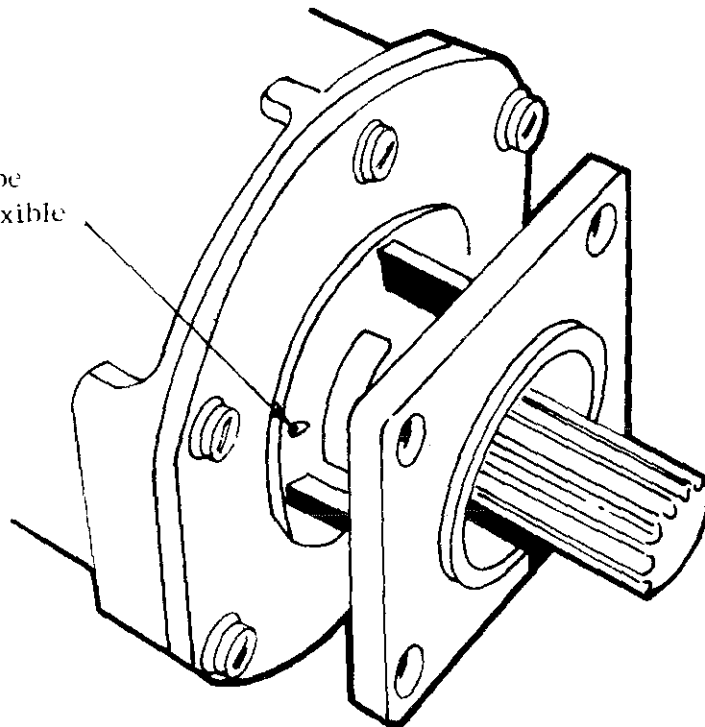
Vent holes to be
covered by flexible
metal shield
