Service Letter No. 392

SUBJECT: Inspection and Adjustment of Nose Wheel Shimmy Dampener Assembly

MODELS AFFECTED: All PA-22 Series Aircraft

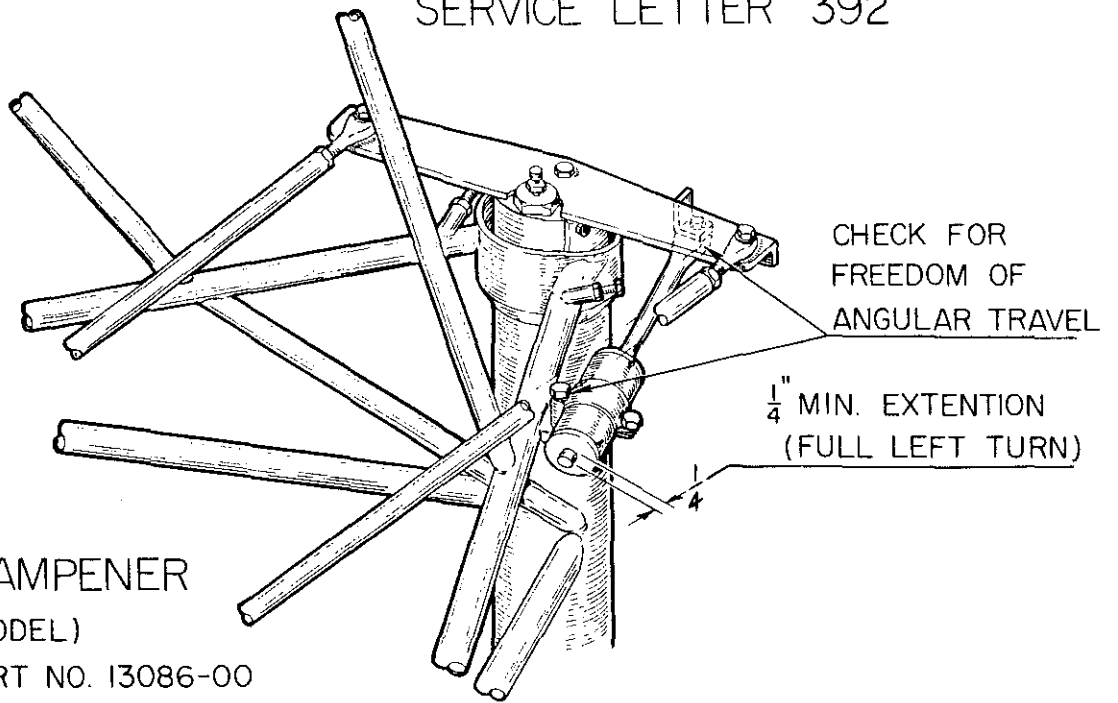
SHIMMY DAMPENER  
(EARLY MODEL)  
TRI-PACER—PART NO. 13086-00

- I. Should the above systems become maladjusted on aircraft equipped with the early model nose wheel shimmy dampener, part number 13086-00, it is possible that, in a maximum left turn, the shaft of the shimmy dampener may enter the end of the dampener housing and jam; thus making any further movement of the nose wheel impossible.

- II. It may also be possible that, through lack of attention during maintenance and inspection, the shimmy dampener may "freeze" to its attachment to the nose wheel structure. In other words, at large angles of nose wheel steering, relative angular travel must be maintained for the dampener. Should the bolt which attaches the dampener become corroded to the supporting structure etc., it would be possible to bend the shaft at the point where it exits from the dampener body.

- III. Freedom of angular travel must also be maintained at the point where the rod end attaches to the nose wheel steering arm. Lack of angular travel at this point could cause bending of the dampener shaft or bending of the rod end with possible failure of the rod end in the threads.

In view of the above, the following inspection will be required. On the Monroe type shimmy dampeners, part numbers 21701-02 and 21701-04, prior to but not later than the next 100 hours of operation and becoming part of the normal maintenance and routine inspection thereafter. On aircraft equipped with the earlier type shimmy dampener, part number 13086-00, prior to but not later than the next 25 hours of operation and becoming a part of the normal maintenance and routine inspection thereafter: (Refer to attached sketch)

1. Determine that the nose wheel travel is  $20^{\circ}$  left and right.
2. Determine that the shimmy dampener rotates freely on the axis of its attachment bolt when approaching the limits of nose wheel travel.
3. Determine that the attachment of the rod end to the nose wheel steering arm is free to accept angular travel.
4. The shimmy dampener should be adjusted, if necessary, so that at full left nose wheel travel, not less than 1/4 inch of the shaft shall be exposed on the back side of the dampener. (Applicable to early type shimmy dampener, part number 13086-00 only.)
