Service Letter No. 405

October 1, 1963

SUBJECT: Inspection of Upper Nose Gear Oleo Bearing

MODELS AFFECTED: PA-22 Tri-Pacer, PA-22-108 Colt, PA-22-135, PA-22-150, PA-22-160 Tri-Pacer

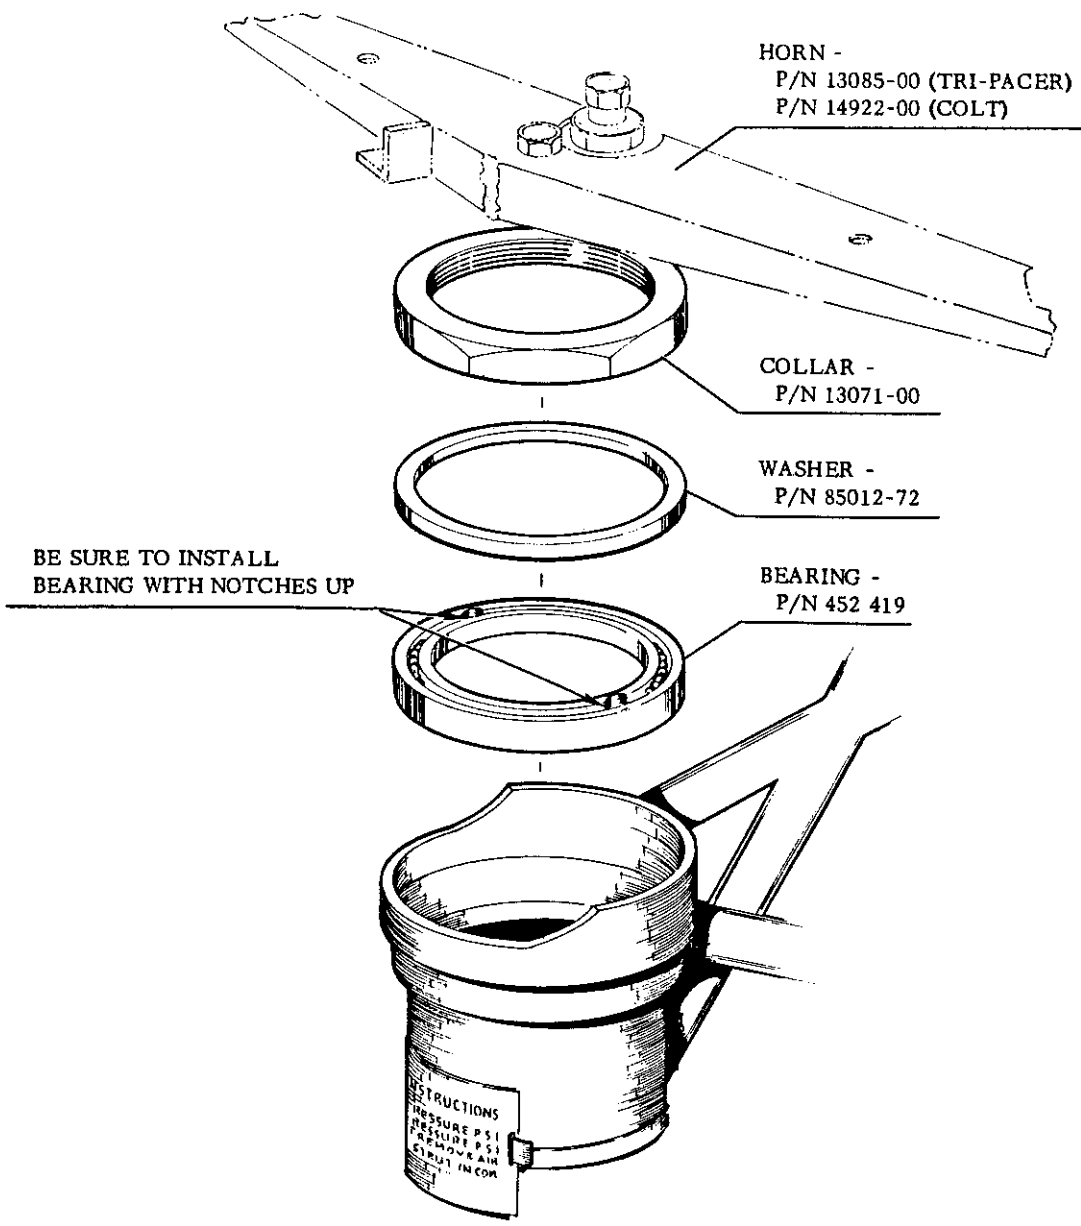
A number of reports have been received indicating that movement of the nose gear can be restricted due to binding of the upper nose gear oleo bearing, part number 452 333, due to lack of lubrication.

Loss of the balls from the bearing races has also been experienced due to excessive wear and the bearing being installed with the loading grooves facing downward.

If the bearing is in satisfactory condition and installed with the loading grooves facing upward, the bearing should be lubricated with MIL-G-3278 lubricant and the steering mechanism reassembled and inspected every 500 hours thereafter.

If the loading grooves are not visible it will be necessary to lower the oleo assembly to remove the bearing. The bearing should be removed, checked, lubricated and installed as indicated above, with the bearing loading grooves facing upward.

If the bearing is not in satisfactory condition, it should be replaced with sealed bearing, part number 452 419. When part number 452 419 bearing has been installed, the above inspections may be discontinued; the bearing should be checked for condition every 1,000 hours.

BEARING SHOULD BE LUBRICATED WITH MIL-G-3278 LUBRICANT.
