SERVICE BULLETIN

STINSON DIVISION
CONSOLIDATED VULTEE AIRCRAFT CORPORATION
WAYNE, MICHIGAN

TITLE: Leakage - Cabin Door Windows

BULLETIN NO. 247

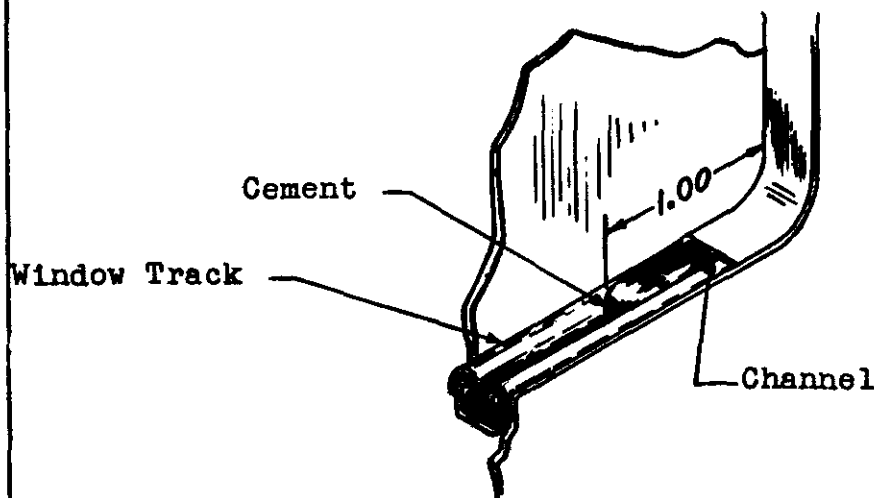
There has been reported a few cases of where rain has filtered into the cabin interior through the upper and lower rear corners of the cabin windows on airplanes within the above serial numbers.

This is not a mandatory correction, but should the problem be encountered we recommend that the aft ends of the upper and lower sliding window track be treated with a sealing compound. The track in the cabin door should be filled with sealer for a distance of about one inch forward of the rear window frame. Using a putty knife or similar tool the sealing compound should be pressed well into the channel making sure that the aft edge of the channel and window frame are sealed. The sketch below illustrates only the lower corner, but the upper corner should be similarly treated. The following types of sealing compounds are recommended:

Mastiseal - Ditzler Color Company
Alumilastic C-2 - Parr Paint and Color Company
Zinc Chromate Compound - Equivalent of AAF Spec. 3598,
Cond. B.
