# SERVICE BULLETIN

TITLE: Protection of Wiring Harness

BULLETIN NO. 248-A

Models Affected: 108-1 through 108-2394

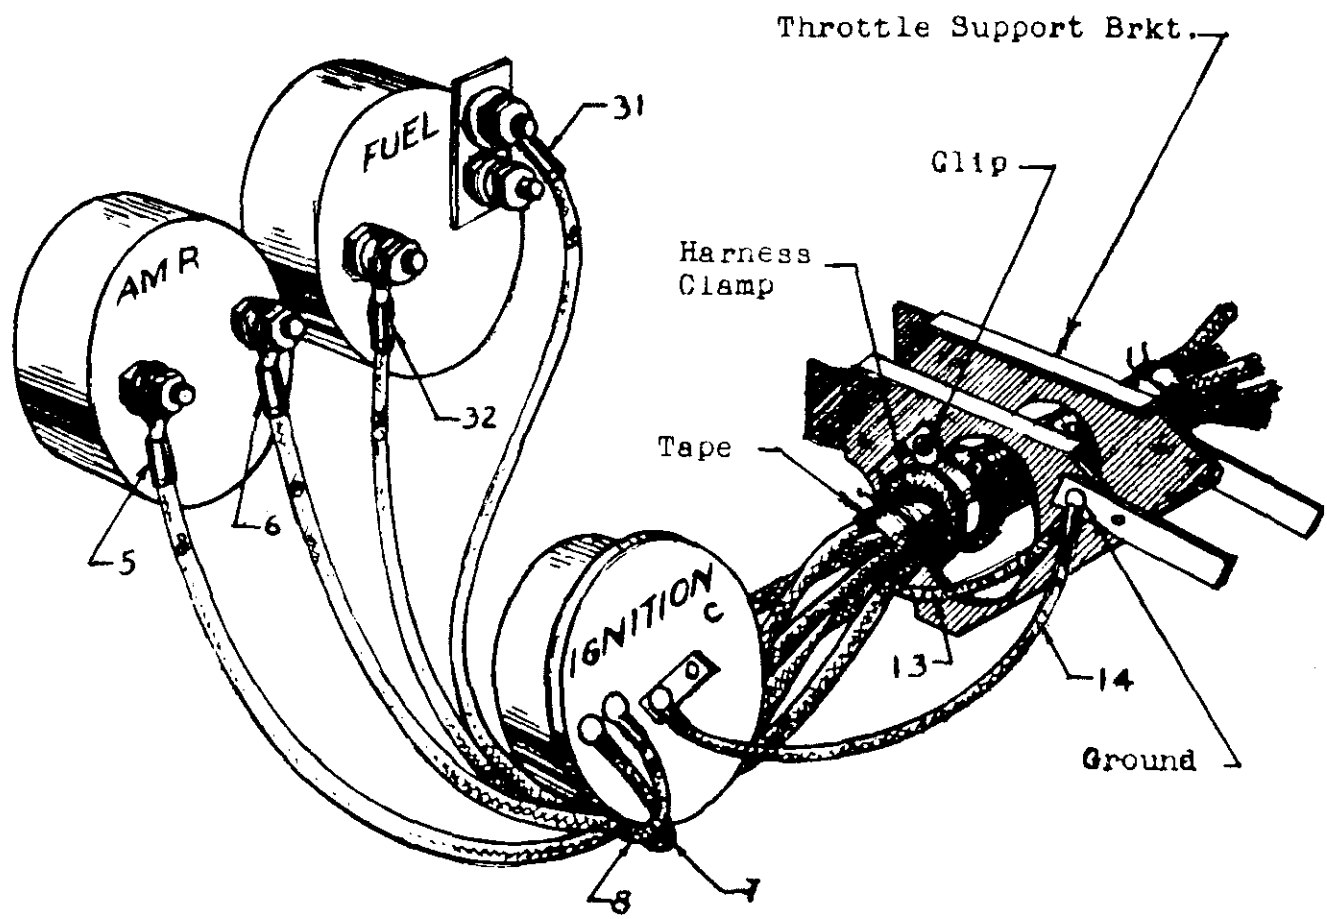
Figure 1

As a precautionary measure we recommend that airplanes within the above serial numbers be examined for possible chafing of the wiring harness at the throttle bracket behind the instrument panel. Should such a condition exist, the following corrective procedure is suggested:

Pull wires to left of panel and wrap into a bundle, using coreprene tape where the wires pass the throttle bracket. Taped area should be about ten inches long. Tie each end of the wrapped area with lacing cord to prevent any possibility of unwinding after performing this correction work.

Thread the wrapped wires underneath the carburetor heat control and through the lightening hole in the throttle support bracket. Install clip and harness clamp as shown in the illustration on the reverse side of this page. Secure the wrapped wires in the harness clamp.
