# SERVICE BULLETIN

TITLE: Fuel Gauge Modification

BULLETIN NO. 251

MODELS AFFECTED: 108 (Voyager and Flying Station  
Wagon) Serial Numbers 108-1  
through 108-41, 108-43, 108-287,  
through 108-2849.

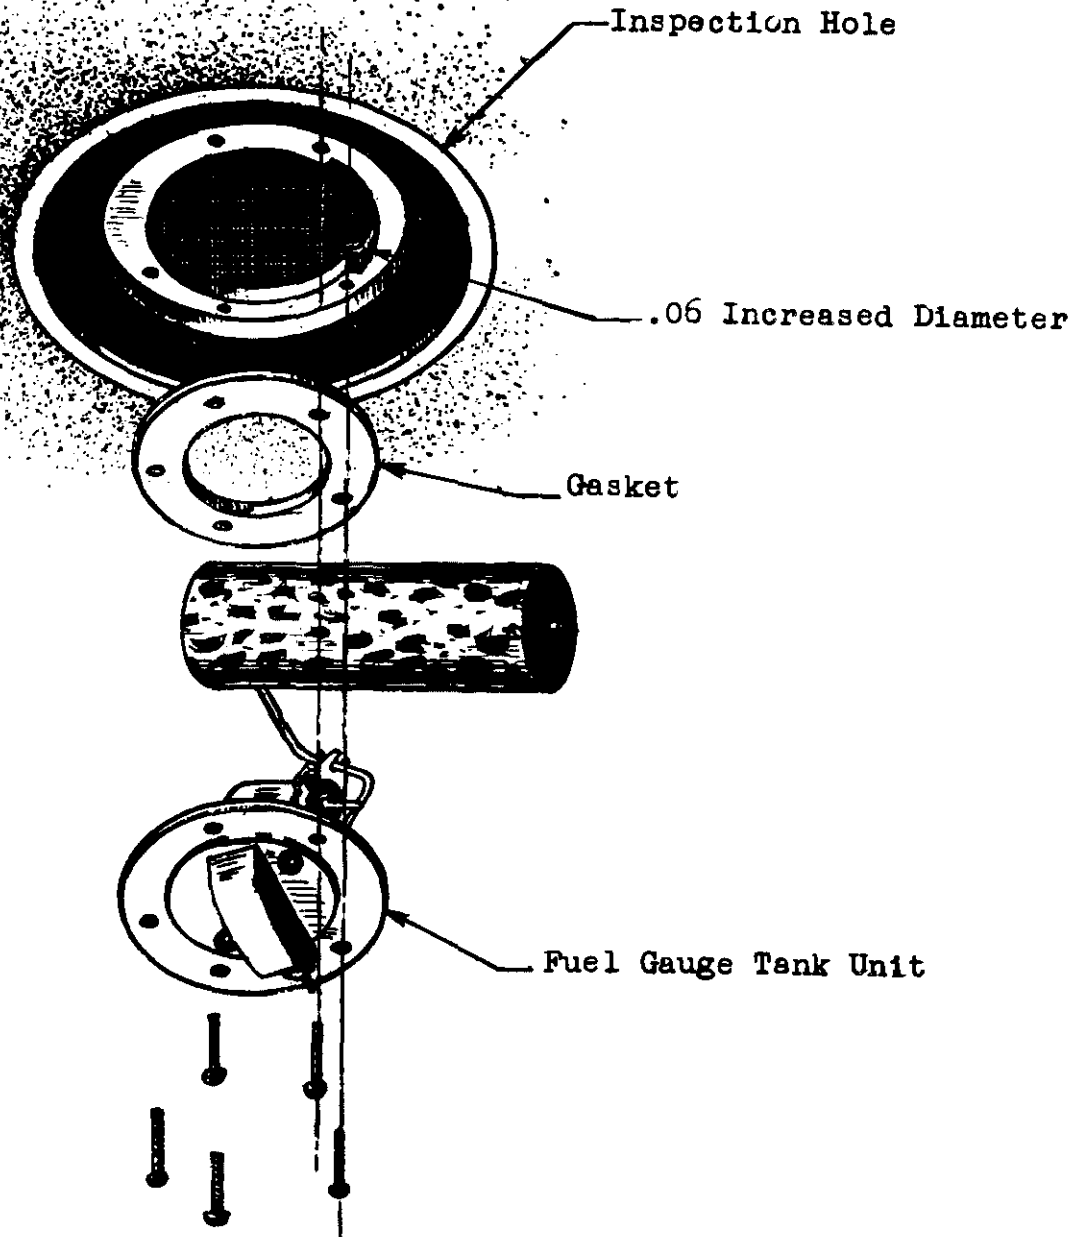
We have found in some airplanes a definite indication of interference between the gas gauge tank unit float arm and the cast aluminum adapter in which the gas gauge tank unit is mounted. This interference prevents the fuel gauge from properly registering the quantity of fuel in the tank. To remedy this condition the following modification is recommended:

Increase the inside diameter of the cast aluminum adapter in the tank by filing .06 inches from the inside of the ring in the region of the float arm (See Illustration on Page 2). The area to be filed will be self-evident upon inspection inasmuch as the tank unit will only fit the adapter in one way.

**IMPORTANT:** File cast aluminum adapter using downward stroke only. Do not allow file to contact adapter on upward stroke.
