TITLE: Tail Wheel Installation

BULLETIN NO. 252

MODELS AFFECTED: 108 (Voyager and Flying Station Wagon)

Date: June 26, 1947

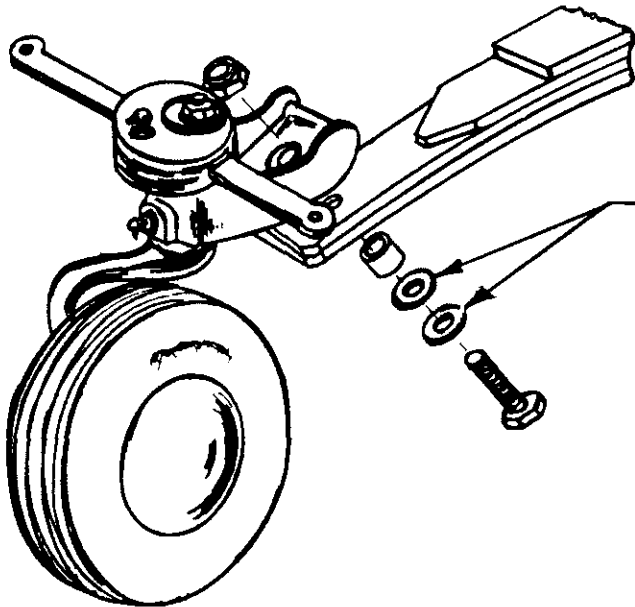
We recently received several reports on the subject of non-functioning steerable tail wheels. A complete investigation of this subject indicated that the tail wheel steering arms were of proper specifications and that the difficulty, where encountered, was caused by the tail wheel arm striking the end of the tail wheel installation bolt. When the tail wheel steering arm swings forward it strikes the end of the bolt and jams the tail wheel mechanism before it reaches the release point.

If any Voyagers in your territory are reported to be experiencing this type of difficulty, we recommend that the tail wheel assembly bolt be removed and two washers installed under the head of the bolt as indicated in the sketch below.
