TITLE: Inspection of Stabilizer Leading Edge
Attachment

BULLETIN NO. 254

MODELS AFFECTED: 108 (Voyager and Flying Station
Wagon) Serial 108-1 through 108-
3500, Inclusive

DATE: September 5, 1947

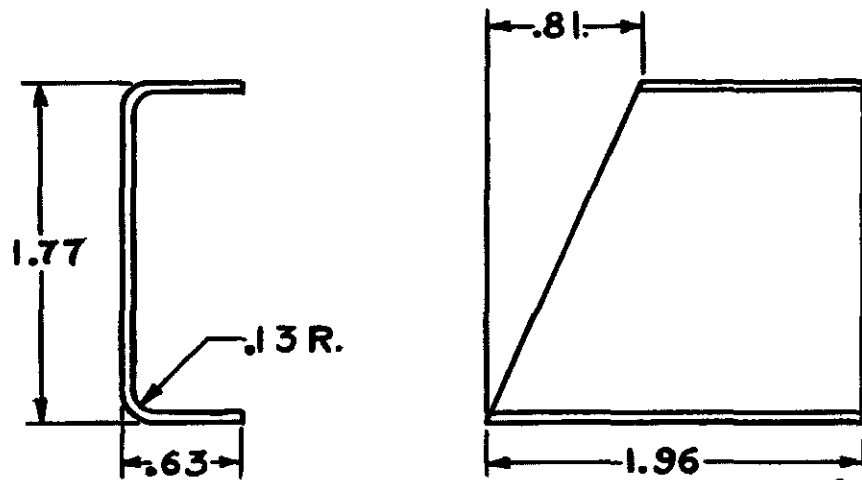
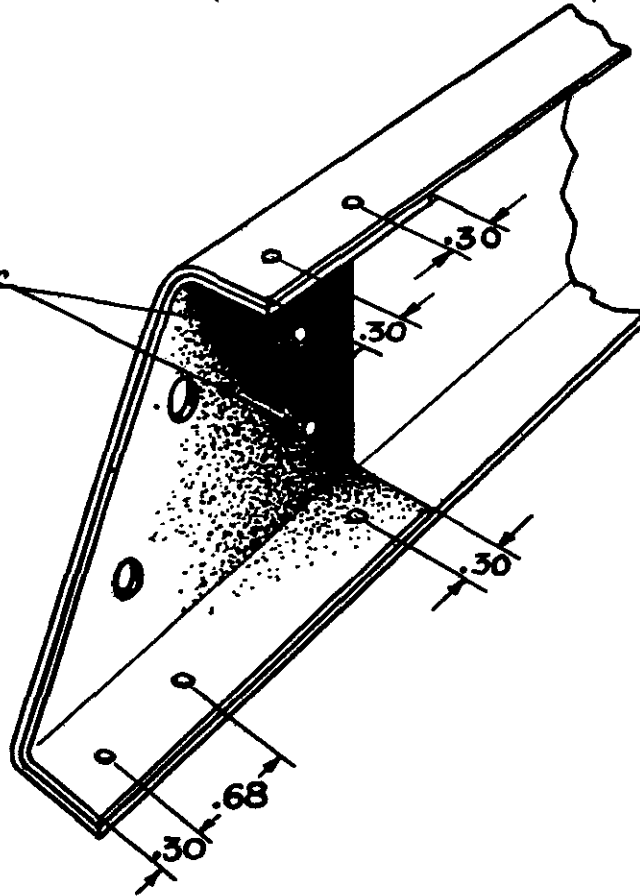
To determine whether or not fatigue cracks have developed in the fitting that attaches the horizontal stabilizer to the fin, it is recommended that all airplanes in the above category be inspected at this point. It is further recommended that this inspection be made after each 100 hours of operation.

Locate two rivets
through web to clear
crack

1. Remove the horizontal stabilizer forward attaching bolts and drop the leading edge to insure accessibility.
2. Drill a 1/16" stop-hole at each end of the crack to prevent spreading.
3. Fabricate and attach reinforcing channel to the stabilizer fitting as shown in the following sketch.

1 Piece 24ST Aluminum Sheet - .040 - 2" x 3"
7 - AN442-AD5 Rivets
