SERVICE BULLETIN

TITLE: Repair or reinforcement of Rudder Skins
at Tab Hinge

BULLETIN NO. 258

MODELS AFFECTED: 108-3 Serial Numbers 108-3502
thru 108-4930

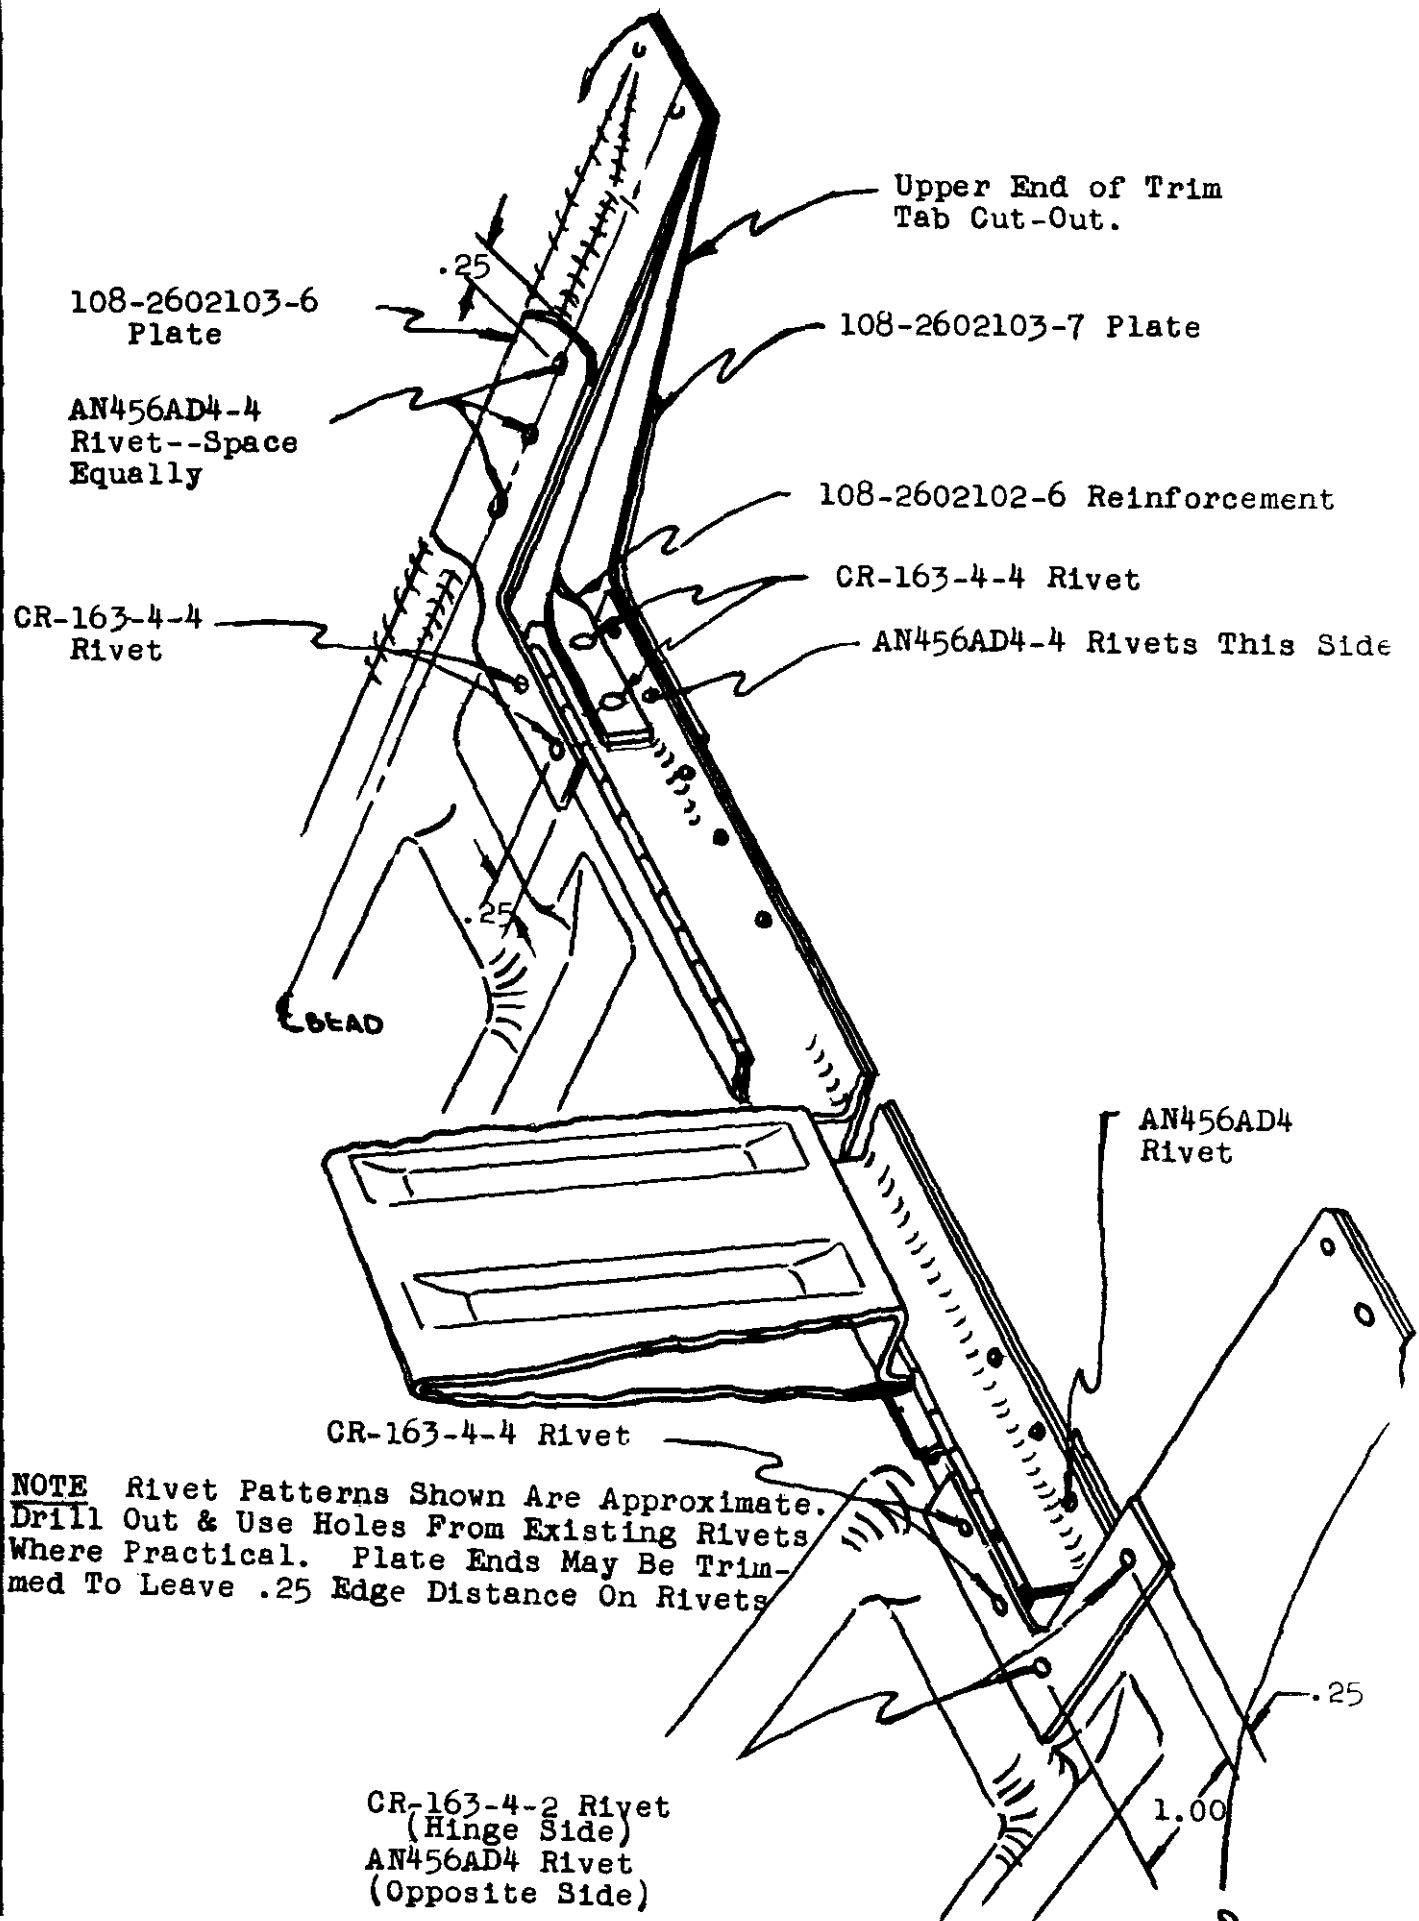
A. Inspect rudder skins at points immediately adjacent to the upper and lower ends of the rudder tab hinge for cracks. If cracks are not present, we recommend the installation of reinforcement, part number 108-2602102-6, to preclude the possibility of cracking. This reinforcement is installed at the factory on airplanes bearing serial number 108-4931 and up. Installation instructions follow:

B. Where cracked rudder skins are found adjacent to the top of the rudder tab hinge, the following repairs should be made.

C. Where cracked rudder skins are found adjacent to the lower end of the tab hinge, the following repairs should be made:

1. Detach rudder tab flexible shaft at tab end.
2. Position reinforcement, part number 108-2602102-6, as shown on drawing on page 3.
3. Attach reinforcement to rudder with two (2) Cherry Rivets CR-163-4-4 through rudder false spar and one (1) Brazier Head Rivet AN456AD4-4 through rudder skins at center of bead.
Drill .128 diameter holes for rivets.

1. Detach rudder tab flexible shaft at tab end.
2. Install reinforcement, part number 108-2602102-6, as outlined in paragraph A. above, EXCEPT DO NOT INSTALL AN456AD4-4 rivet through rudder skins.

3. Drill #40 (.098 dia.) stop hole at end of cracks in rudder skins.
4. If the rudder skin is cracked on the tab hinge side, drill out the top two rivets which attach the tab hinge to the rudder. If the skin is cracked on the side opposite the tab hinge, drill out the two top rivets on that side. Naturally, if the skins are cracked on both sides, all four rivets must be removed.

5. Install reinforcement plate, part number 108-2602103-6, over crack on tab hinge side and plate, 108-2602103-7, over crack on opposite side.
6. Drill .128 diameter holes through plate (or plates) to pick up holes from drilled out rivets. Drill .128 hole through plate (or plates) at center of skin bead. Drill additional hole through plate (or plates) so as to have three holes equally spaced on the centerline of the skin bead.

7. Attach plate (or plates) with three Brazier Head rivets AN456AD4-4 through skin beads. Use two (2) Cherry Rivets CR-163-4-4 to attach plate to hinge side of rudder and two (2) Brazier Head rivets AN456AD4-3 on opposite side.

1. Drill a #40 (.098) stop hole at the end of the crack.
2. If the rudder skin is cracked on the tab hinge side, drill out the two bottom rivets which attach the tab hinge to the rudder. If the skin is cracked on the side opposite the tab hinge, drill out the two bottom rivets on that side. Naturally, if the skins are cracked on both sides, all four rivets must be removed.

3. On most 108-3 models another rivet was installed directly below the rivets mentioned above. If this rivet is present, it must also be drilled out.
4. Position reinforcement plate, part number 108-2602103-10, and drill .128 diameter holes through plate to pick up holes from drilled out rivets. If the rivet mentioned under item 3 was not present it will be necessary to drill another .128 hole - see drawing. Drill a fourth .128 hole as shown on drawing.

5. Attach plate on hinge side with two Cherry Rivets CR-163-4-4 through plate and hinge. Use Brazier Head rivets AN456AD4-3 in all other holes and for attaching reinforcement plate on side opposite tab hinge.

NOTE Rivet Patterns Shown Are Approximate. Drill Out & Use Holes From Existing Rivets Where Practical. Plate Ends May Be Trimmed To Leave .25 Edge Distance On Rivets
