STINSON DIVISION  
CONSOLIDATED VULTEE AIRCRAFT CORPORATION  
WAYNE, MICHIGAN

TITLE: Relocation of Battery Vent Tube

BULLETIN NO. 259

MODELS AFFECTED: 108-3

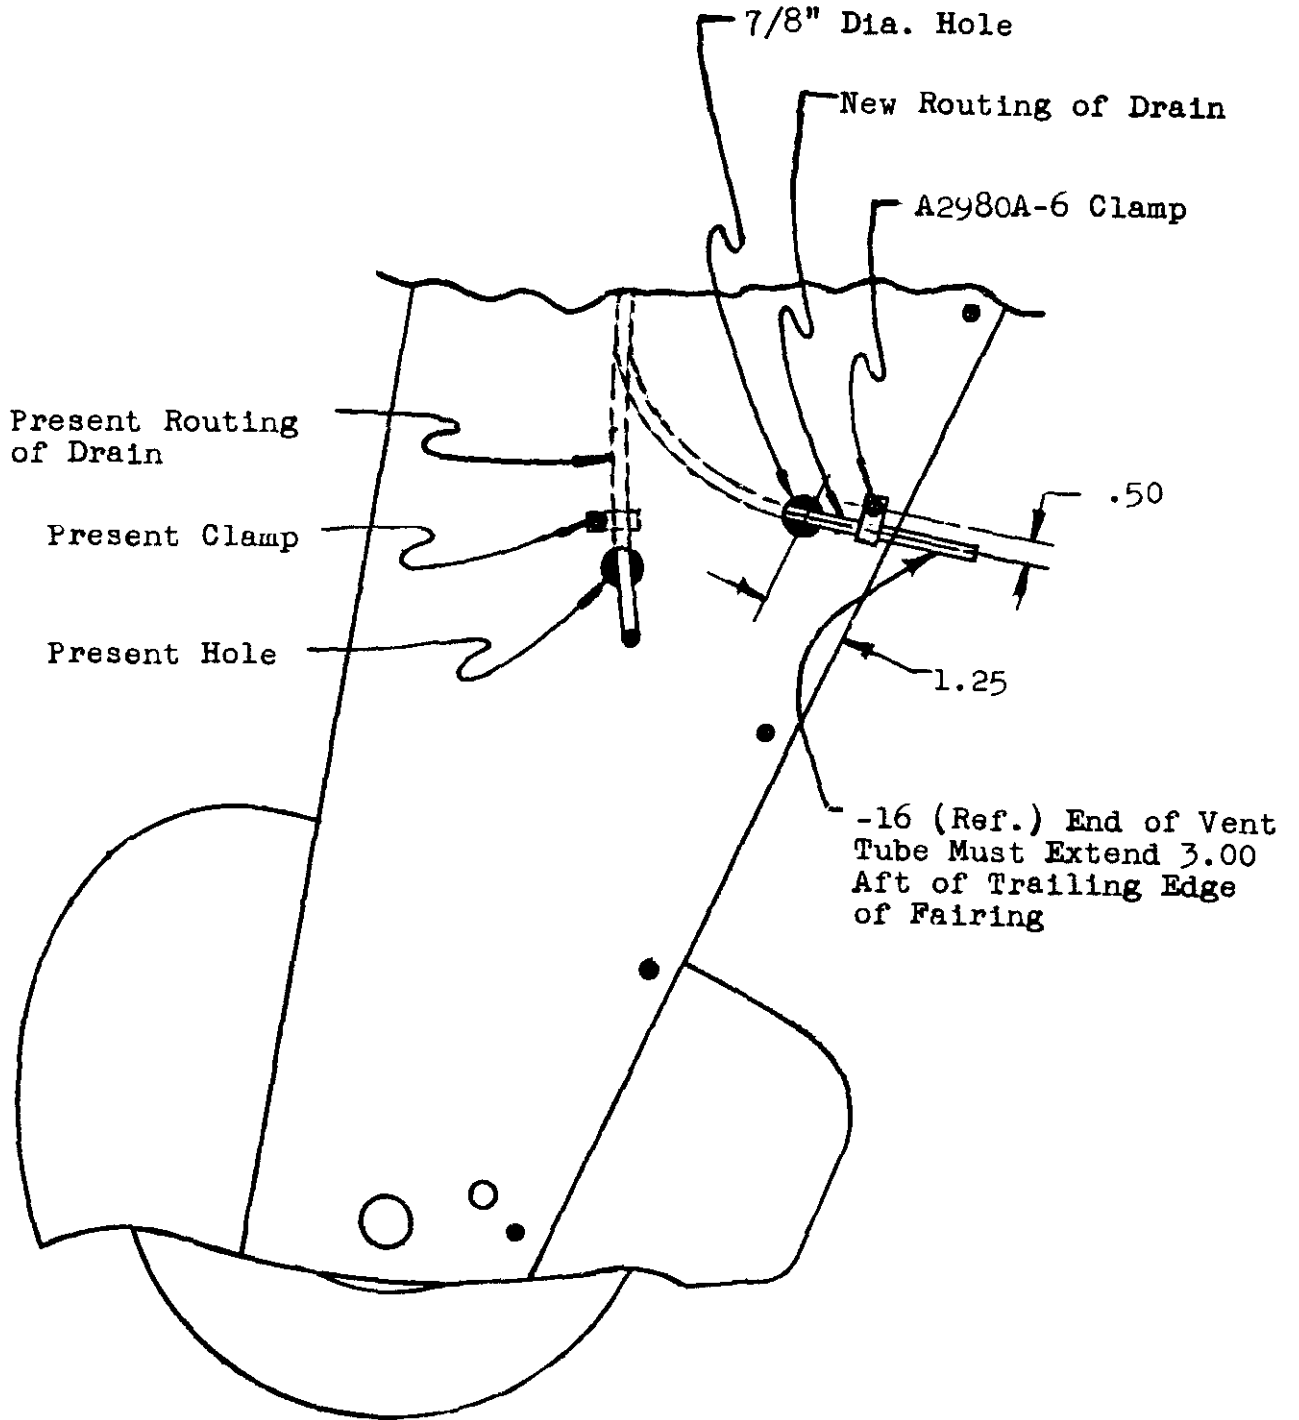
The present location of the battery vent tube, under certain operating conditions, will cause the acid vapors to attack the paint on the landing gear fairing. Tests conducted at the factory prove that relocating this tube will entirely prevent this possibility. The following modification is suggested.

Cut a 7/8" diameter hole in the under side of the right landing gear beam fairing at a point near the trailing edge. See sketch. Disassemble trailing edge of the fairing so as to make the vent tube accessible. Re-position tube through the new hole and secure the end of the tube by installing an A2980A-6 clamp. Use a screw which is already installed on the trailing edge of the fairing. Do not remove present hose clamp. The end of the vent tube must extend 3" aft of the fairing trailing edge.

Note: It is not necessary to remove the fairing to perform this work.
