Stinson Service Bulletin #266

February 1, 1950

Subject: Stinson Rudder Cables Model 108; 108-1; 108-2; and 108-3

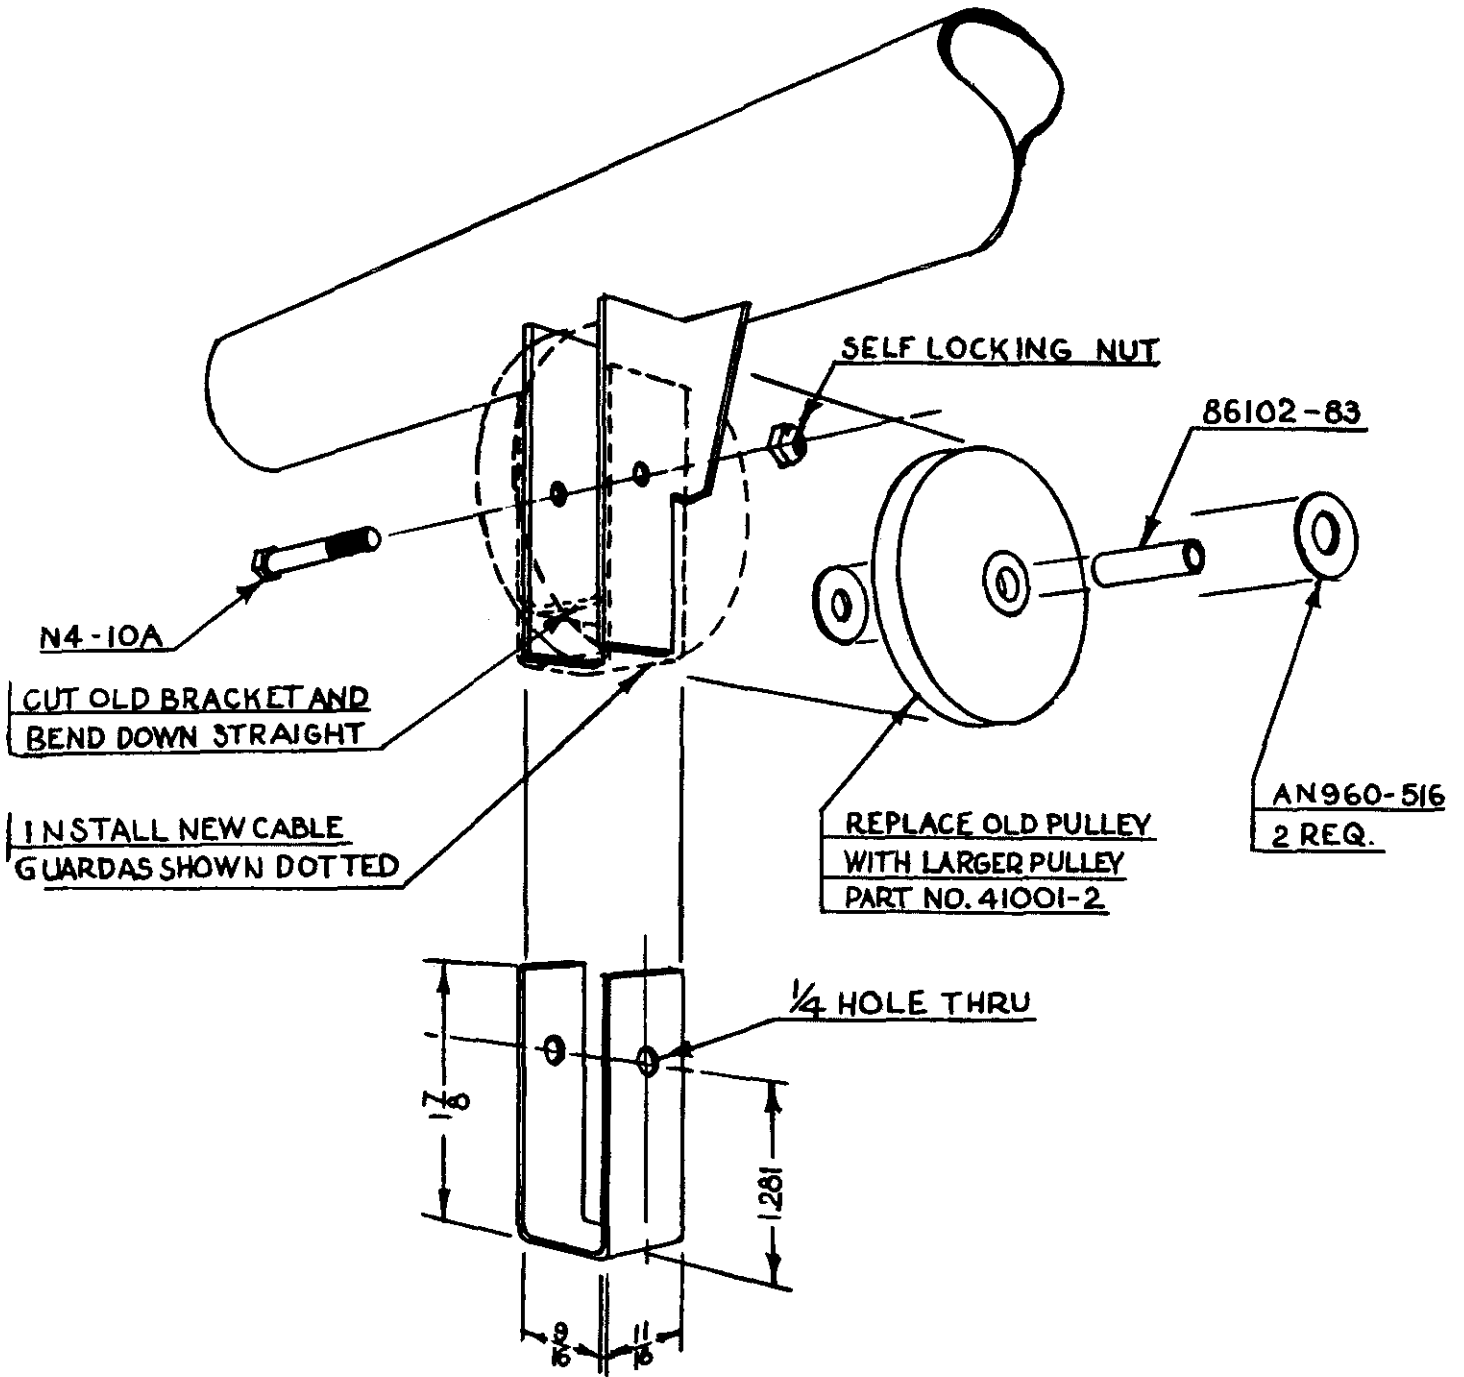
PULLEY BRACKET MODIFICATION  
STINSON 108

We have received several reports from the field that the core strands of the rudder cables were found to be broken at a point where the cable passes over the AN210-3A pulley at fuselage station 18.75, (immediately under rudder pedals.)

The cable strand breakage was caused by too great a degree of bend around the pulley. It is recommended that the pulley modification, as indicated on the accompanying sketch, be accomplished on all subject aircraft. The listed instructions should be followed in performing the modifications:

CUT OLD BRACKET AND  
BEND DOWN STRAIGHT

INSTALL NEW CABLE  
GUARDS SHOWN DOTTED

REPLACE OLD PULLEY  
WITH LARGER PULLEY  
PART NO. 41001-2
